# Congresbury Village Cross, Broad Street, Congresbury, Somerset Archaeological Excavation

**YCCART 2016/Y6**

Scheduled Monument 28824  
North Somerset HER 377

August 2016 Client: Congresbury Parish Council

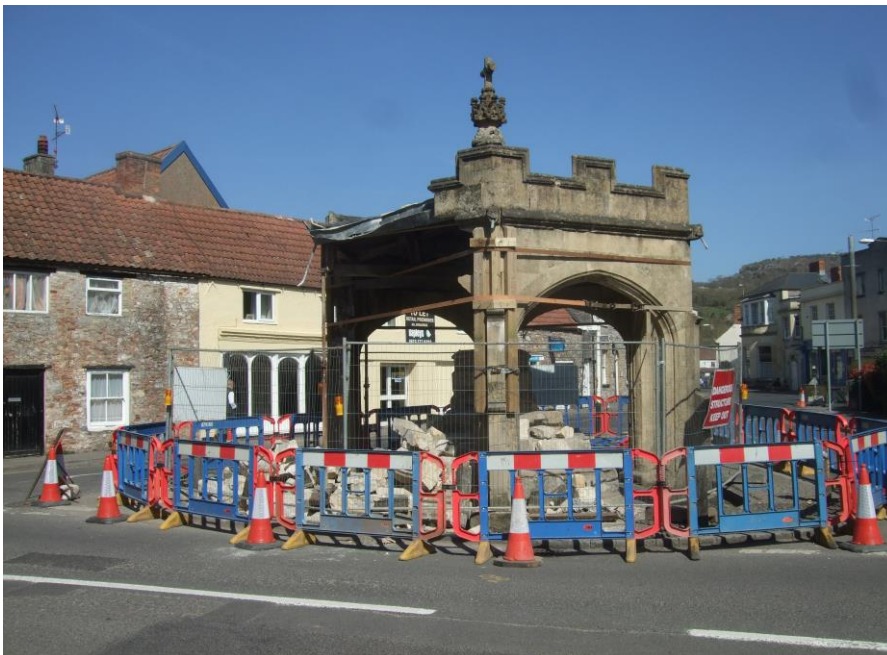
*Fig 1: Cheddar market cross semi demolished by a private car for the second time in 12 years (2012)*

- 3.4 The cross is in a vulnerable setting, lying as it does immediately next to the link road from A370 to A38 (Congresbury to Churchill), with a heavy and seemingly increasing traffic load. The vulnerability of such structures to traffic can be seen locally from the examples of the partial demolition of the Market Cross at Cheddar, twice in the 21<sup>st</sup> century, by small vehicles (private cars) (Fig 1). Vehicles on this road in Congresbury regularly drive over the lowest step or hit the structure of the cross (both personally witnessed and photographed July 2016).

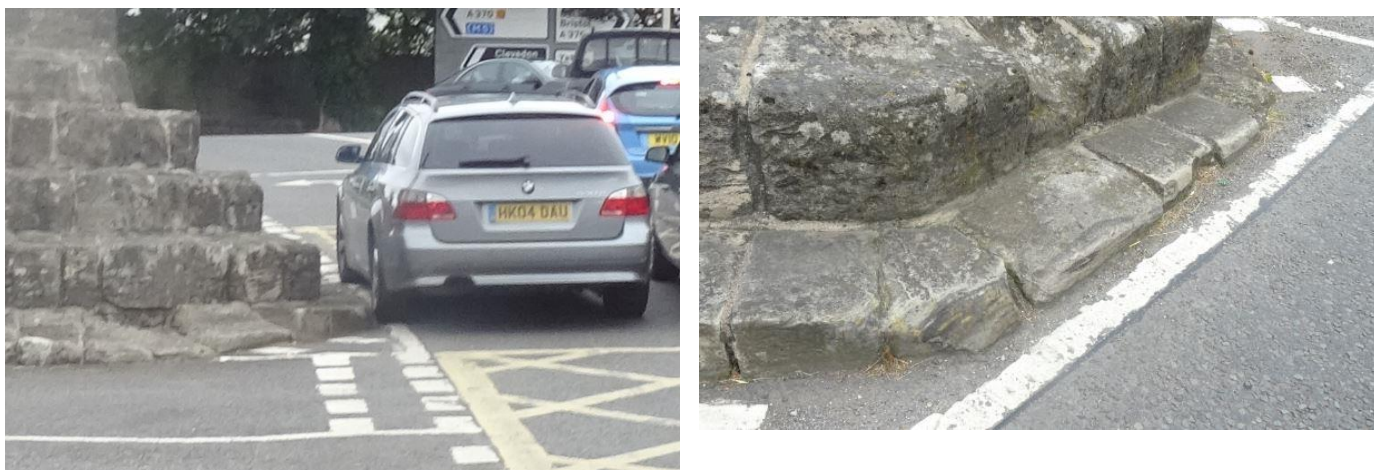
Fig 2: Left: BMW hits Congresbury cross, July 2016 Right: Scuff mark from above (among earlier collision marks). Note the damaged nature of the edge of all the roadside stones (not seen on other sides of the cross)

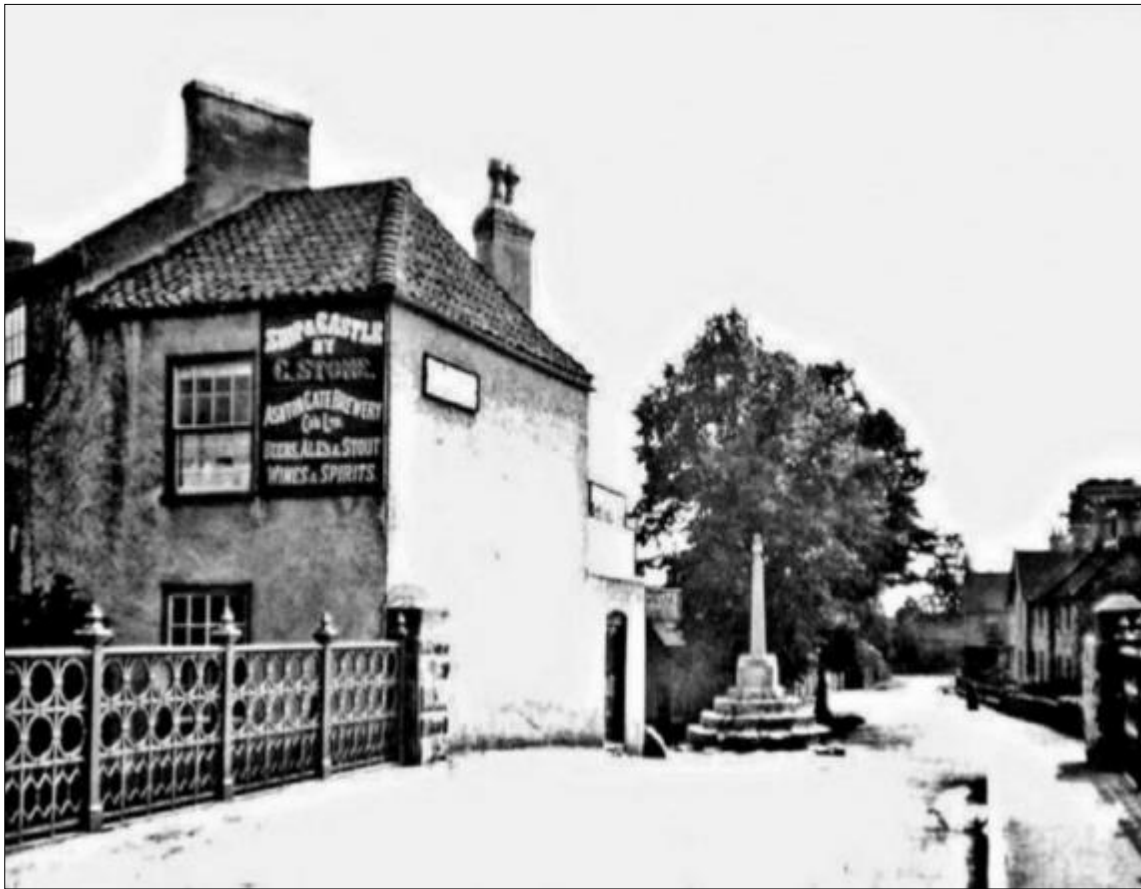
*Fig 5: View of Congresbury Cross from Congresbury Bridge in 1914, showing the cross at the crossroads in the centre of the village. The Bridge and road have subsequently been moved further west in the mid-1920s*

- 4.2 Local speculation that 'the cross has been moved before' almost certainly arises from the photographs of the Congresbury Bridge and cross taken before 1920 (e.g. Fig 5 below): these show the view down Broad Street (and the cross) from the Bridge, but it is the road and river that have moved, not the cross.
- 4.3 In addition, the presence of small scale maps of 1840 (Congresbury Tithe) and 1818 (Bristol RO 33041/BMC/4/PL1 & 2) clearly indicate the cross in its present position: no evidence was found in the excavation the subject of this report that the cross had ever occupied any position but its present.

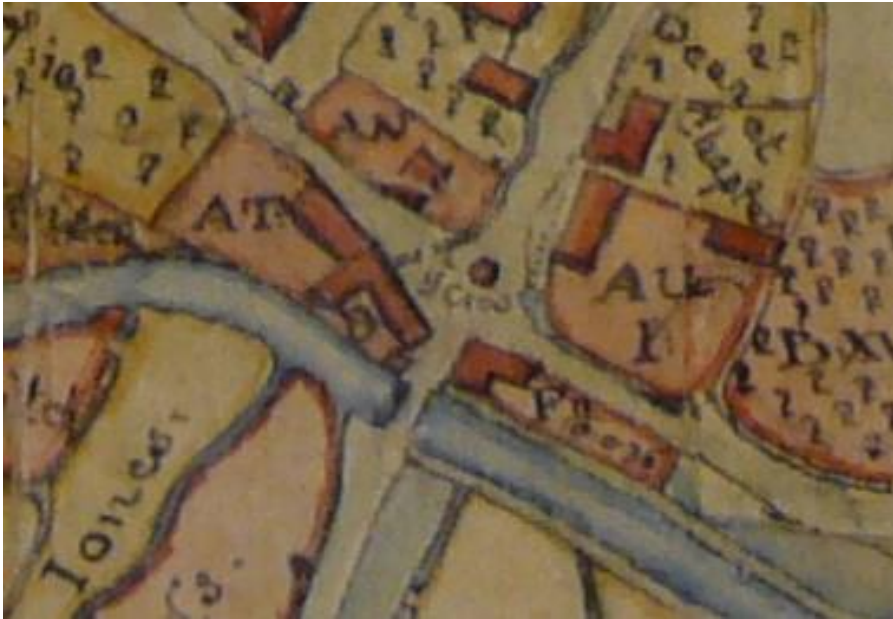
*Fig 6: The earliest known depiction of Congresbury village cross, c1818*

The cross lies within 35m of the pre-20<sup>th</sup> century course of the Congresbury Yeo, and maps of 1818 (see Fig 6 below) show the former existence of watercourses either side of the site. One runs across The Cross / High Street (where it is crossed by a narrow bridge) from the vicinity of the Ship and Castle, then alongside the east side of Broad Street, to drain into the Moor to the south. This is not depicted any later, and was presumably culverted during the course of the 19<sup>th</sup> century. A further pond is depicted on the map within 10m of the west side of the cross.

- 7.18 The copy of the deWilstar map of Congresbury of 1818 shows 'ye Cros' with the streams of water in Broad Street at its current position in about 1818 (Fig 6).

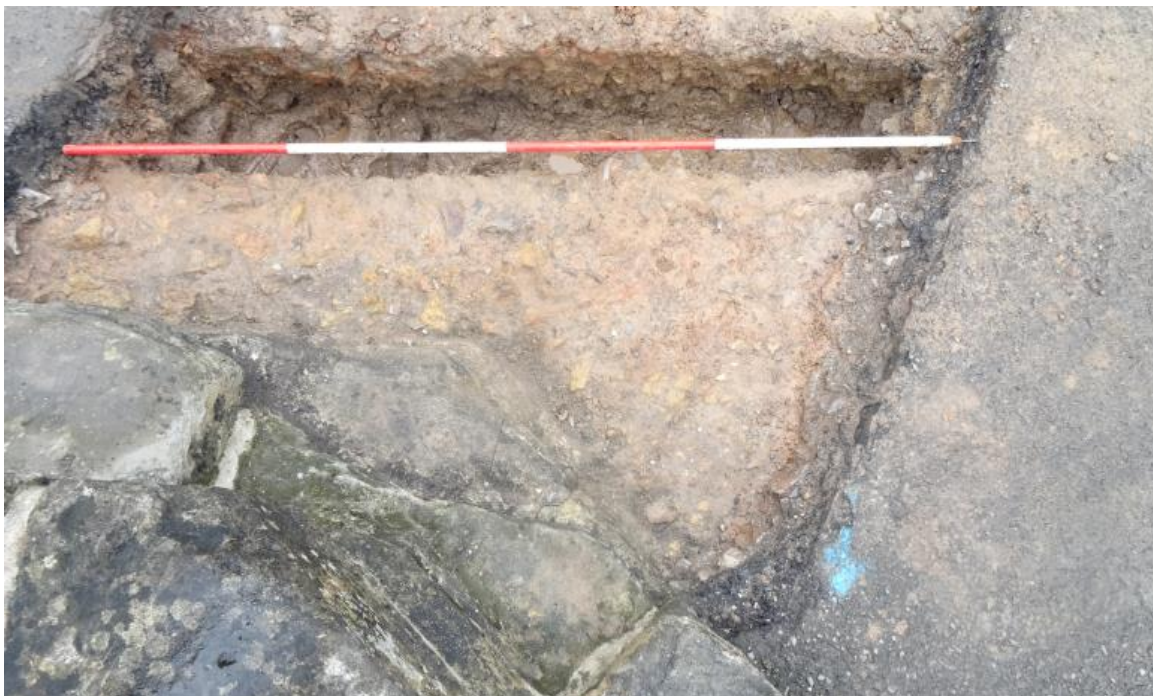
Fig 8: View from cross of cut [2], F3, showing severity of isolation of the cross from its stratigraphic environs

The regrettable severing of the cross from its adjacent stratigraphy by a modern service trench (undetectable by CAT scanner beforehand) has impacted on the usefulness of this work, although information regarding the engineering for construction of the cross had survived. The dearth of pre-17<sup>th</sup> century finds is not unexpected. All north points use the southern edge of the trench as E-W definition.

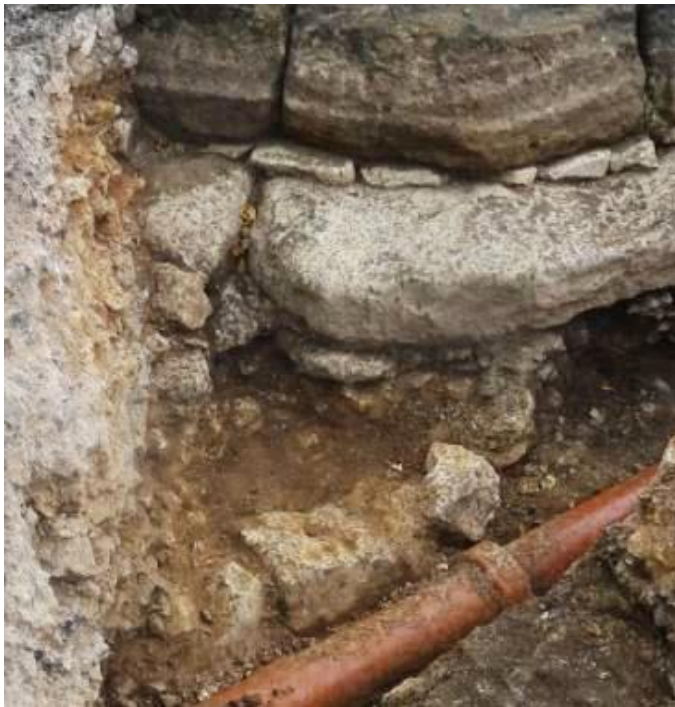
*Fig 11: F1 in context (during cleaning!) Abutment [16] is the line of Carboniferous Limestone blocks parallel to and behind pipe [13]. The construction trench for the pipe has removed the right-hand end of this context. It's stones can be seen to clearly underlie the rubble of [11] the cross sub-basement.*

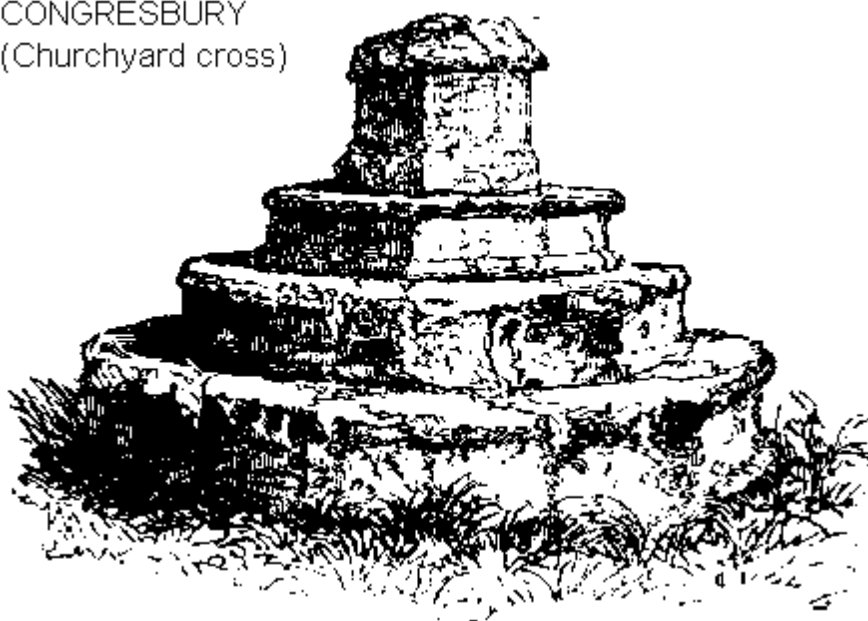
*The basement measures 4 ft. each face, by 1 ft. 7 in. in height; the second step, 2 ft. 9 in. each face, by 1 ft. 1 in. in height; and the third, 2 ft. each face, by 1 ft. in height. The socket is 2 ft. 5 in. in height, and 2 ft. 10 in. square at base. (Pooley 1877)*

*Fig 2: Congresbury churchyard cross (from Pooley 1877)*

This is somewhat damning with faint praise. The cross is of freestone (Jurassic limestone, probably from Doultong) throughout.

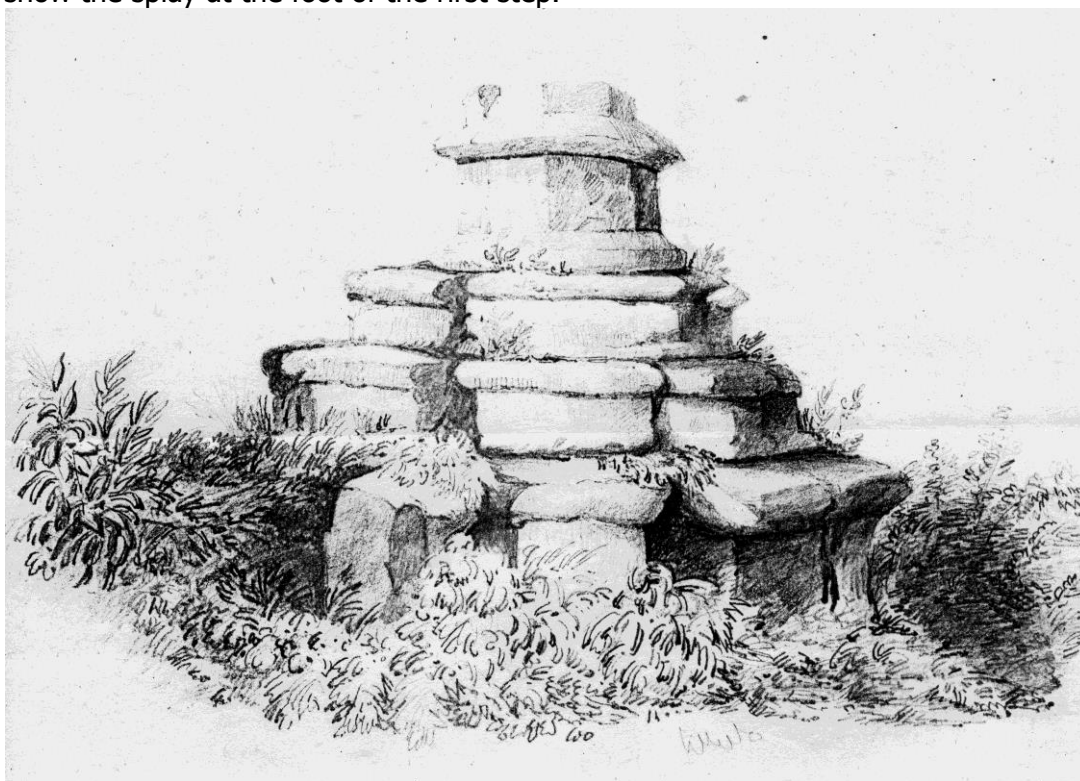
*Fig 4: Churchyard cross in 1840 – 50 (Braikenridge collection)*

A slightly later (and far more accurate) drawing of the 1840s (Braikenridge 1840x1850 – Fig 4 below) shows the cross in a dilapidated and overgrown state, with large gaps between the stones, but otherwise much as in Pooley, with the possible exception of detail of the top of the socket, where the earlier drawing appears to show an octagonal section above the string which now forms the top of the socket. The cross is certainly in the same position as today, and was missing its shaft as early as that date. There must presumably have been a restoration between 1840 and the 1870s.

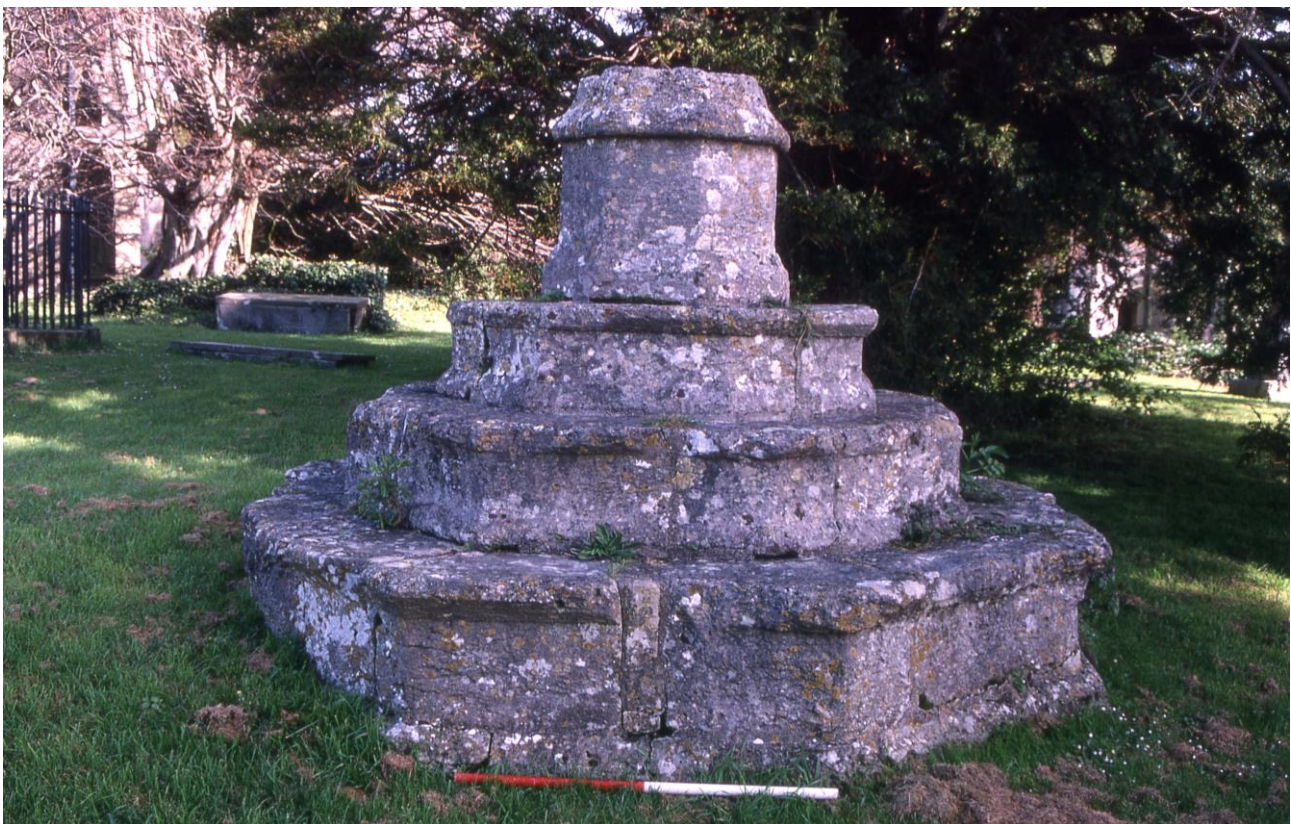
*Fig 5: Churchyard cross in 1994 (Vince Russett 1994) (scale = 1.0m)*

There are no traces of iron fittings or drill holes in the steps or socket of the cross, but these may have been removed during uninformed 'restorations' since the medieval period.

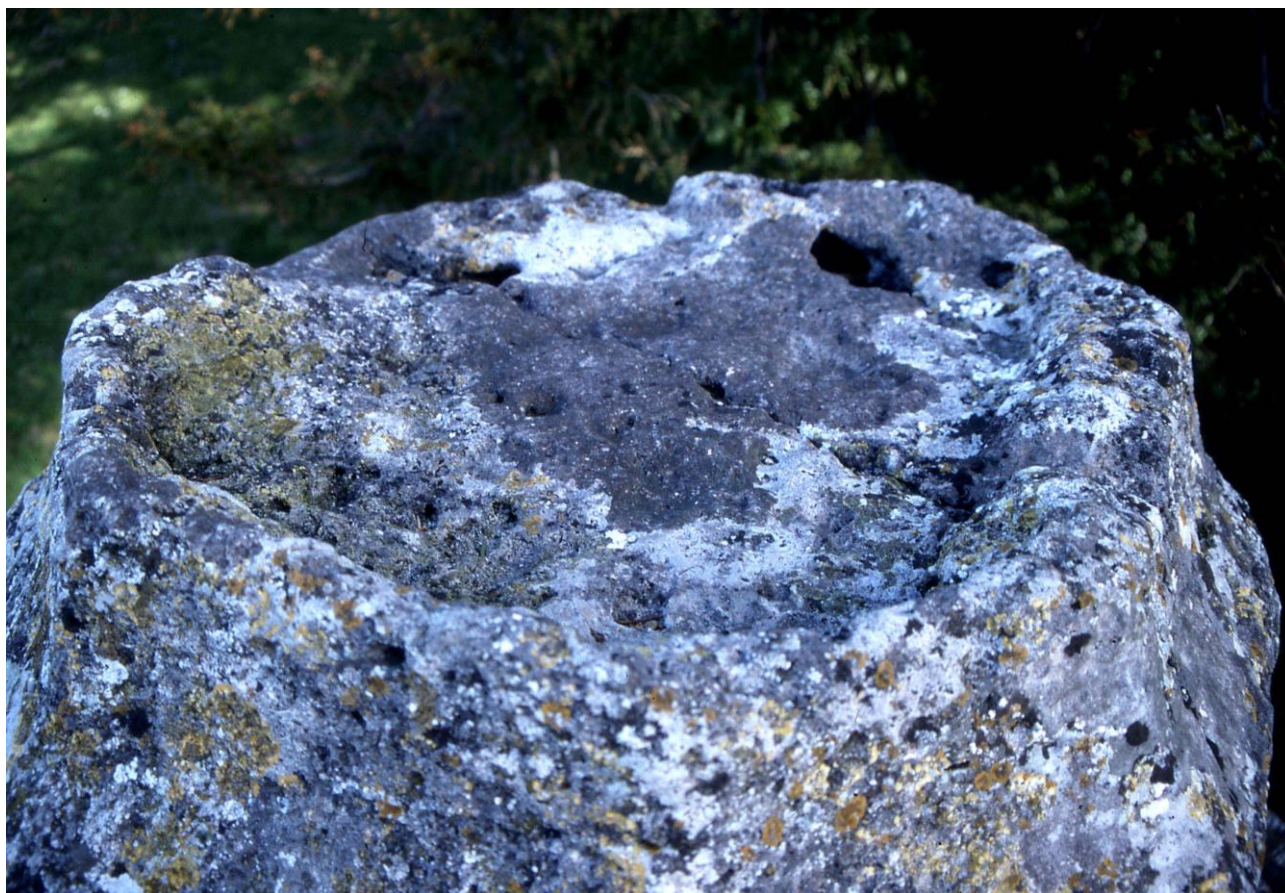
The hollow top to the socket is (Fig 6 below), as far as I am aware, unique: all other sockets have either a shaft, the remains of one, or a deep mortise for a shaft, either round (rarely) or square (usually) in section. Quite how the Congresbury cross socket functioned is unclear. It is, of course, possible that the socket has been hollowed out for some purpose after the shaft was demolished: in many areas, there is folklore based around the sockets being filled with vinegar to disinfect coins during trade at a time of plague – this could even reflect alteration of the top of the socket because of knowledge of, or even belief in, such tales.

*Fig 6: The unusual hollow top to socket of churchyard cross (Vince Russett 1994)*

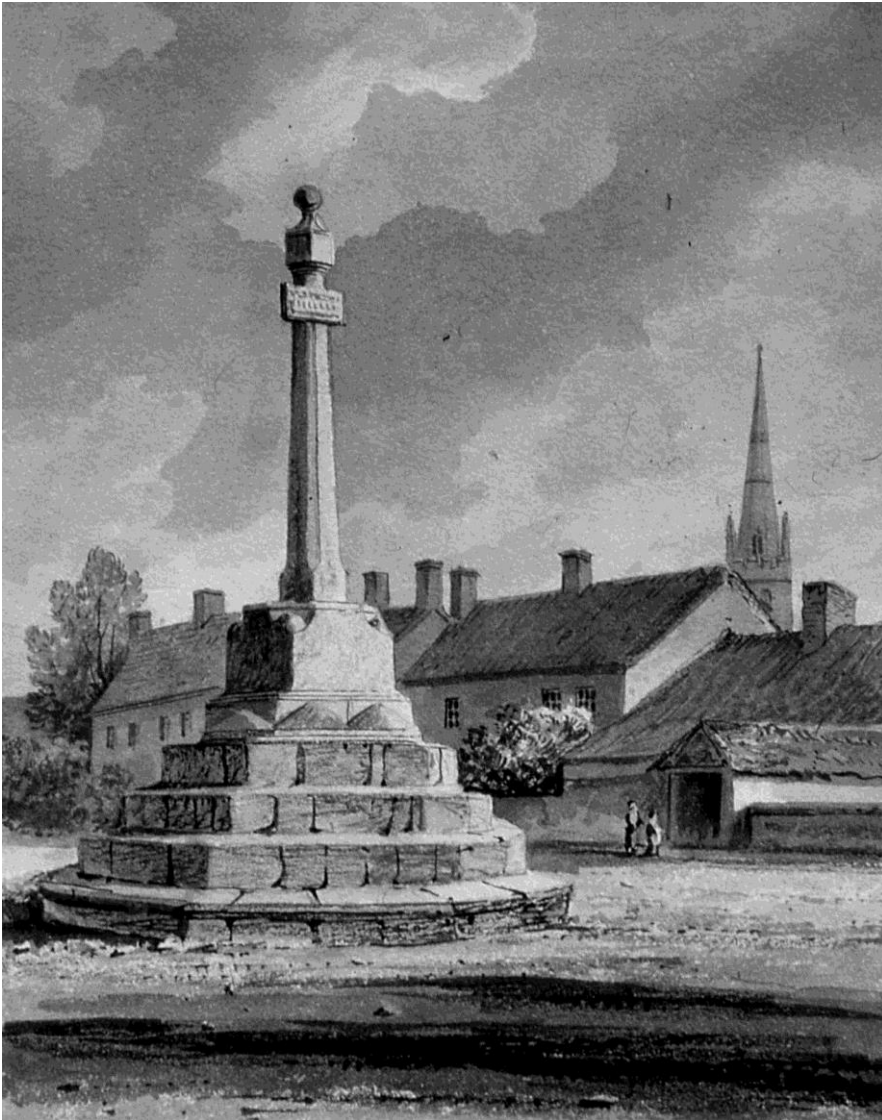
*Fig 9: Congresbury village cross in 1827 (Piggott collection)*

The Piggott collection also contains the earliest known detailed depiction of the cross (Fig 9 above). While the depiction of the 'star-plinth' (see below) is unsure, the basic details of the cross (including that it had just four steps) are clear. If there had been another two steps, as Pooley says, they would surely have been visible in this pre-metalled road times. The nature of the affix at the top of the shaft is not clear from the drawing, but it appears to bear two lines of text – 'CONGRESBURY / MARKET' perhaps?

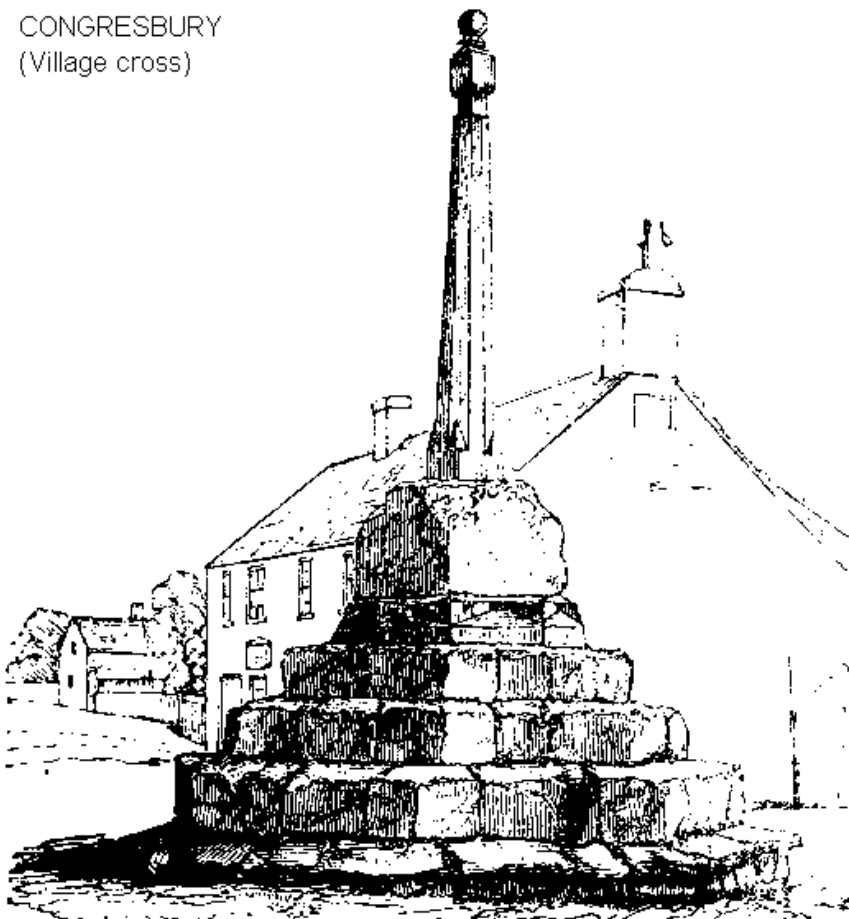
*Fig 11: The village cross in 1870s (Pooley 1877: page)*

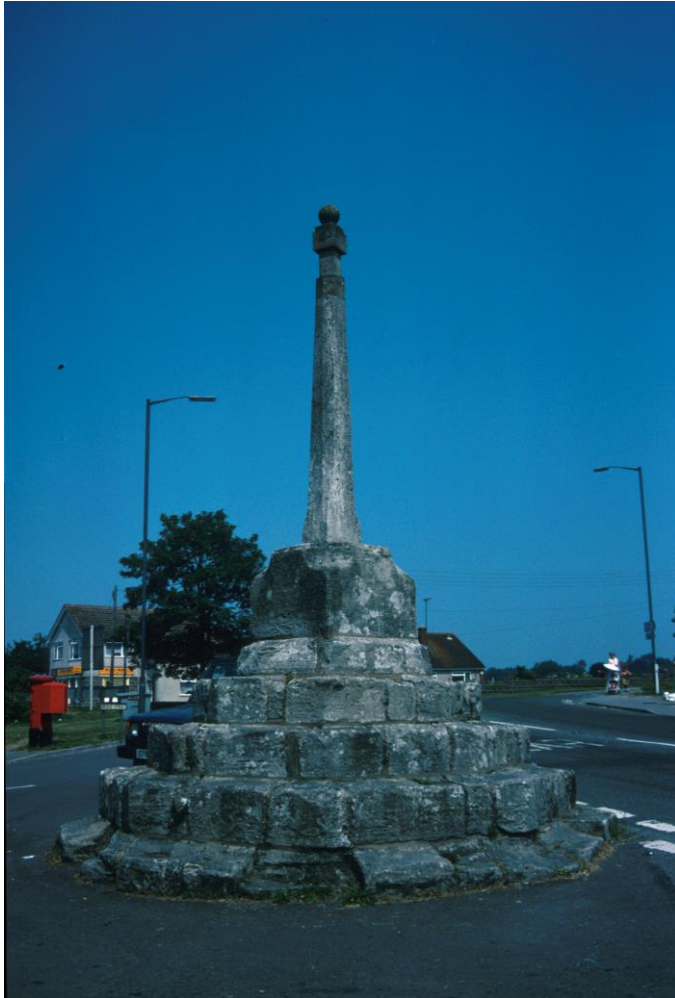
*Fig 12: Village cross in 1994 (Vince Russett)*

Although road resurfacing has crept up the lowest step, the cross is in otherwise good condition, and sometimes over-eager schemes to 'restore' the cross have by and large been resisted. This cross, a Scheduled Monument (Avon 111), formerly belonged to the Charity Trustees of Bristol Corporation as Lords of the Manor, but was handed back to the parish in the early 1970s. It is well preserved, but the story that there are two further steps below the road surface seem not to be based on any hard evidence. Six steps would be very unusual for a stone cross in Somerset. The deep drip on the lowest step that Pooley mentions was almost entirely gone by 1973, although its last traces could just be seen: they are now covered by subsequent tarmac. Its former existence is a powerful argument for there only ever having been four steps: certainly, only four are shown on Braikenridges drawing of c1840-50 (Fig 10 above).

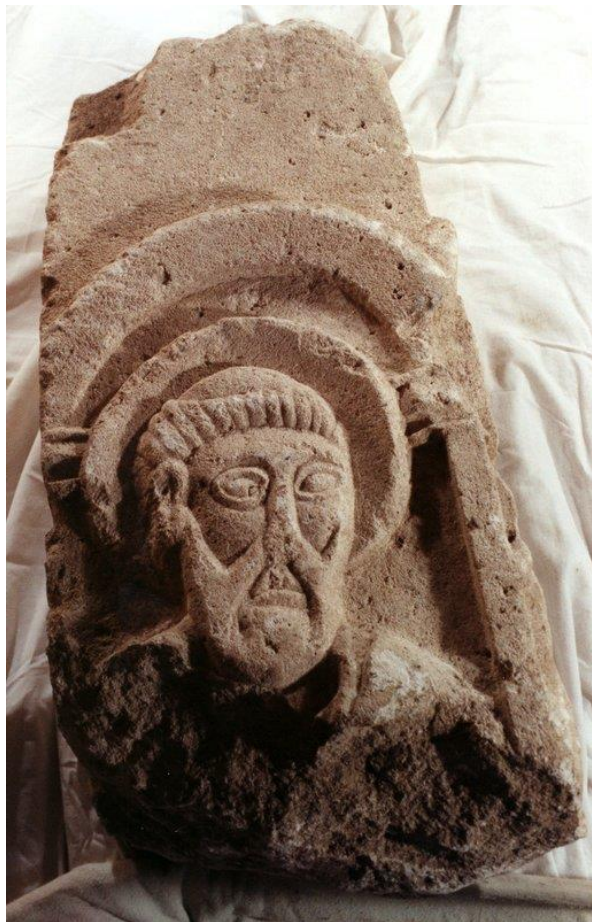
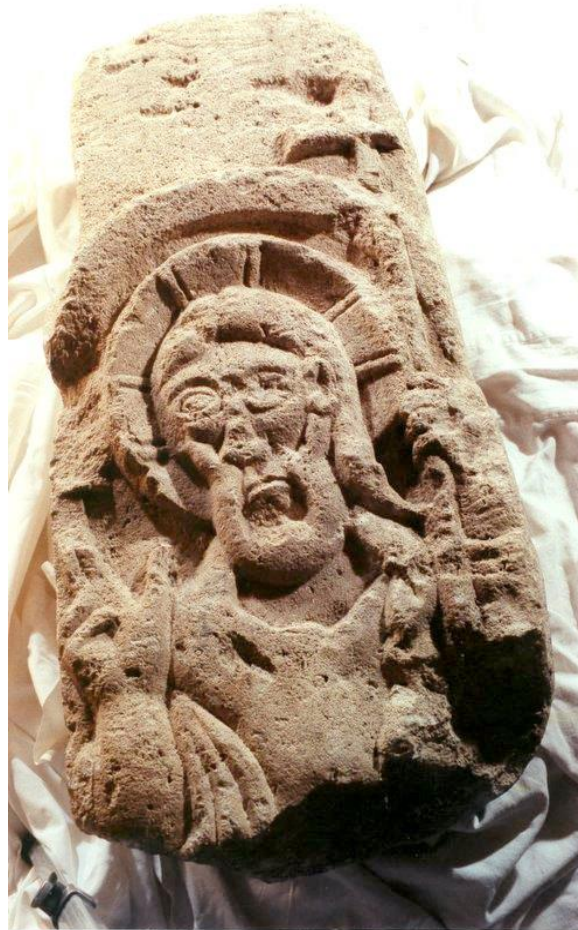
*Fig 13: Two of the Brinsea Road stones (Mike Bedingfield)*

It is apposite to include here a brief note on the very high-quality pre-Conquest carved stones found in 1995 in the foundations of a building under conversion in Brinsea Road, Congresbury. These striking late saxon carvings (see below) were at the time interpreted as being parts of a Saxon cross.

They are now believed to be portions from a shrine to St Congar, that formerly stood in the parish church of St Andrew. (Oakes and Costen 2003).

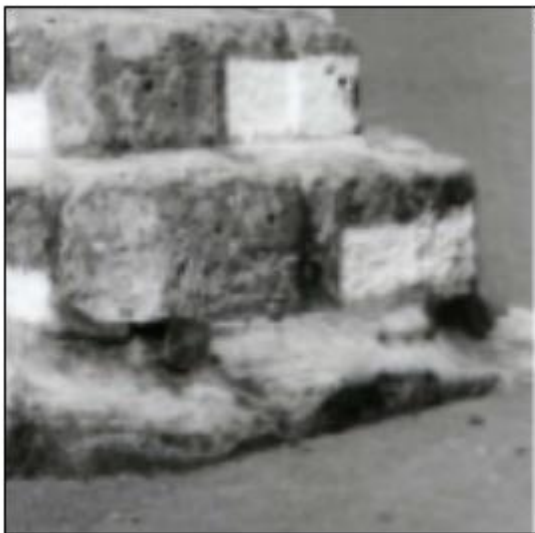
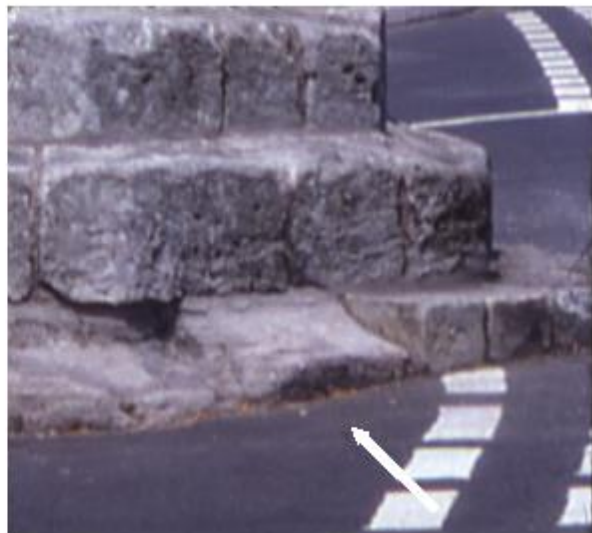
Left  
:  
194  
0  
Right:  
197  
5

Not  
e  
the  
arr  
ow  
ed  
sto

A further repair seems to have been carried out in the mid-20<sup>th</sup> century, which so far appears undocumented. A photograph of the cross in 1940, with painted stripes to assist cars in the blackout, and a photograph taken from the same direction by Russett in 1975, show that two curiously unworn cubic stones in the lowest visible step of the cross, opposite the Ship and Castle, had been placed in the interim. The stones are of a different, finer-grained lithology than the main body of the cross, and still bear clear working marks on their exposed end. Records of this may survive in the Parish Council archives.

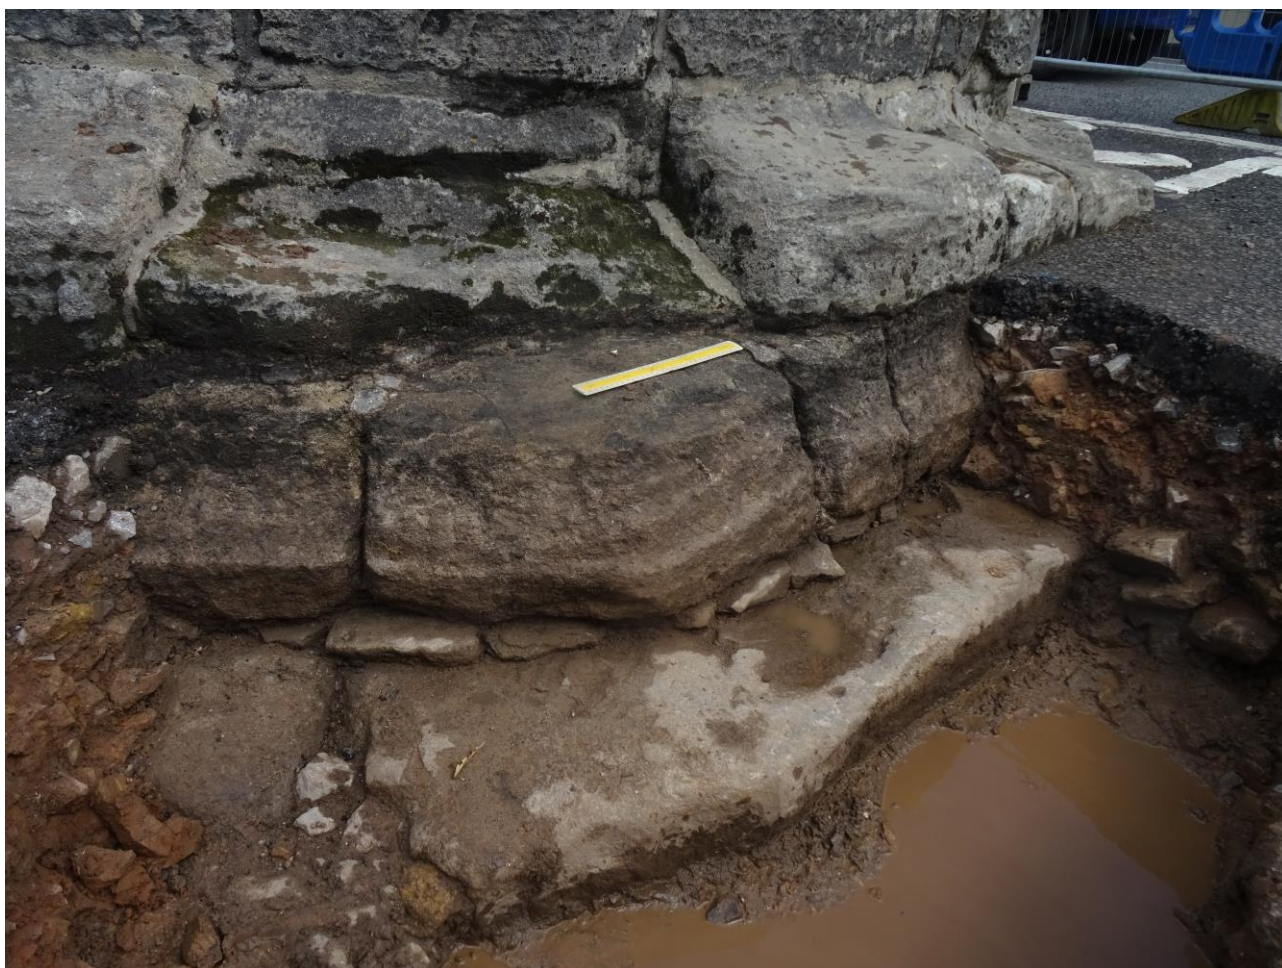
Photograph 1 (4 August 2016): The relationship of basement [7] and [8], chocked by [9] below the lowest step of the cross. Note this lowest step is darkened by its burial. F3 flooded.

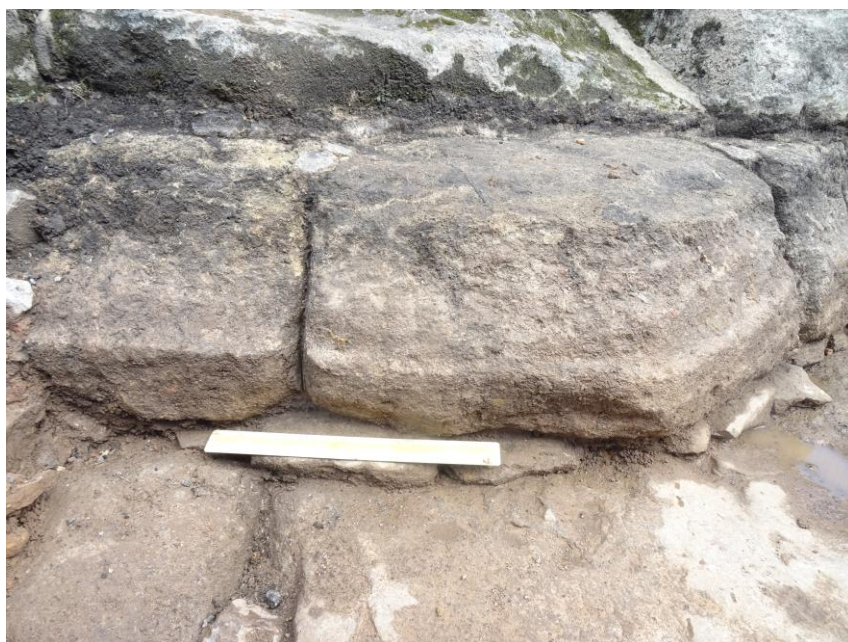
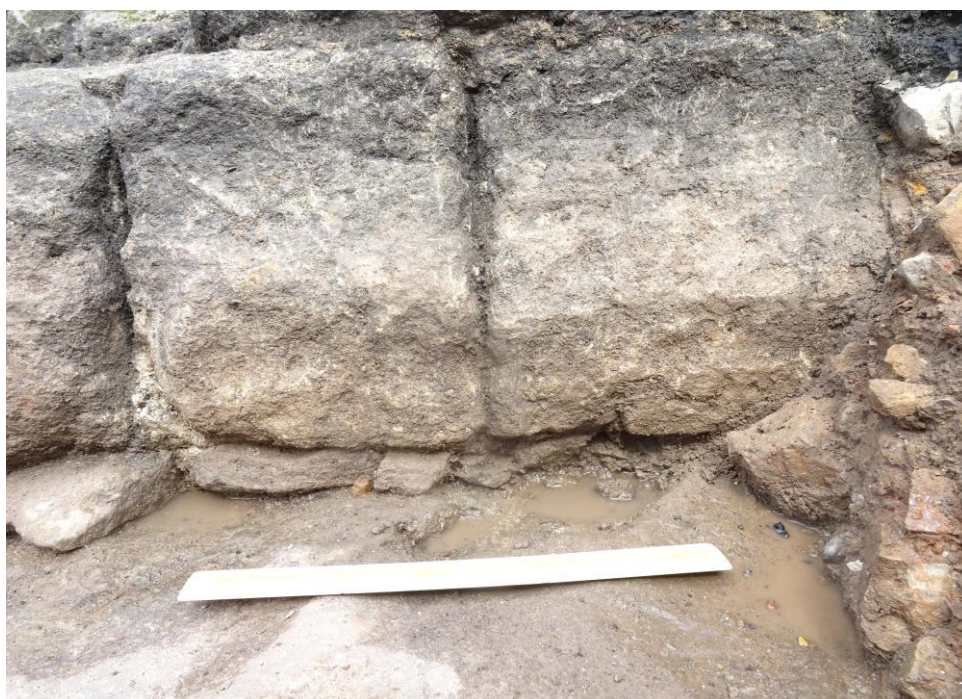
Photographs 2 and 3 (04 August 2016): SE view and E view of the lower part of the lowest step of the cross, usually buried.

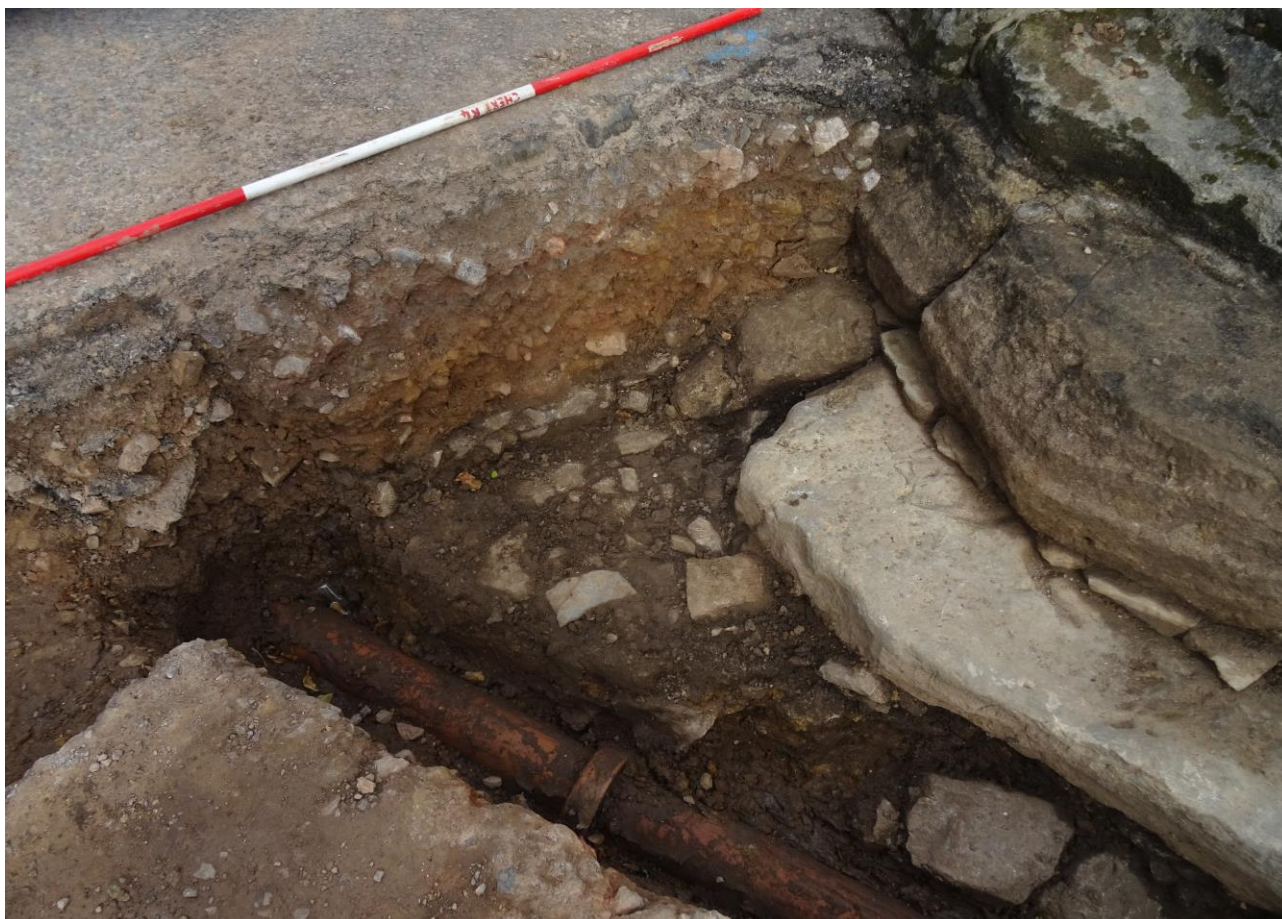
Photograph 4 (5 August 2016): Relationship of Section 3 to cross, with context [10] lying against stones [7] and [8]. Context [25] (possible road surface) visible at base of section. Possible missing stones of [16] visible at lower right.

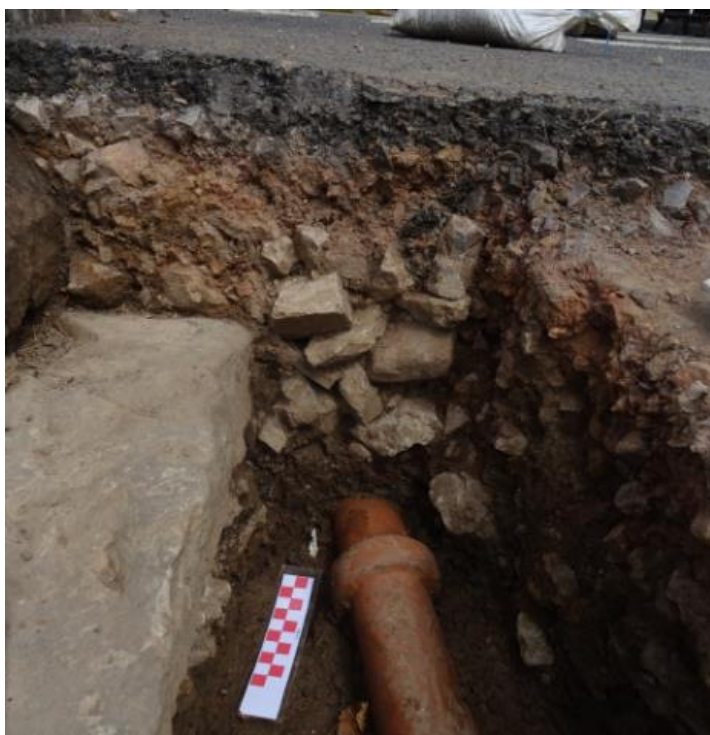
Photograph 5 (9 August 2016): Backfill of cut [2] in Section 5, looking N. Note the cut has passed immediately down the face of [7].

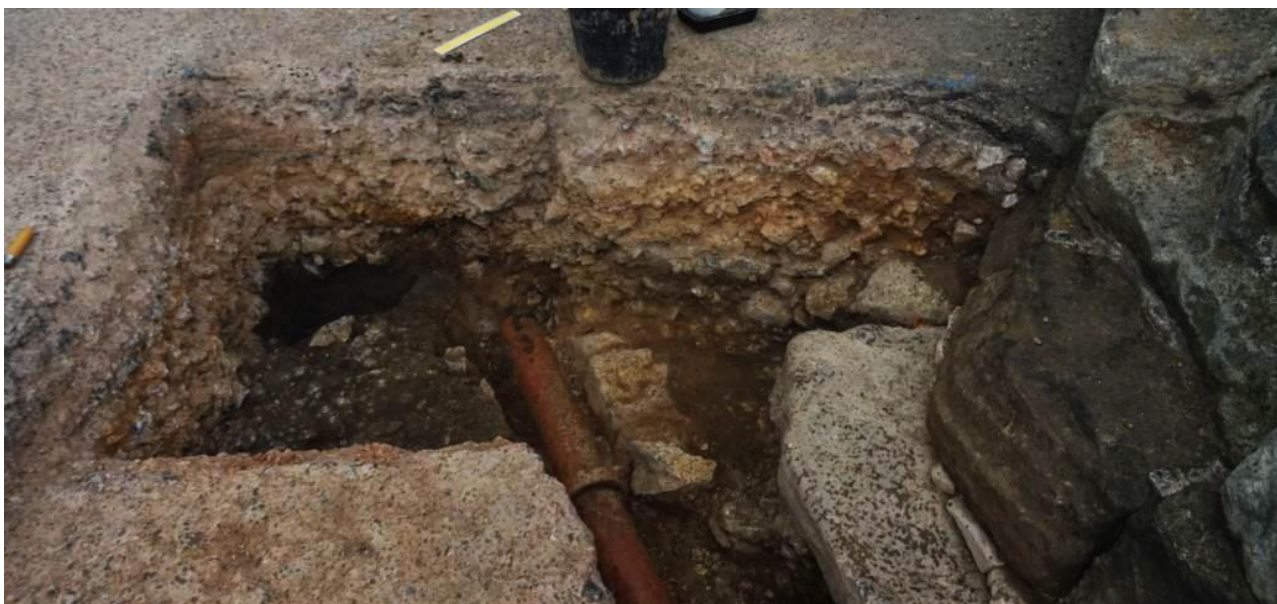
Photograph 6 (08 August 2016). View of Section 3, with evidence for cut 2 (F3) destruction: note the dark clayey [28]/[29] on left has no equivalent on right. The upward curve of [25] at the cross end of the section is clear. F1 (right of pipe) clearly had no more courses.
