**YCCCART 2024/Y10**

**Geophysical survey and site recording at Rose Cottage, Kingston Seymour**

**YATTON, CONGRESBURY, CLAVERHAM AND CLEEVE ARCHAEOLOGICAL  
RESEARCH TEAM (YCCCART)**

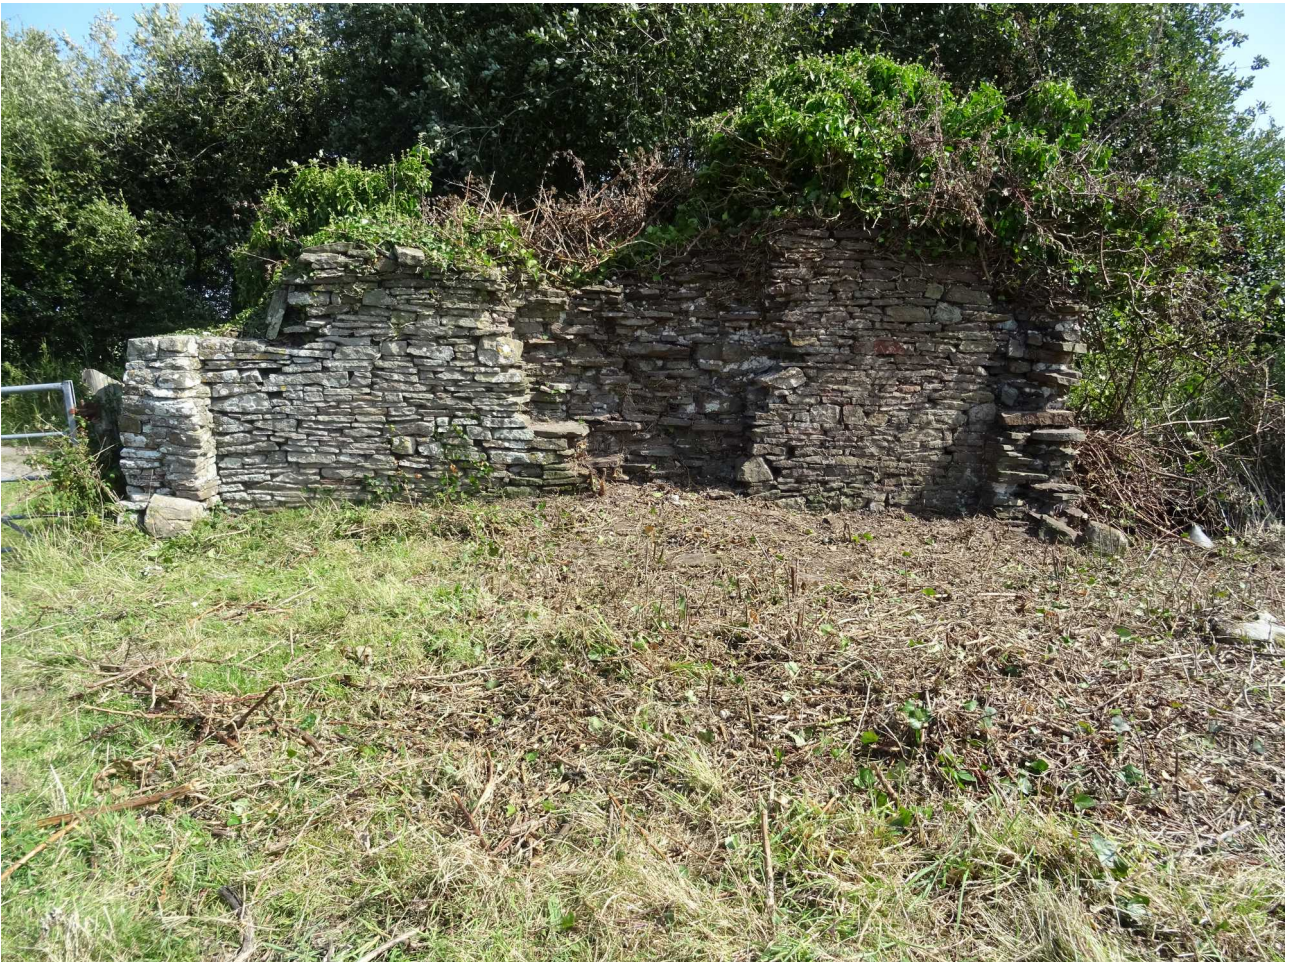
Surviving standing gable wall of Rose Cottage against the local lane

The trackside wall still stands to a height of c2m, and is 5.5m (c 18 feet) long to the corners of the north and south returns (see cover illustration and Fig 13 below).

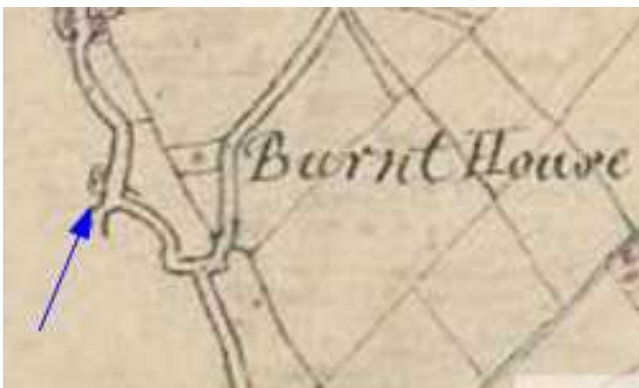
*Fig 3: A feature (arrowed) is shown on this 1810 OS First draft map, close to the named Burnt House (British Library)*

The earliest documentary reference to Rose Cottage so far known is on the OS 1st edition map of 1810 (Fig 3 below). This shows a building on the current site: the nature of the pre-industrial mortar in the standing wall, and a couple of hints from finds at the site (see below) imply that the site (and possibly the building) is older, although precise evidence is lacking.

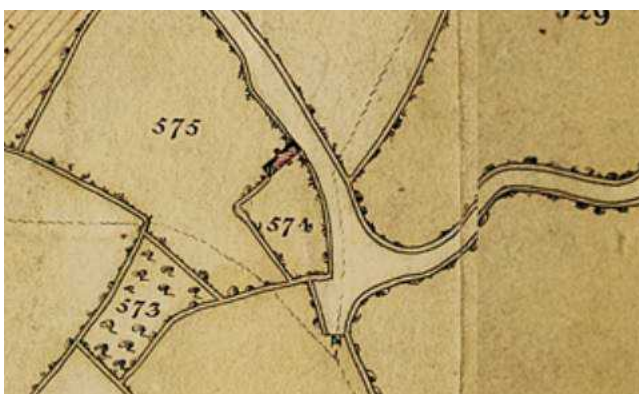
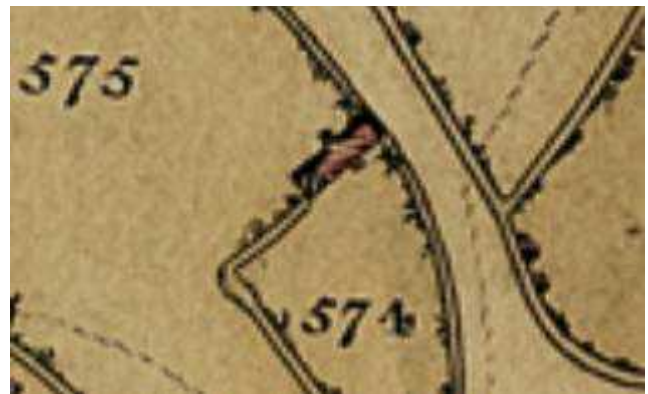
The first clear indication of the site is on the 1821 parish map of Kingston (Fig 4). This clearly shows (red colouration) a long dwelling with front and back porches, possibly two rooms on either side of a cross-passage.

*Fig 4a & 4b: Rose Cottage from 1821 map, and enlarged view of the same (per Jane Bell).*

Adjacent at the south-western end is a small outbuilding (hatched on the map). Note, the current standing wall is already in place, surprisingly close to the ditch against the lane.

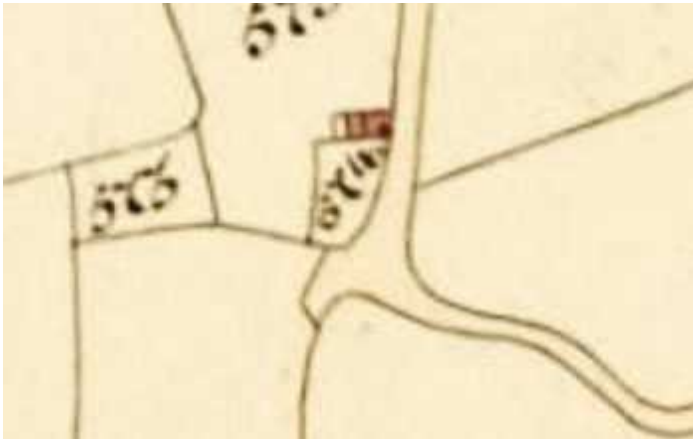
The 1846 Tithe Map and the Tithe Apportionment show the buildings (less clearly than the earlier map: the porches are not shown, but are certainly there later - see below).

*Fig 5: Rose Cottage site from the Tithe Map (1846)*

It also shows that the site was owned by one Samuel Rawlings (his only possession in Kingston) and tenanted, with a garden, by Elizabeth Pearson, the whole being 1 rood 2 perches (0.64 Ha) in size (but see below).

The quality of this map is poor.

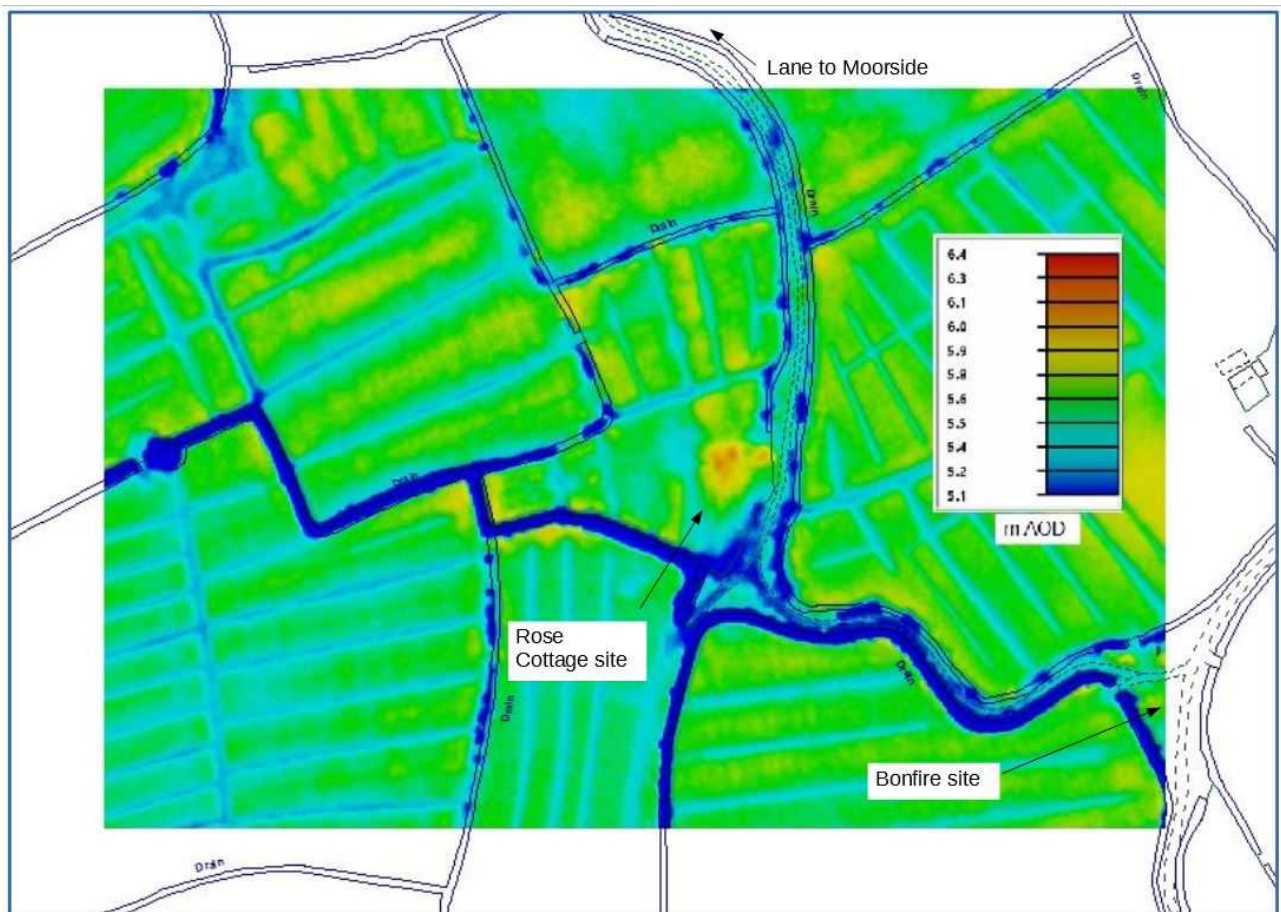
*Fig 8: Rose Cottage site (lidar 1m resolution)*

This showed that under the bramble clumps, an earthwork survived reflecting the previous buildings on the site. Fig 8 (above) shows the minimal topographic variation of the area (total c 1.3m at greatest): the drainage grypes in all the adjacent fields show as cyan and blue coloration: the cottage site is the only area in the vicinity where the absolute height rises above 6.4m AOD, implying a collapsed structure.

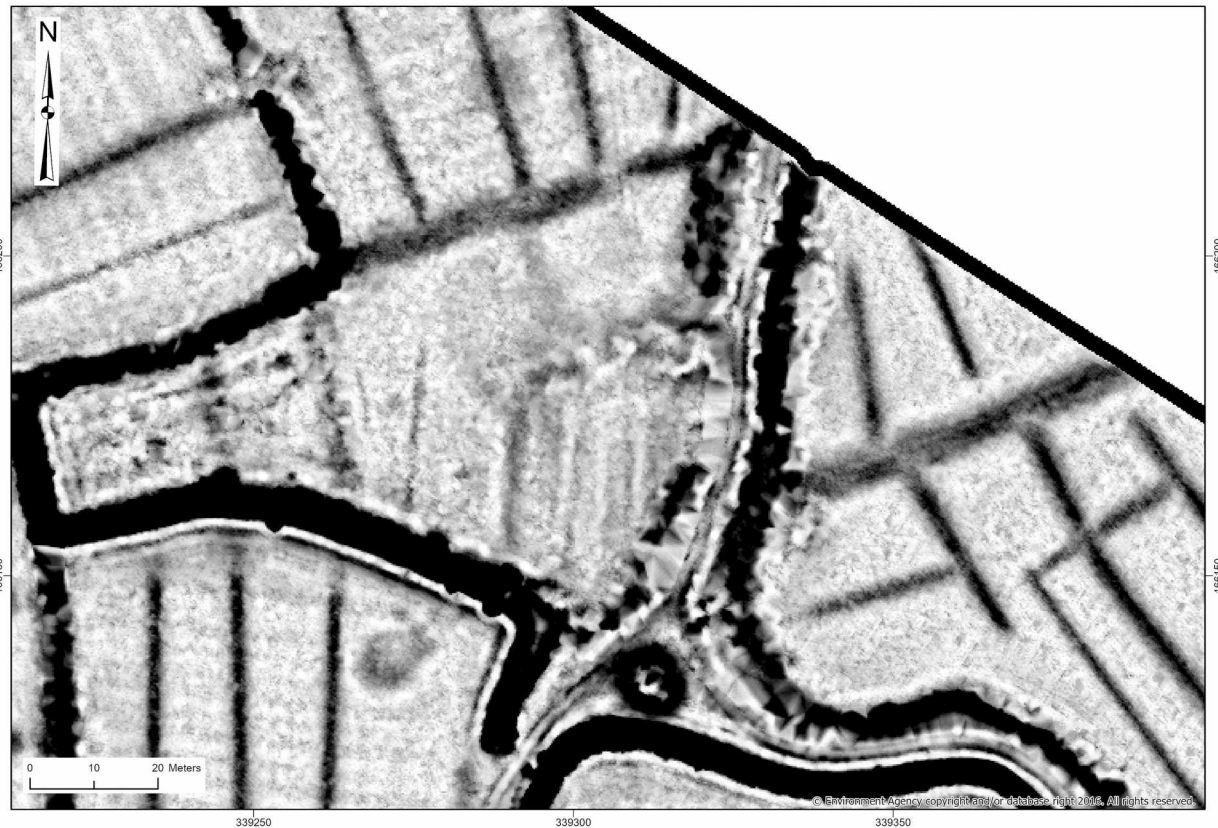
Rose Cottage - Kingston Seymour - 25cm lidar - Sky View Factor

The higher resolution lidar clarifies the picture slightly. The earthwork representing the collapsed buildings is clearer in Fig 9 (largely as clumps of brambles in the centre!): this also shows the corrugated nature of the 'garden' to the south of the dwelling.

Fig 9: 25 cm resolution lidar (Sky View) showing orchard earthworks and dwelling site (© Environment Agency copyright and/or database right 2016. All rights reserved. per Richard Pearson)

This almost certainly relates to use as an orchard at some past time (the fruit trees are grown on the raised areas to prevent waterlogging of the roots, while the gullies help to drain the area). The 'Young Orchard' immediately west of the dwelling also has these ridges, and a couple of trees survive there.

A profile across the 'garden' area shows the ridges, which run parallel to the east ditch of the garden. It is entirely possible that this was a plum orchard: plums currently thrive in the soil conditions at Kingston, and there are several plants in the east and west hedges of the plot which have a small sweet fruit which may be a hybrid with the local *Prunus spinosa* (sloe). For further lidar information, see Appendix 4.

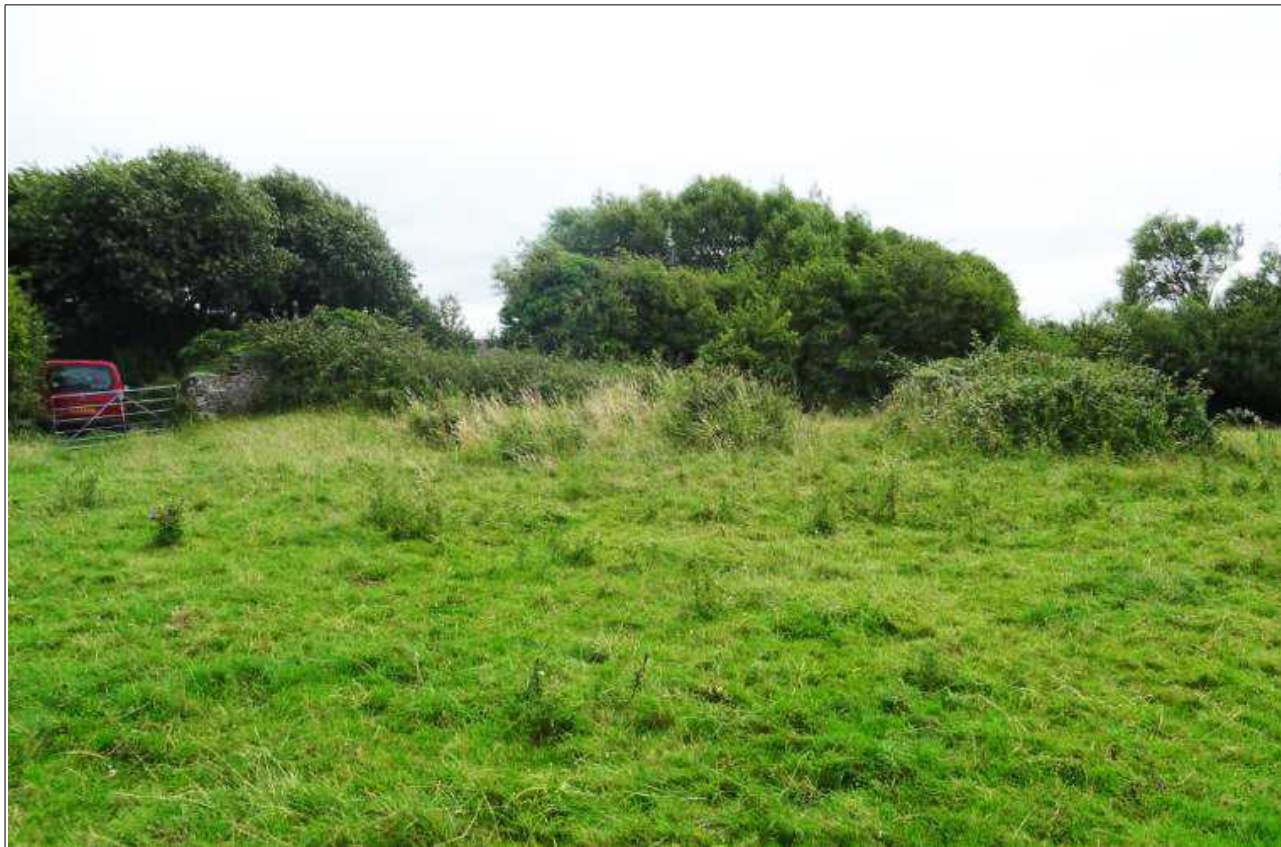
*Fig 10: Site before bramble clearance, from west: the brambles are mainly growing on rubble piles from building collapse / demolition*

The site looked as below (Fig 10) in late July 2024:

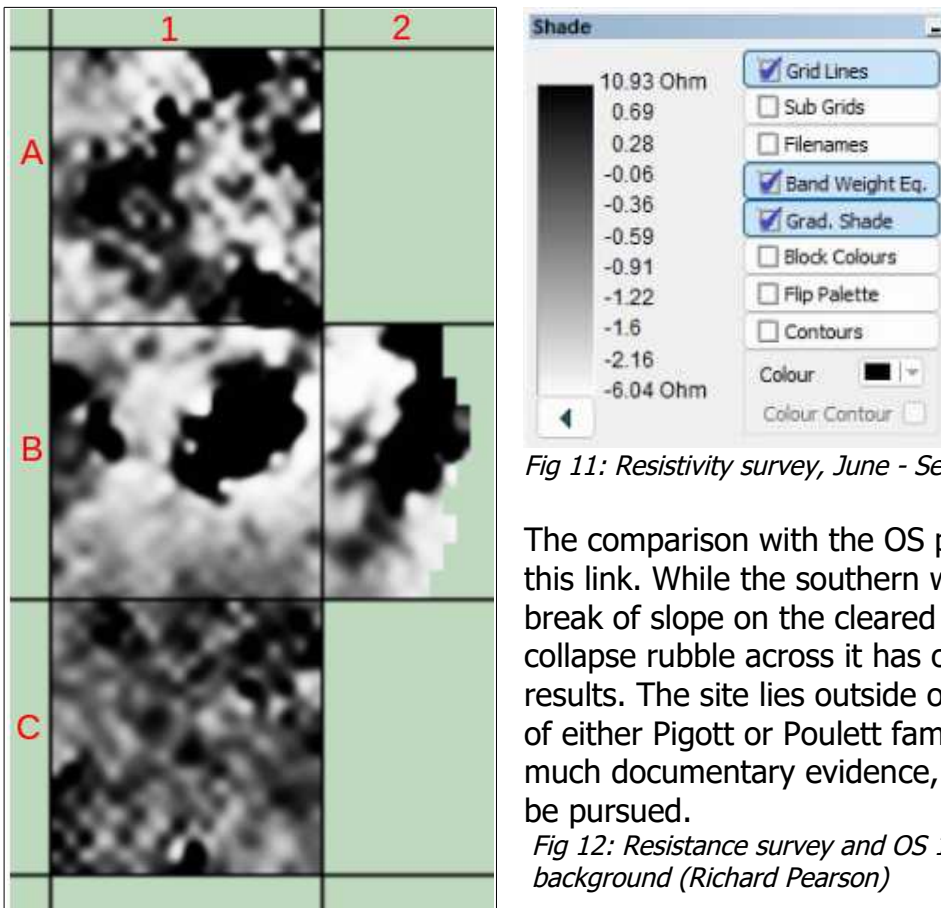
The full resistance survey is included in Fig 11. The uppermost and lowest grids show typical alluvial signals, with very low resistance.

Fig 11: Resistivity survey, June - September 2024

The central grids lie directly over the mapped remains of the building. As can be seen from Fig 12, with an overlay of OS building outlines over the resistivity results, much of the outline of the buildings is obscured by the very high resistance of rubble piles within, and to the south of, the known buildings.

These rubble piles imply that the dwelling was (as might be expected) a stone building: the far smaller area of high resistance in the area of the western 'barn' probably implies that this was not.

Grid B2 reflects the high resistance of the rubble fallen from the surviving gable wall (including the visible collapse in the centre of the wall in mid-2024).

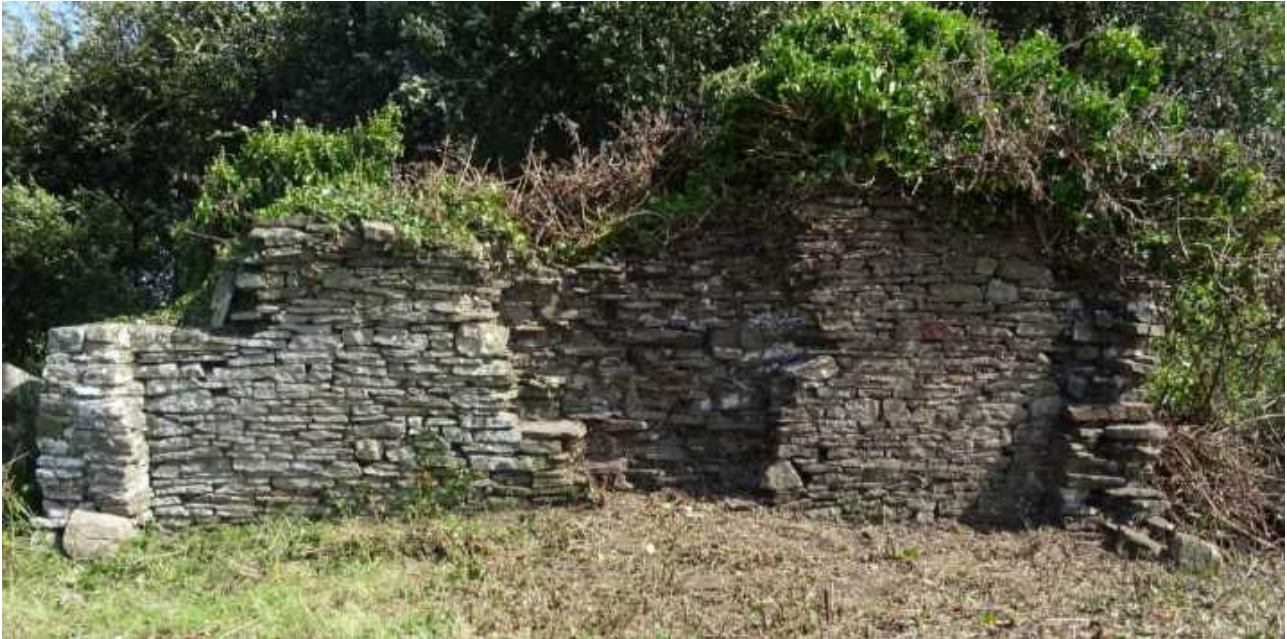
*Fig 13: The trackside wall (west elevation)*

Only the west elevation was available for recording: the east (track side) is covered in a heavy growth of mature ivy, which is stabilising the wall structure.

The wall is mostly composed of coursed Pennant Sandstone, set in an off-white mortar (2.5Y 9/1) with abundant rounded sand (probably washed sea sand). This was covered on the interior of the room by a very pale yellowy plaster (10YR 9/2) which in places was decorated with a splashing of painted pale red ochre (10R 6/3): see Appendix 2 Finds. Both are likely pre-industrial, with no sign of the conspicuous charcoal / coal fragments usually found in mortars later than c 1800.

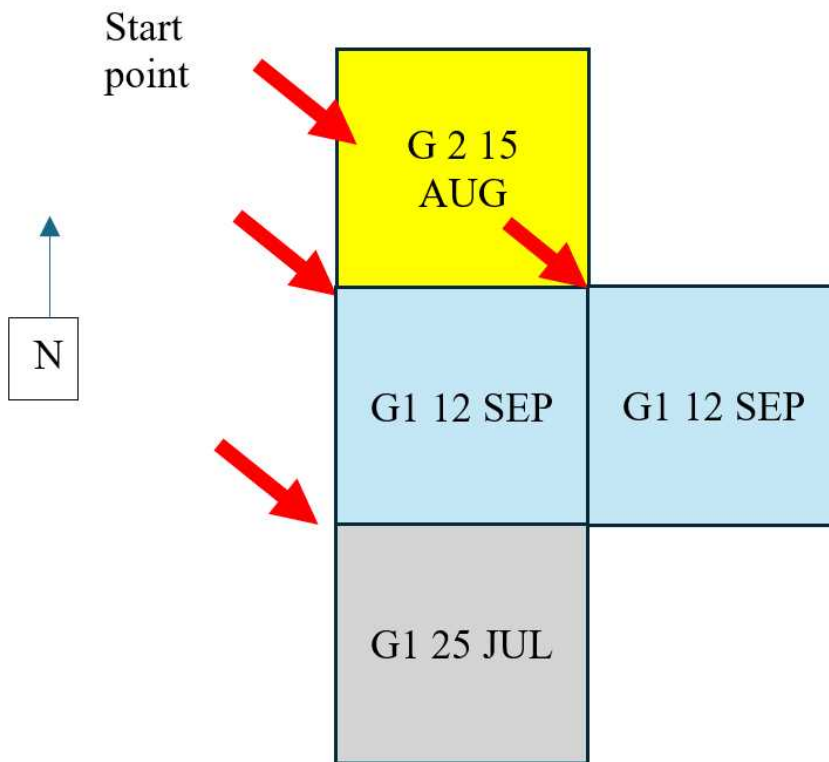
Grid layout

Date	Number of grids	Grid size	Direction of survey
25 July	1	20 x 20m	EAST
15 Aug	2	20 x 20 m	EAST
12 Sep	2	G1 – 20 x 20m ( <i>Repeat of grid 1 15 Aug</i> ) G2 – 20 x 12m appx	EAST

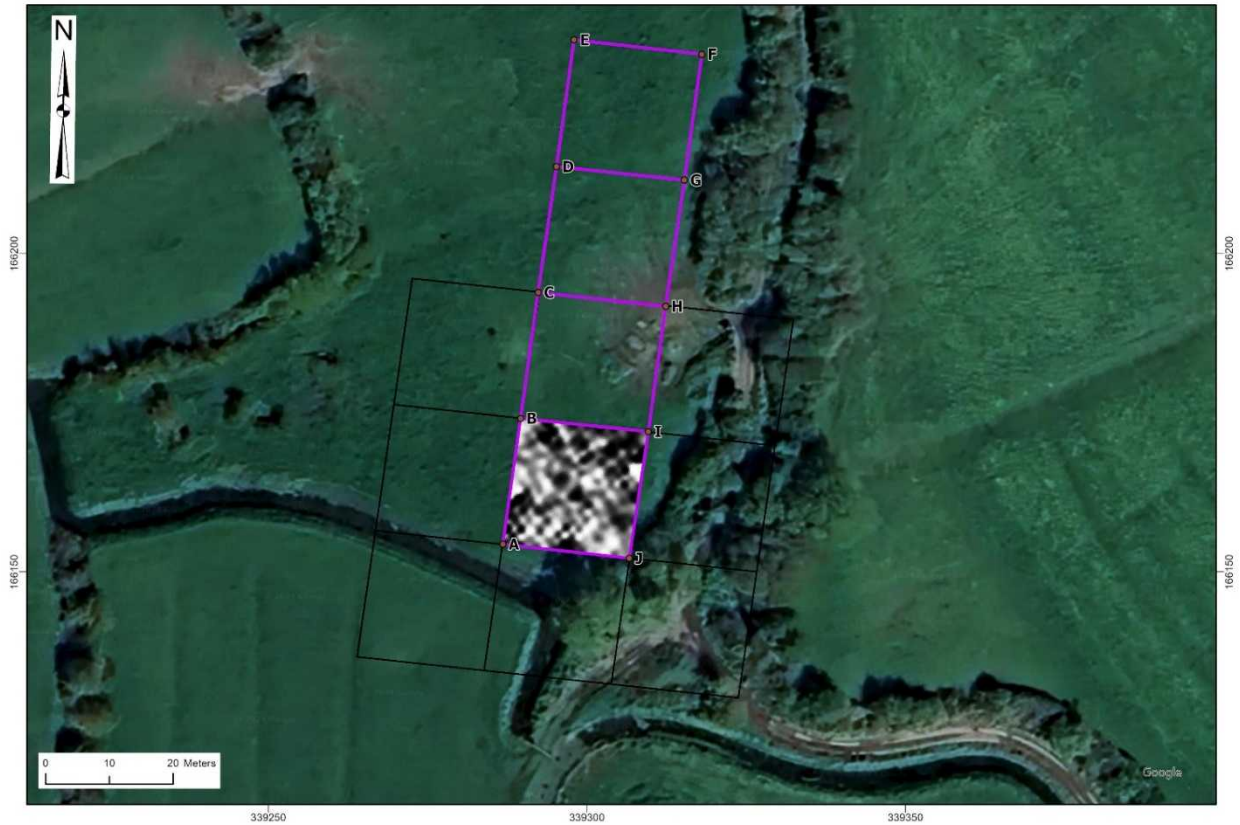
Rose Cottage - Kingston Seymour - Grid coordinates

A	B	C	D
Survey	Point	Easting	Northing	
Rose Cottage RM15	A	339286.80	166154.34	
Rose Cottage RM15	B	339289.59	166174.09	
Rose Cottage RM15	C	339292.33	166193.87	
Rose Cottage RM15	D	339295.22	166213.64	
Rose Cottage RM15	E	339297.98	166233.55	
Rose Cottage RM15	F	339318.04	166231.29	
Rose Cottage RM15	G	339315.30	166211.52	
Rose Cottage RM15	H	339312.35	166191.68	
Rose Cottage RM15	I	339309.64	166172.01	
Rose Cottage RM15	J	339306.66	166152.13

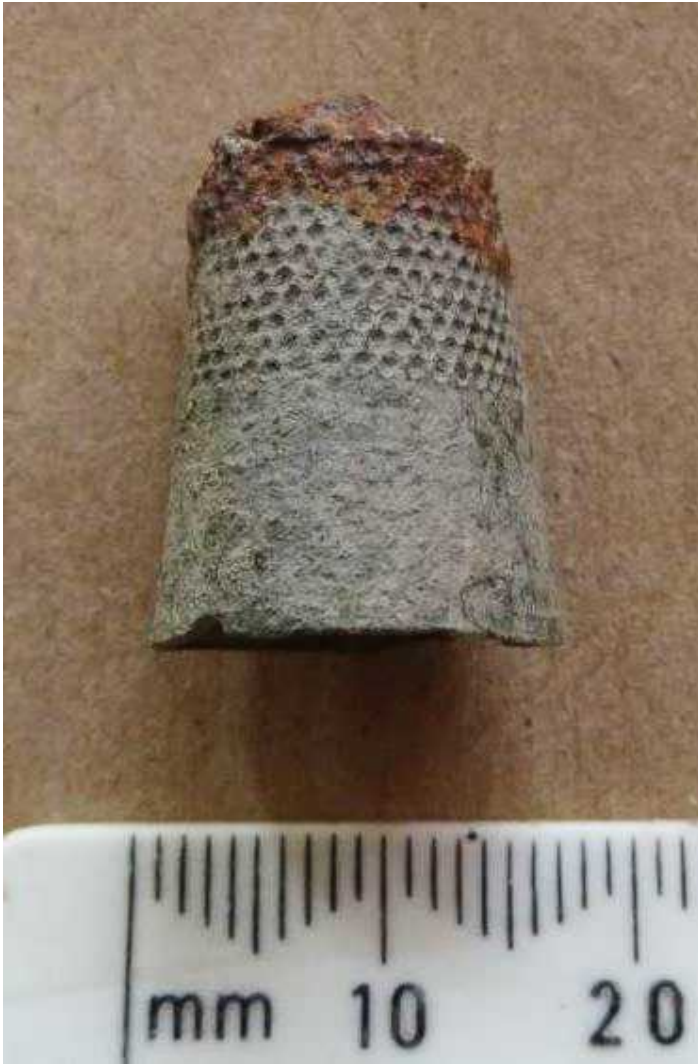
*Brass thimble, tiny in size (16mm at opening); probably a child's toy (or thimble for use with extraordinarily small hands).*

The thimble has iron scale on its closed end, possibly post-burial. As machine-made, it is datable only as 'industrial' i.e. post-1780.

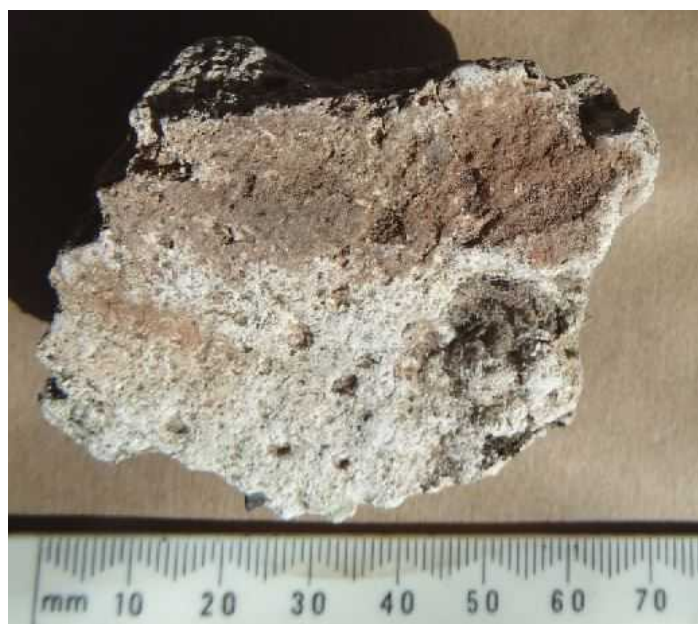
*Fragment of mortar from trackside wall, showing brushed ochre decorated surface of plaster.*

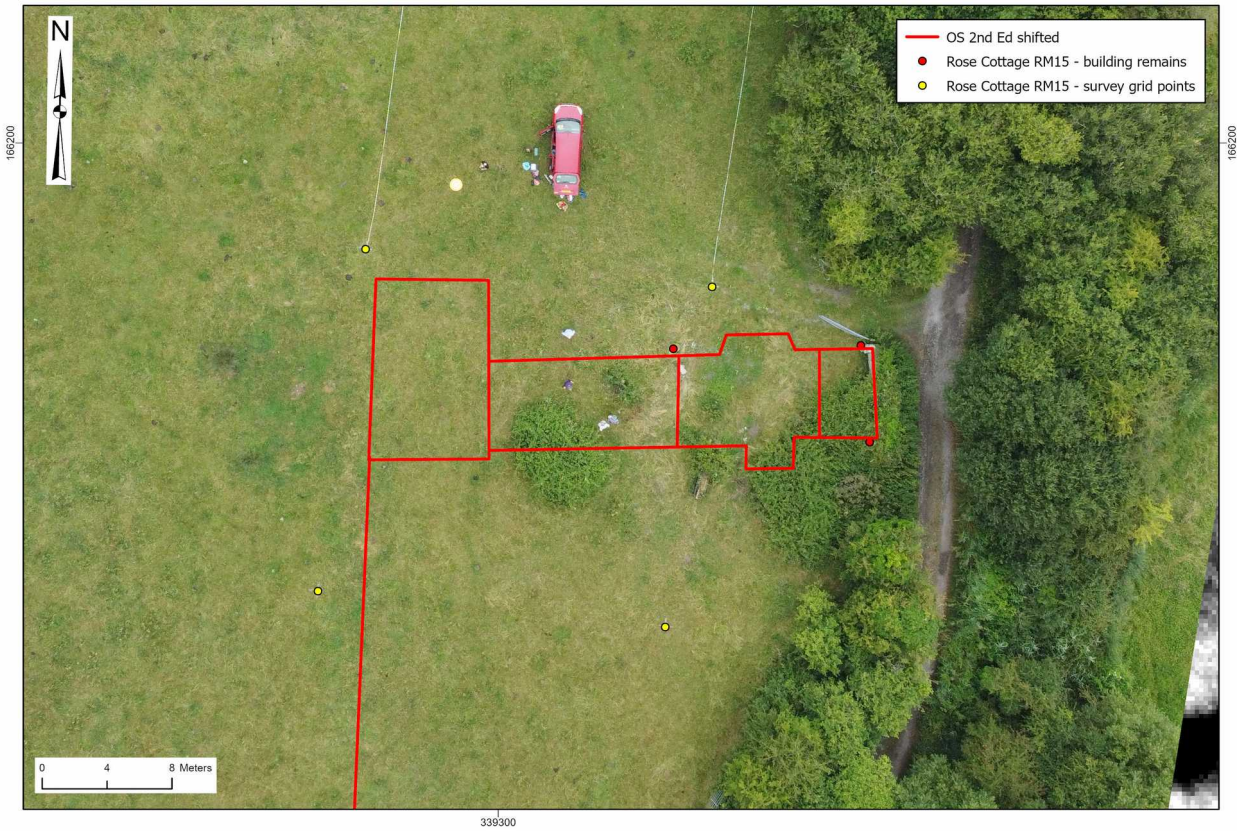
Rose Cottage - Kingston Seymour - Drone - Building outline from OS moved to match remains

*Drone image with OS 2nd edition plan superimposed, August 2024*

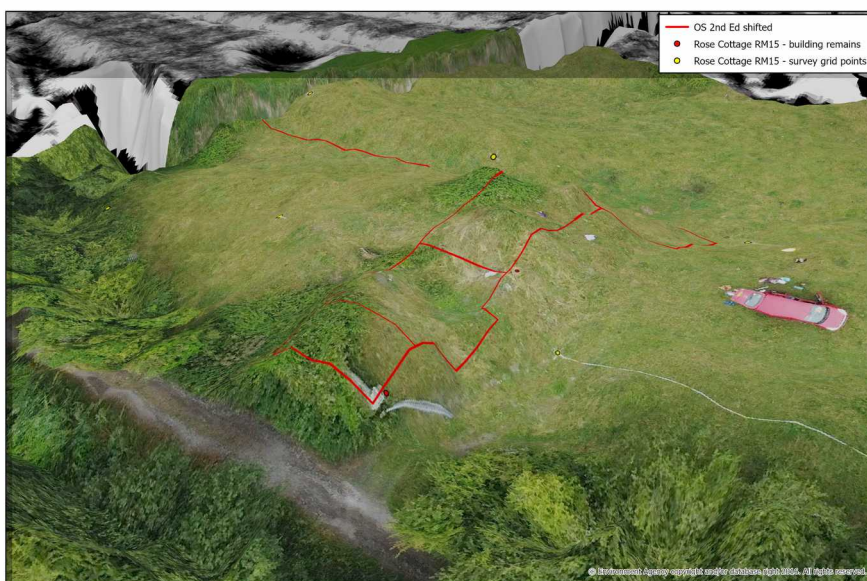
Rose Cottage - Kingston Seymour - building outline - 3D x8 vertical exaggeration

*Rose Cottage analysis 8  
- building outline plus  
drone 3D, showing  
earthwork of dwelling*

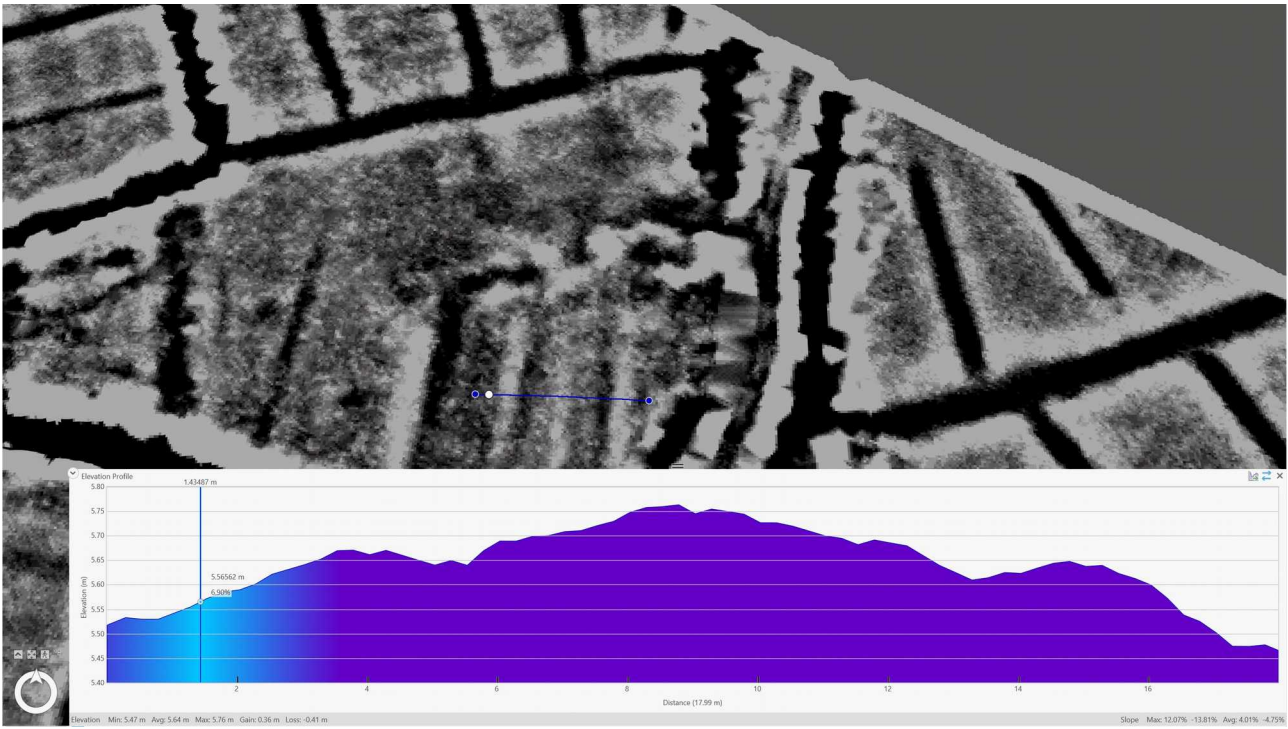
*Profile (blue line) across earthworks in garden south of dwelling (© Environment Agency copyright and/or database right 2016. All rights reserved.)*
