YCCART 2024/Y9

Litton churchyard cross

**YATTON, CONGRESBURY, CLAVERHAM AND CLEEVE ARCHAEOLOGICAL
RESEARCH TEAM (YCCART)**

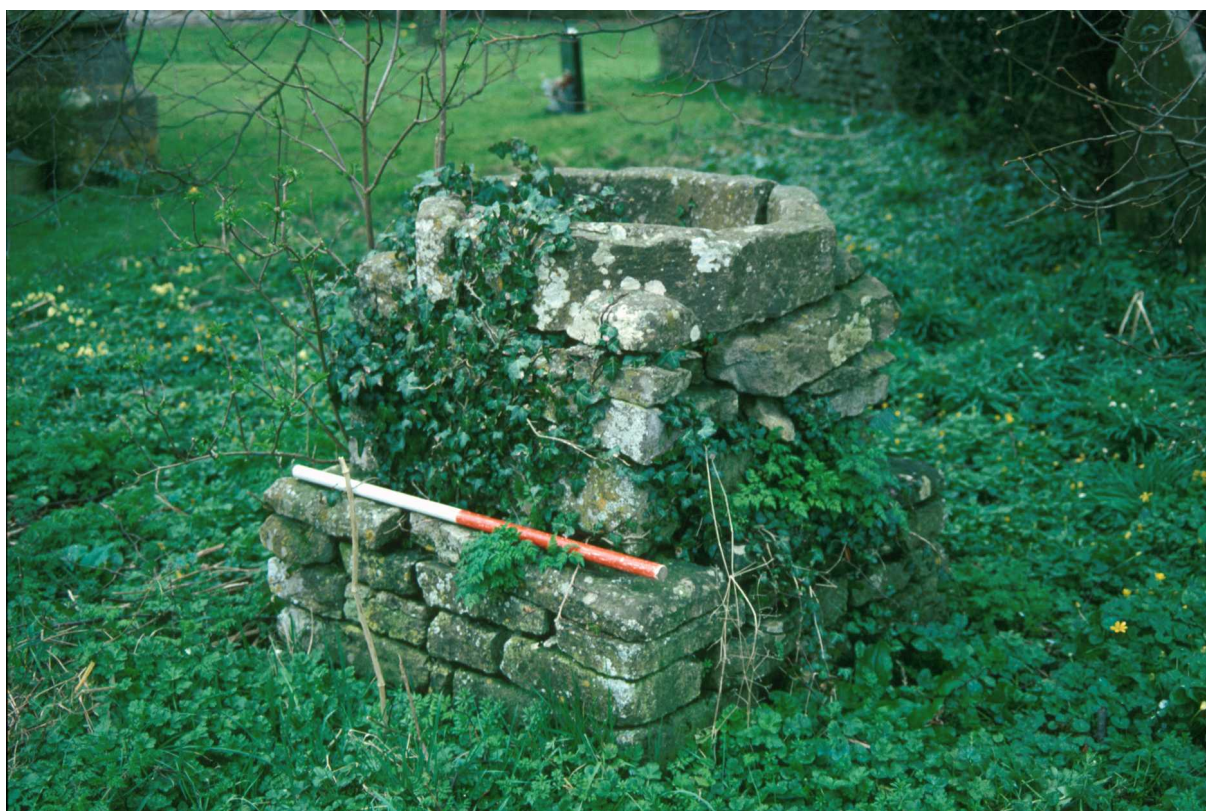
Litton churchyard cross March 1994 (*scale 2 x 50cm*)

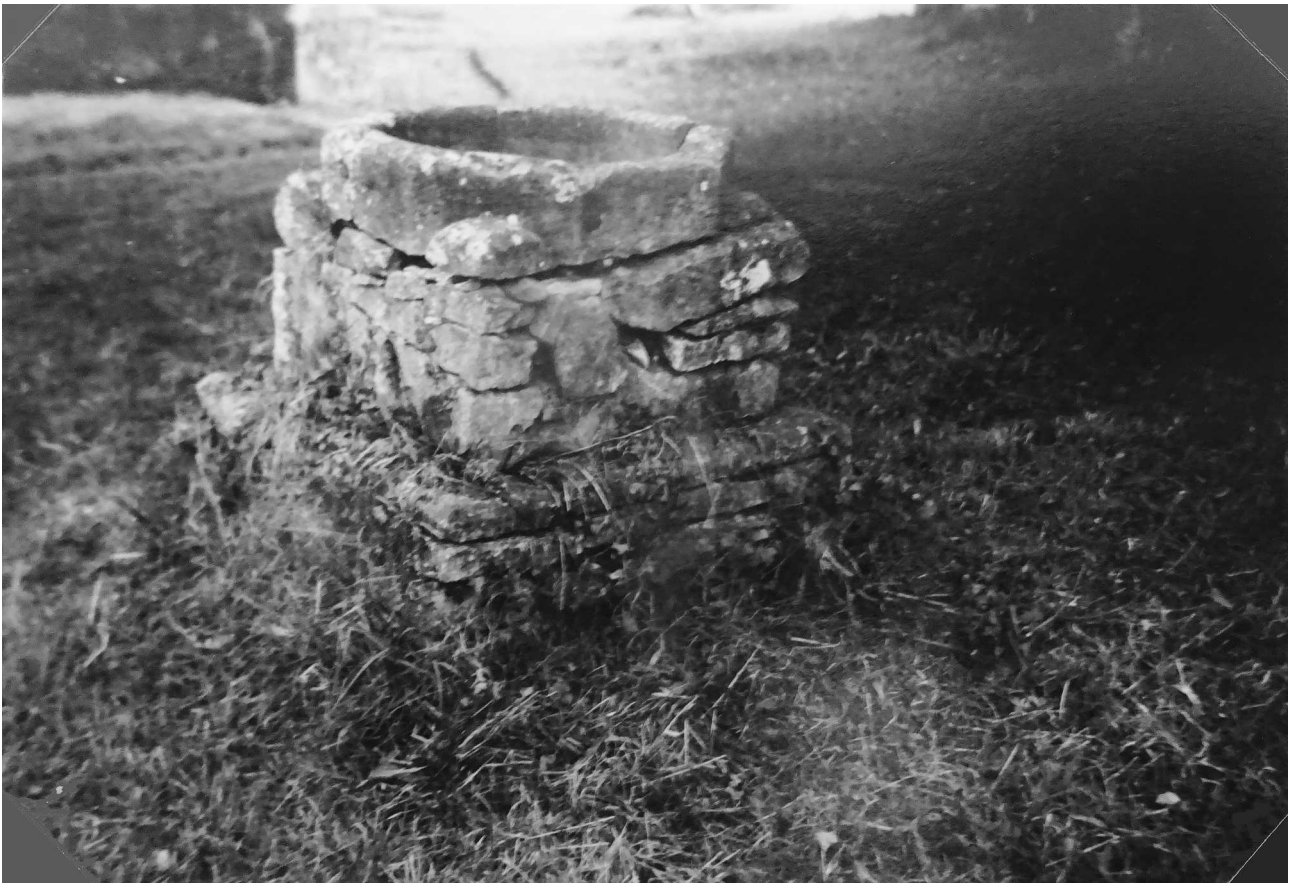
The earliest known photograph is in the Somerset Heritage Centre, by the Devon antiquary 'CND' (name withheld by SHC) in c1960 (Fig 4) (SHC DD\X\CND\2\1\109).

The cross is of typical square to octagon type, much worn, and 0.82m square, although this includes expansion due to cracking. It is c 0.60m high. The hole in the socket is no less than 0.64m across, leaving a 0.09m thick surround. It has presumably been hollowed out at some time to act as a trough or bowl (Fig 4 below), something that has happened to other cross sockets (such as one at Tickenham in North Somerset).

Fig 4: CND's photograph of c1960

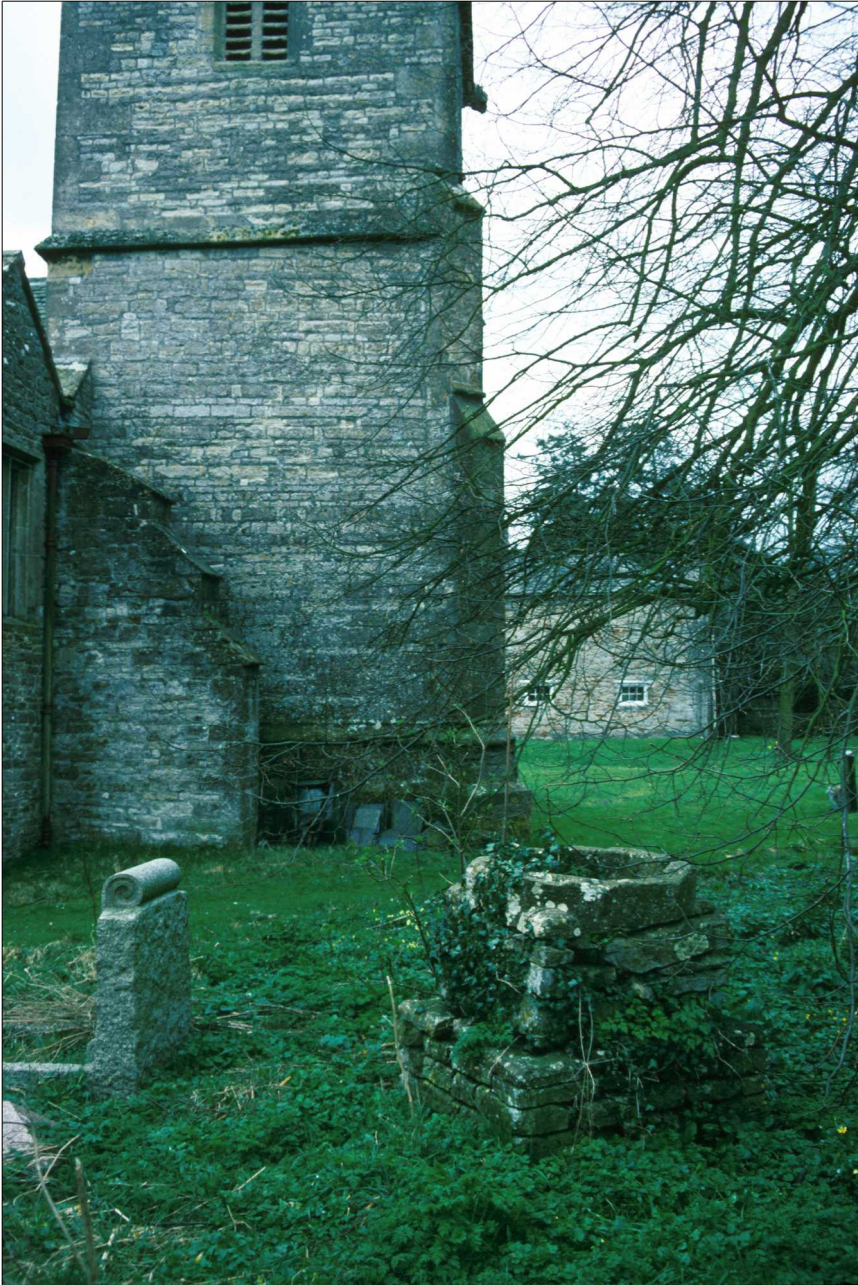
Subsequently the earliest photograph appears to be one in the Somerset HER from 1985, and then mine from 1994 (Fig 5 and cover).

The lower part of the stone is frost shattered and may not be original. The socket rests upon a dry stone built base (1.06m square by 0.42m high), and itself is in about 30 - 40 pieces, cracked both vertically and horizontally, and mainly held together by ivy. The cross is at the south-east angle of the church, about 15m from the tower (seen in 1994) (Fig 5 below).

When visited in 2024, the cross was heavily overgrown, unfortunately lying outside of the

Fig 5: Litton churchyard cross and church 1994

maintained area.

It is recommended that the cross be cleared of undrgrowth, so this historically mportant part if the suite of structures in Litton parish churchyard can be enjoyed by the parishioners. Further work in maintenance and /or conservation repairs would depend on availability of funds and other matters (not least, its Listed status).
