YCCART 2024/Y3

Crossing the water: Congresbury Yeo: the other bridges (Wrighton to the sea)

**YATTON, CONGRESBURY, CLAVERHAM AND CLEEVE ARCHAEOLOGICAL
RESEARCH TEAM (YCCART)**

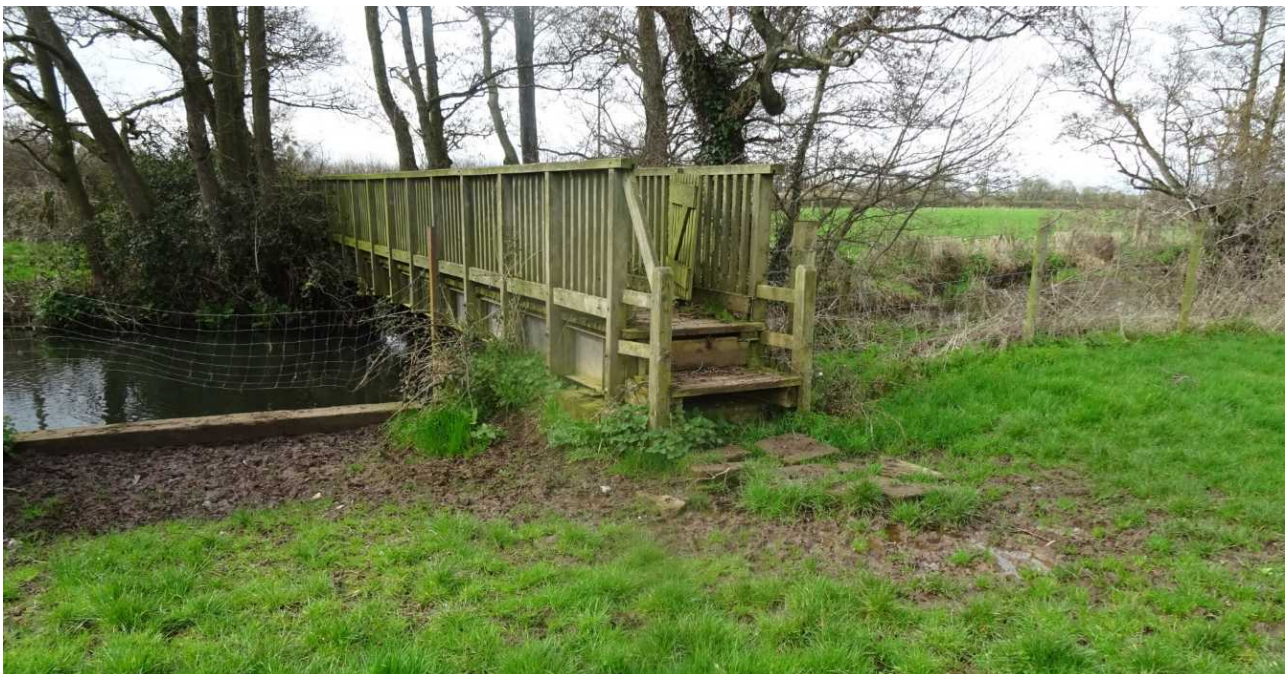
Fig 5: Iwood footpath bridge, 2018

Clearly the current crossing structure is very recent: usually such crossings are spanned by single (or if lucky, several parallel) planks. The footpath runs from Wrington to Iwood, with side paths to West Hay and the Churchill Road.

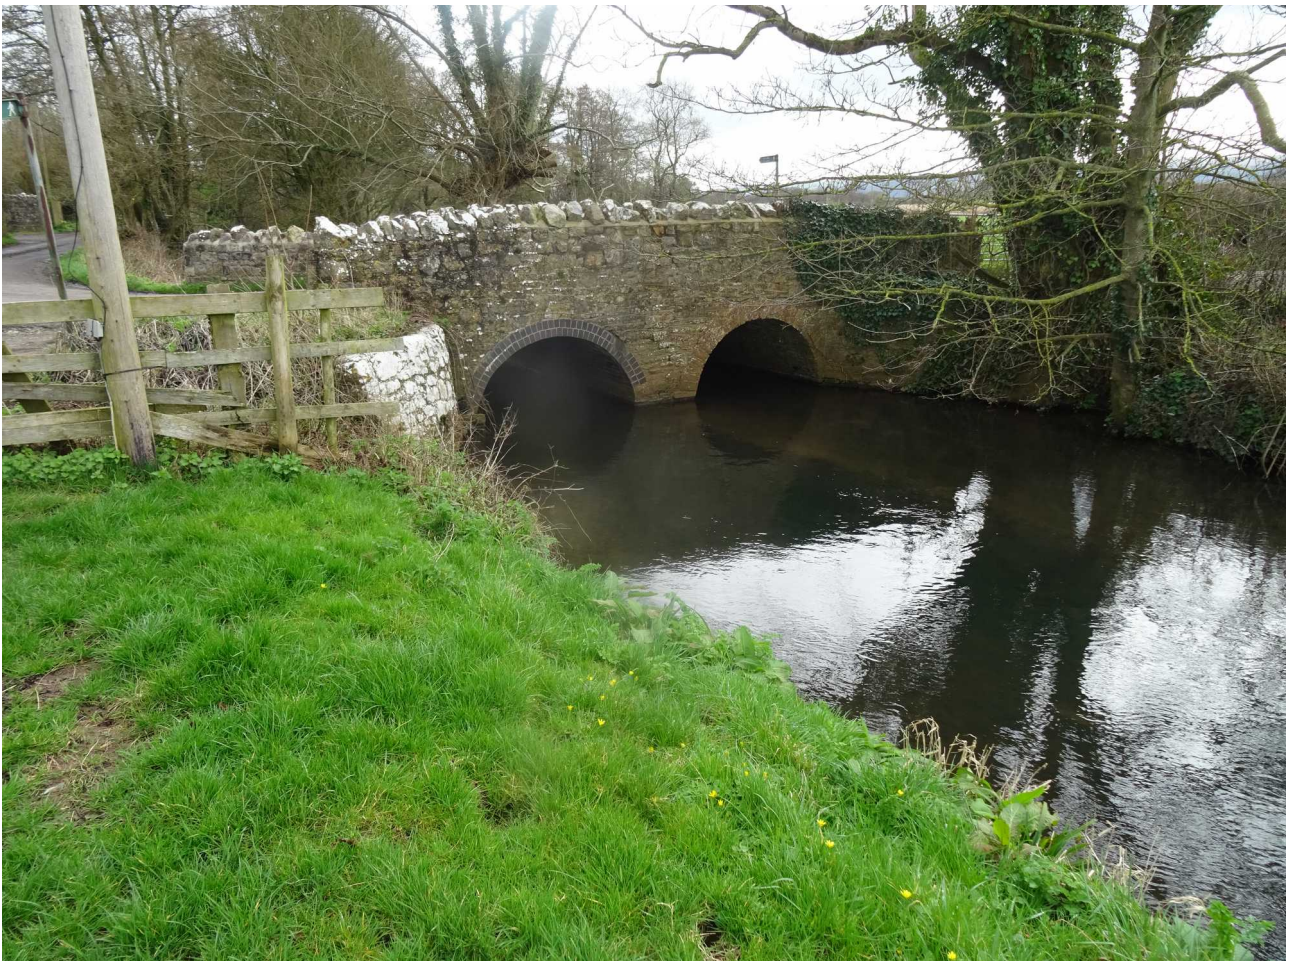
Fig 6: Iwood road bridge from the west, 2016

The bridge consists of a double arch, the north lined with black engineering brick, and the south by normal red; the body of the bridge of uncoursed Carboniferous limestone rubble, in black mortar, topped on each side by a parapet with stones set on edge. The current version looks very much late 19th century, or even early 20th: local recollections that it replaced a ford at the site may be confused recollections of this construction.

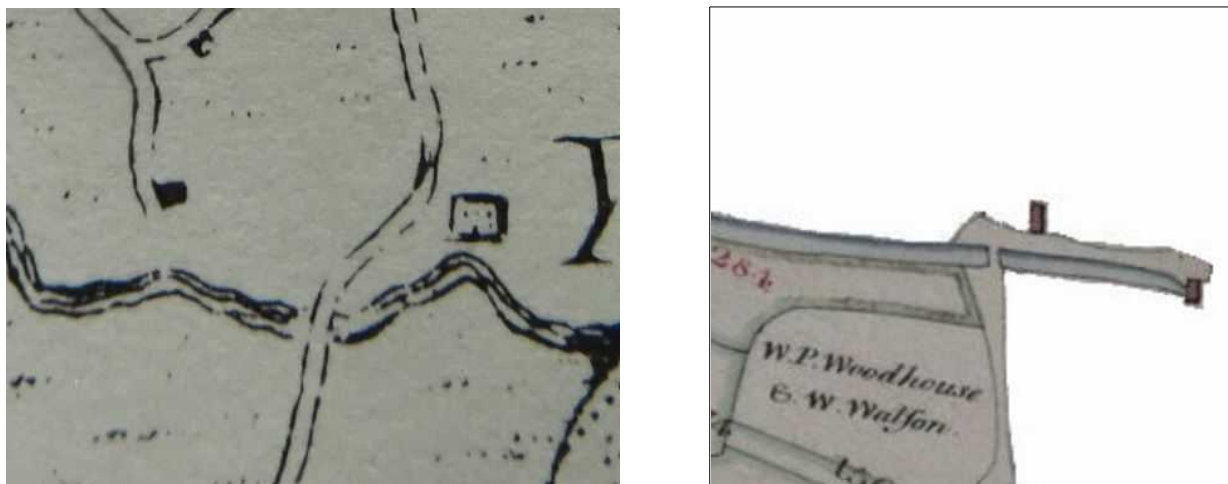
The crossing is certainly depicted on both the Congresbury Inclosure map of 1816 (Fig 8) and Day and Masters Somerset map of 1782 (Fig 7).

Figs 7 & 8: The crossing 1782 (left) and 1816 (right)

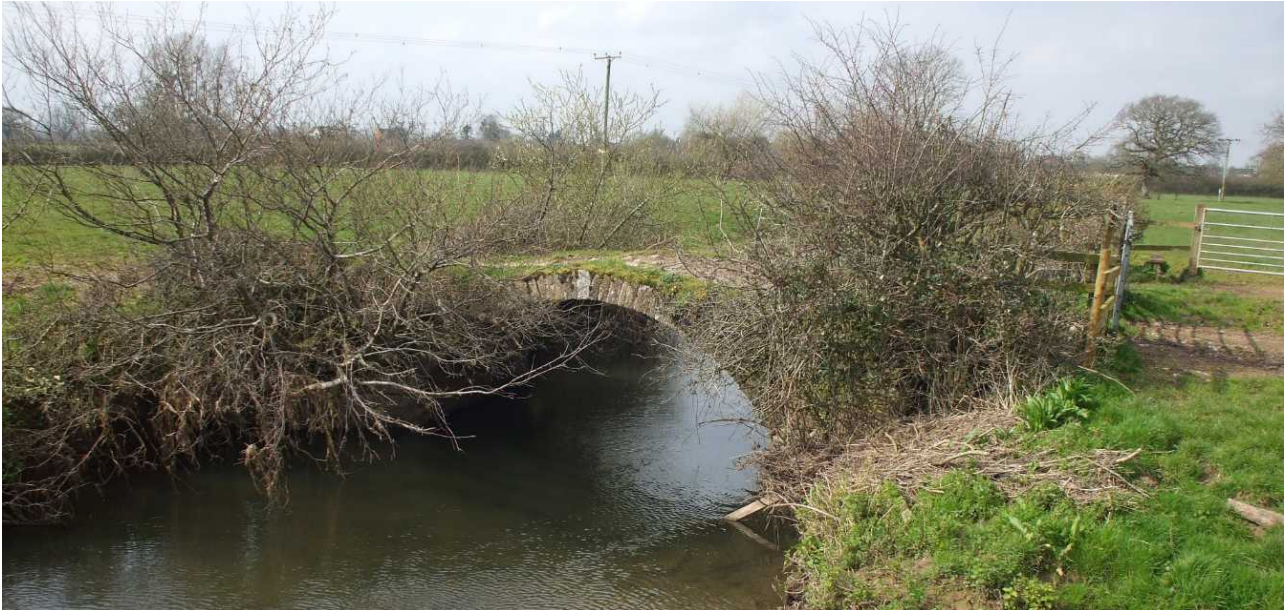
Fig 10: Iwood bow bridge, east elevation 2014

This is one of three parapetless bow bridges over the Yeo between Iwood and West Mill at Congresbury.

GV II Bridge spanning the River Yeo to the south east of Congresbury. Possibly late-C18 or early-C19. Local stone cut and squared. It has a single span arch of approximately 5.5m consisting of a single row of voussoirs on either side with a very low, single-coursed stone parapet.

Their construction details do seem similar, with a central arch spanning an area between two solid stone abutments: the top of the archstones is usually visible in the surface of the bridge. They all have later 'cheek' walls protecting against the widening of the river.

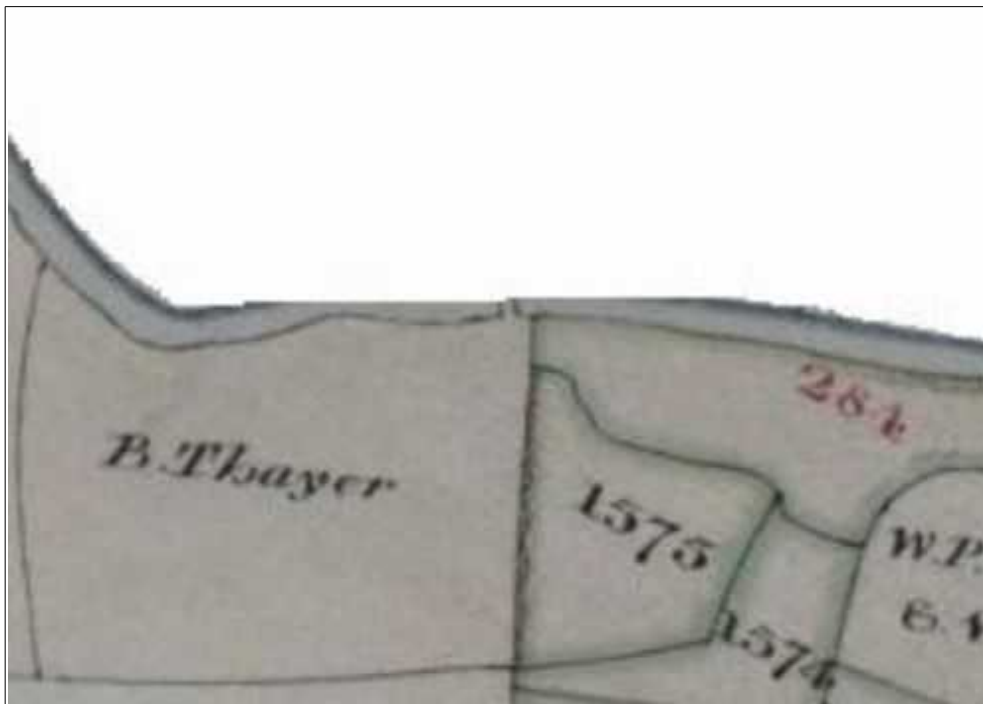
It does appear, however, on the 1816 Inclosure map (Fig 12) but is unfortunately outside of the area depicted on the de Wilstar maps of Congresbury of 1736-9.

Fig 12: The bridge seen on the 1816 Inclosure map (at the top right of the field labelled B. Thayer)

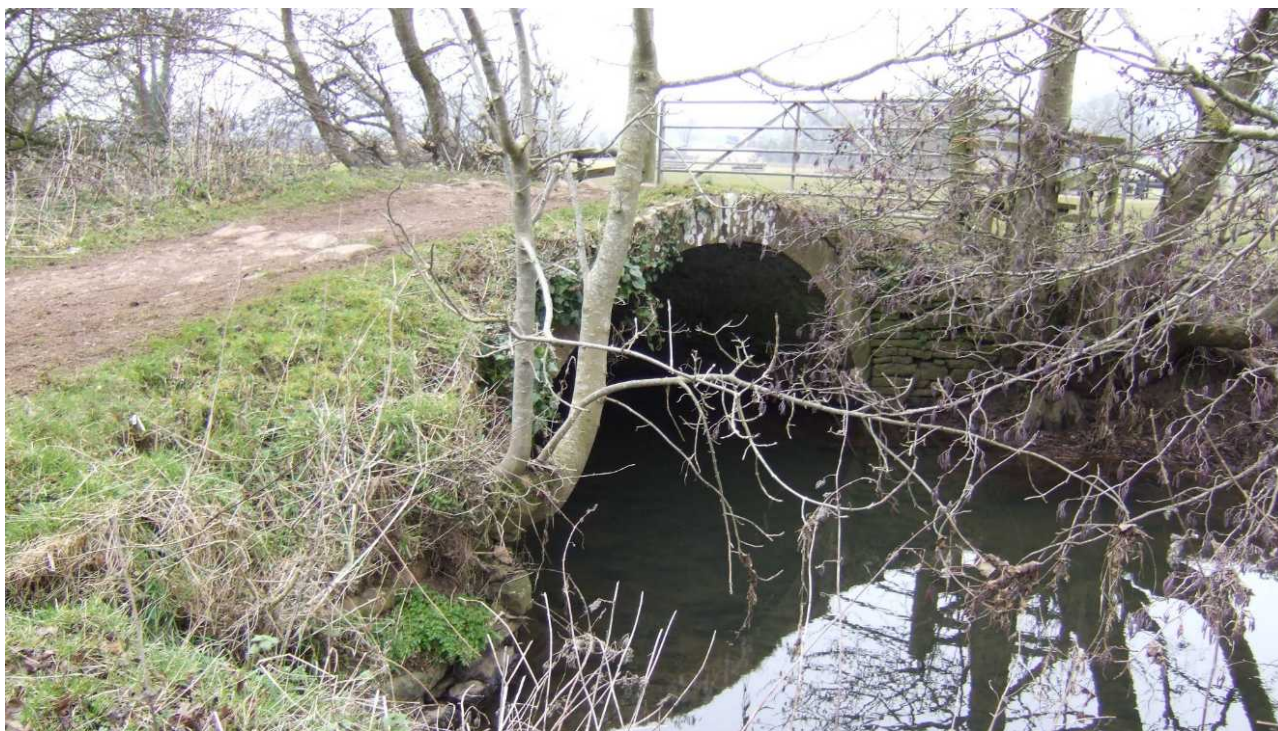
Fig 13: Somerset Lane bridge, east elevation 2006

Bridge across the River Yeo at Congresbury. c.1800. Dressed Pennant stone, rubble infill. A single span arch approx. 3 m. wide, with a span of approx. 4 m., consisting of a single row of voussoirs on either side. There is no parapet: whether one existed, and has been knocked into the river, is unclear. To the east side is a slightly projecting keystone.

The height of the arch on the three Listed bridges is clearly different, Bridge 4 being distinctly higher in the arch than 3 or 5: while they may well be contemporary, some subtle differences exist.

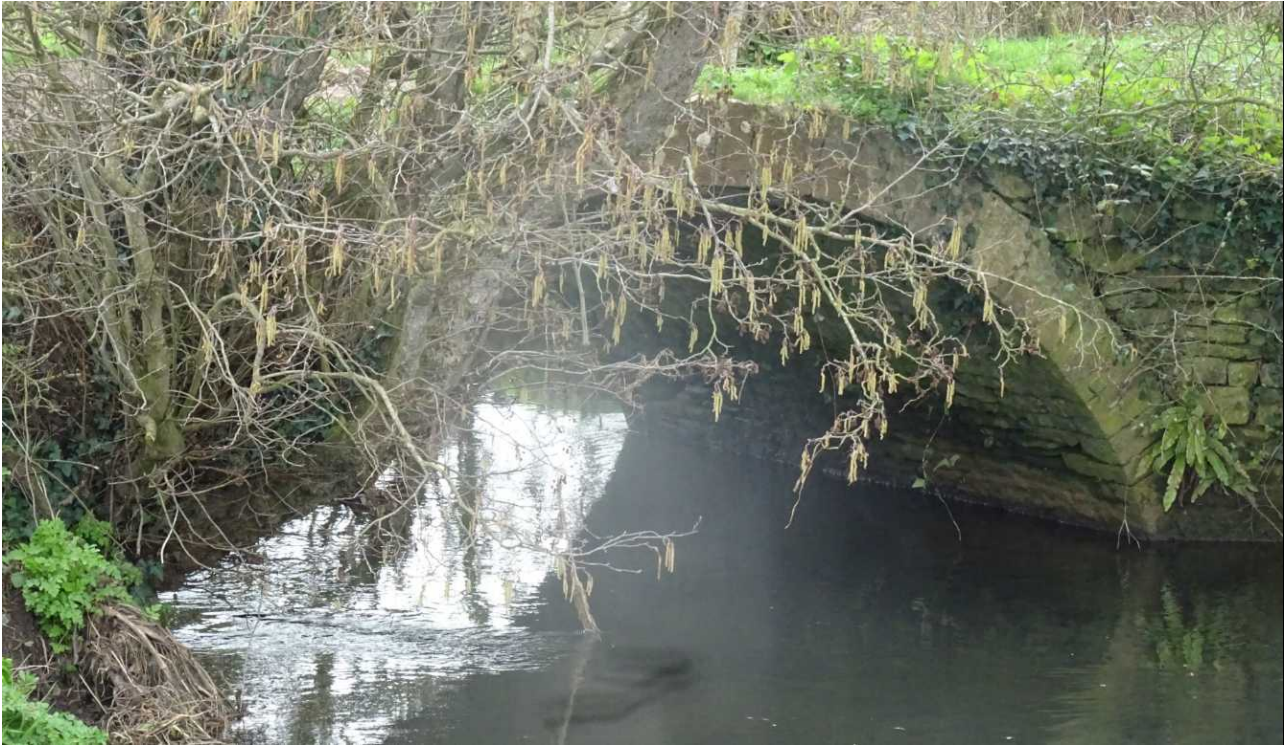
Fig 14: Somerset Lane bridge, west elevation 2014

The bridge is on the line of Somerset Lane, a track connecting Venus Street in Congresbury with Urchinwood. The track is extremely overgrown at its southern end, but visible as a clear earthwork towards Urchinwood Manor.

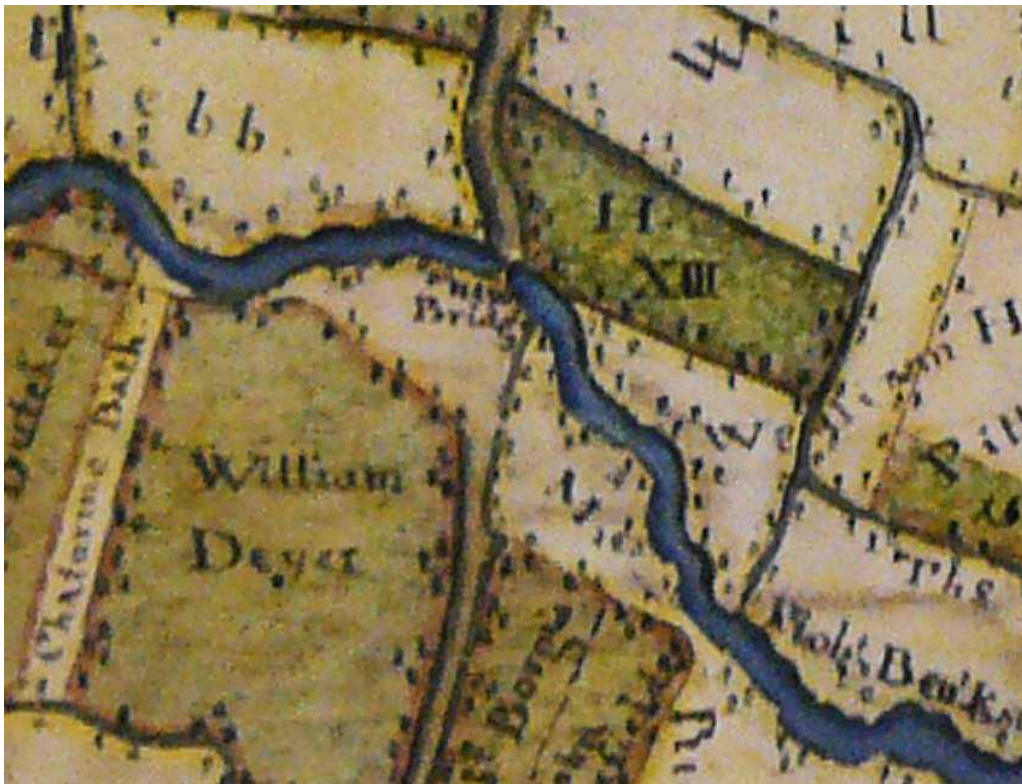
Fig 15: The bridge shown on the deWilstar map of 1736-9, labelled 'New Bridge'

The bridge at Somerset Lane (below) is called 'New Bridge' on the de Wilstar maps, perhaps implying either no predecessor, or new construction in 1736-9, although 'New' as a placename can be very misleading (new by comparison with what?).

The field to the north-west of the bridge is named 'Bridge Plot' on the 1809 copy of the de Wilstar maps, reflecting the importance of the structure. Its presence and naming on the 1736-9 map shows it probably dated to the early 18th century (unless, of course, it is a replacement for an earlier, in which case, Historic England's dating is possible).

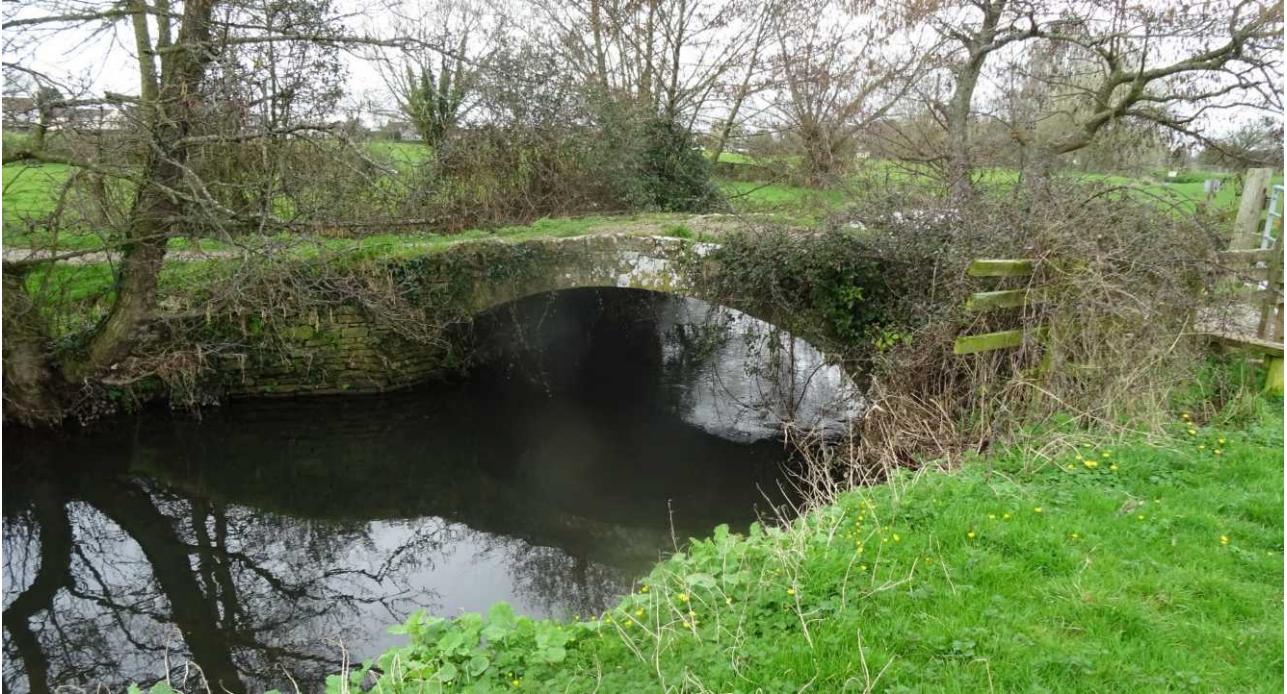
Fig 16: Bow bridge at the Park, east elevation, 2007

GV II Bridge spanning the River Yeo to the east of Congresbury. Probably late-C18 or early-C19. Local stone cut and squared. It has a single span arch of approximately 7m consisting of a single row of voussoirs on either side. There is no parapet: whether one existed is unclear.

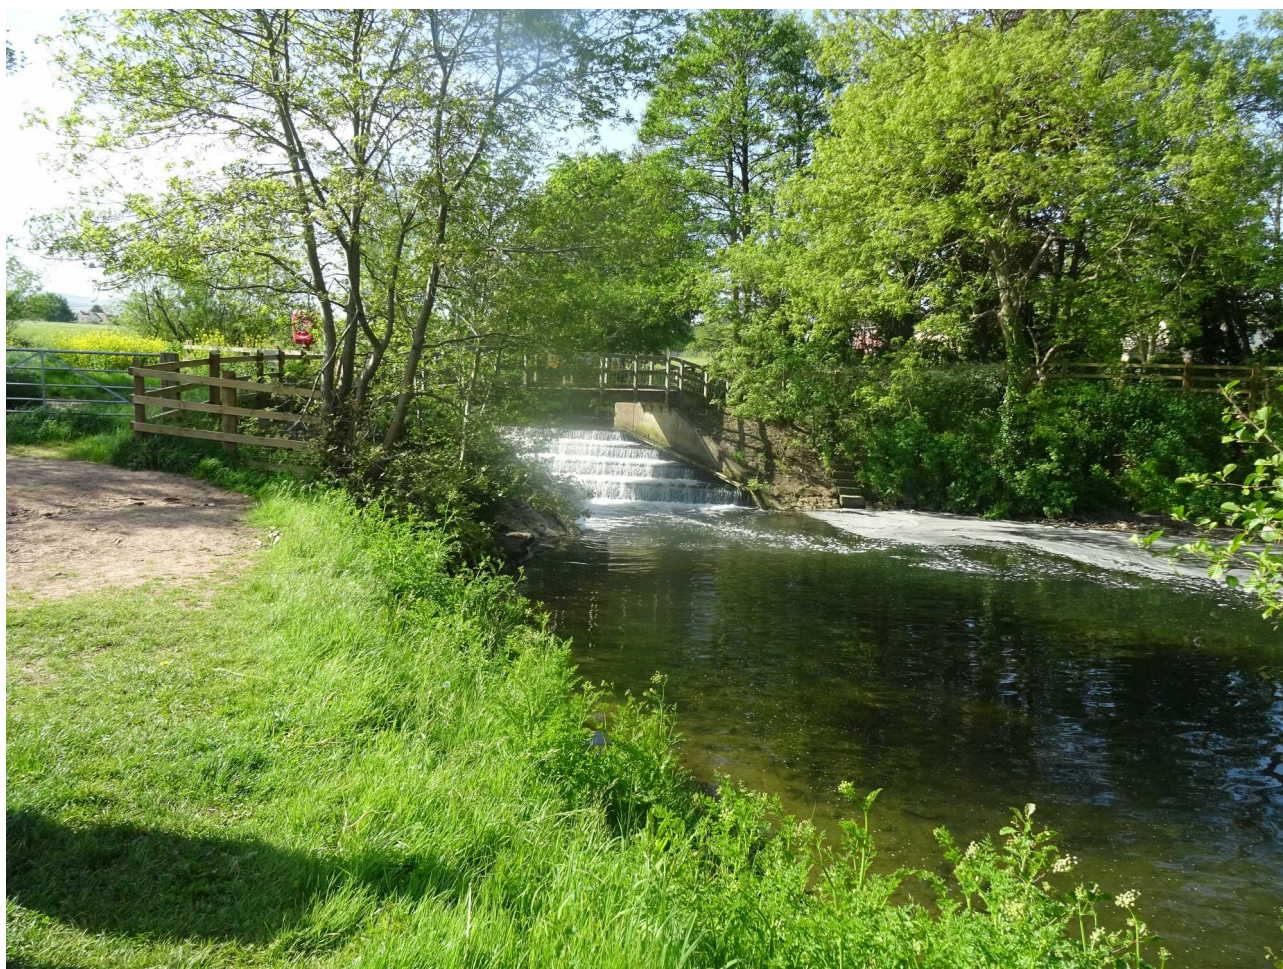
Fig 19: Weir and river crossing at West Mill, 2018

There would have been a weir of some kind at the beginning of the mill, since it was necessary to divert river water to provide flow to power the mill wheels. Depending on the nature of the weir, it may have been passable even then, as many were, especially those reconstructed in stone.

The weir was largely rebuilt in the 1970s, replacing a much older, much repaired and patched weir, recorded in 20th century photographs.

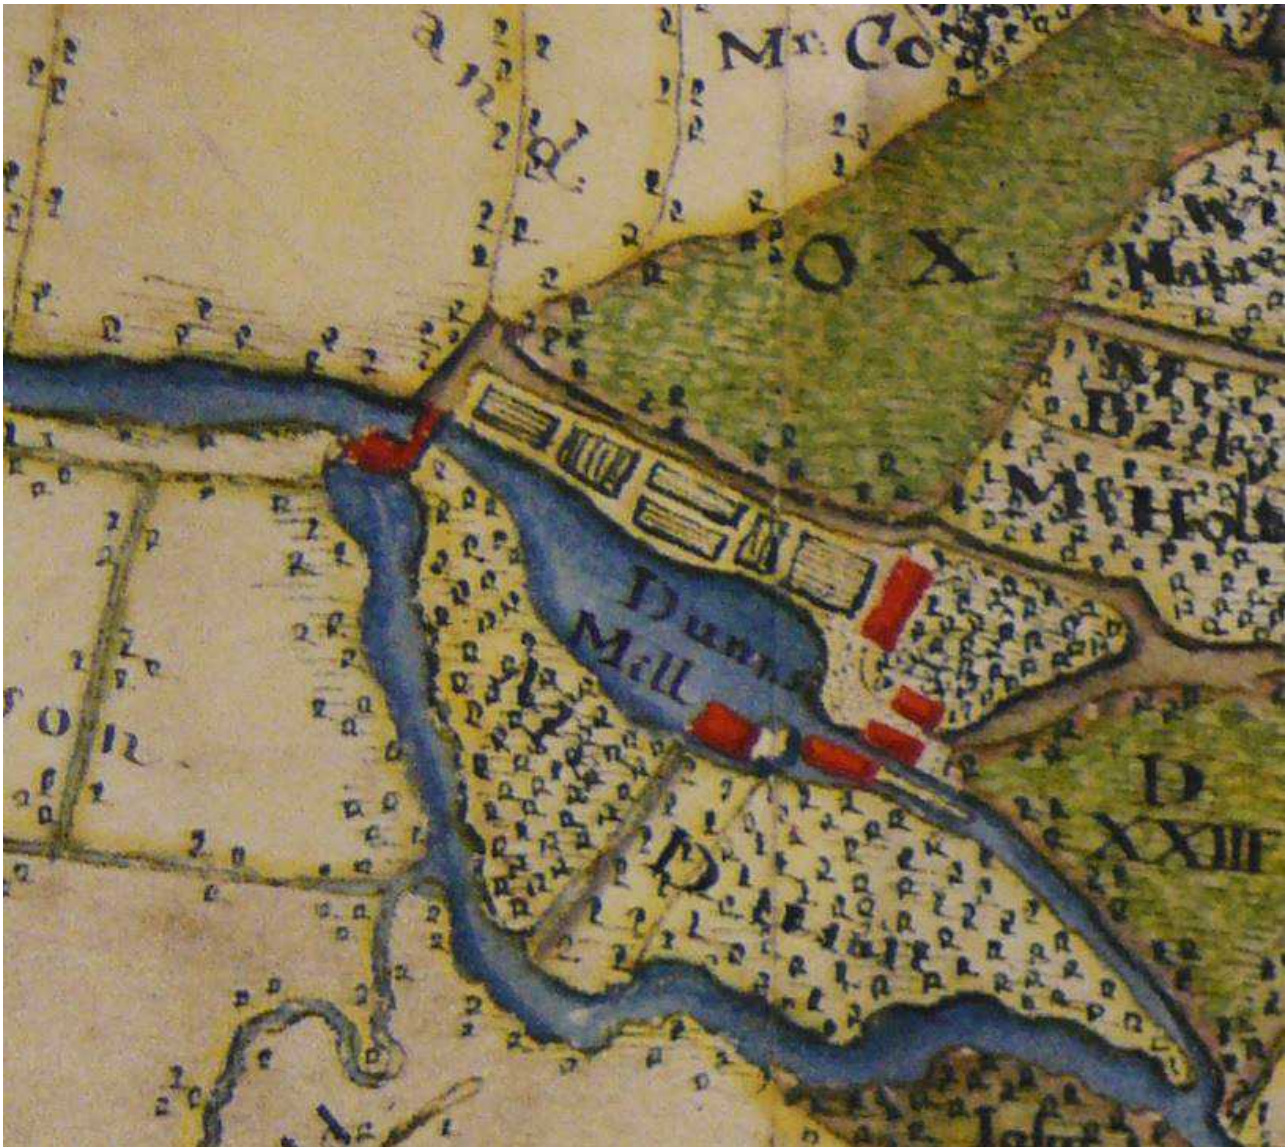
This weir formed the limit to navigation for seagoing vessels from its construction. In the 18th century, Dunn's Mill at this site was a pioneering 'iron slitting' site, its water powered conversion of iron precursor bars to become nails, a foretaste of the Industrial Revolution. Iron was transported up the Congresbury Yeo to the site from as far away as Sweden and Russia.

Fig 22: West Mill weir from the de Wilstar map of 1736-9

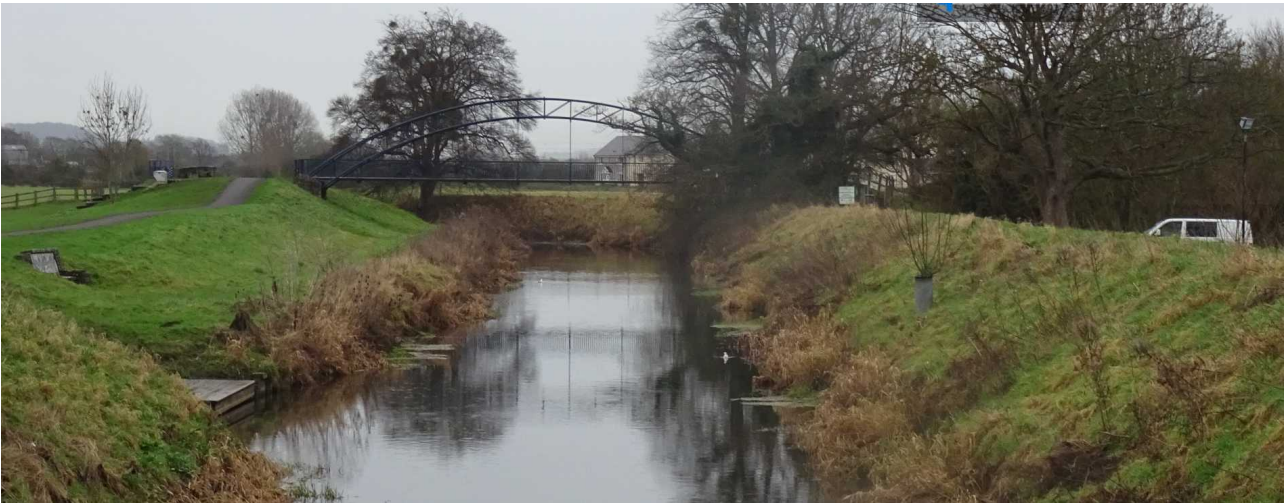
This new pedestrian bridge was a product of the millennium celebrations (hence the name), and is described elsewhere.

The area around Congresbury Bridge was, of course, radically altered in the replacement of the bridge in 1924, with the river course being altered away from the back of the Ship and Castle pub: the Millennium Bridge is at the end of the unaltered course, which from this point formerly ran through what is now the pub car park (YCCART 2018)

Fig 23: The Millennium bridge, 2017

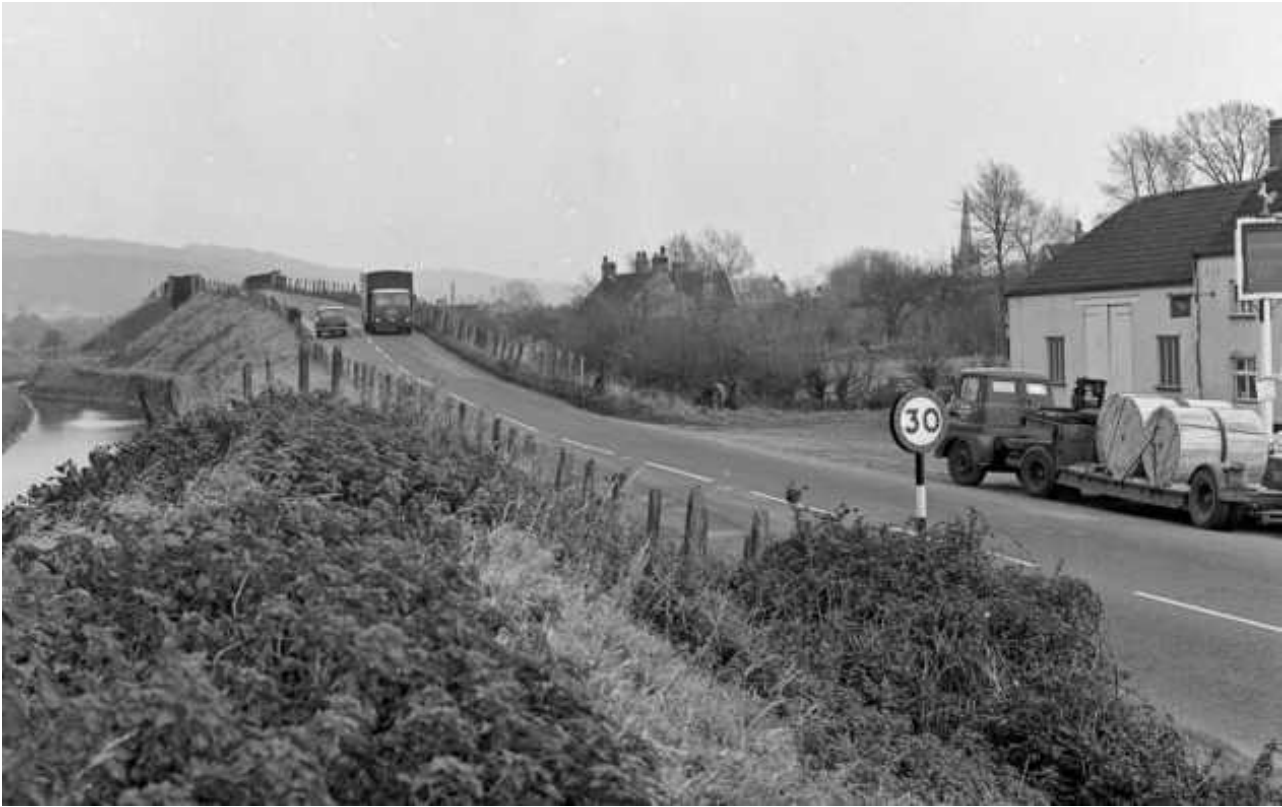
Fig 25: Mid-1960s photograph showing the river crossing already removed, while the road bridge awaits removal.

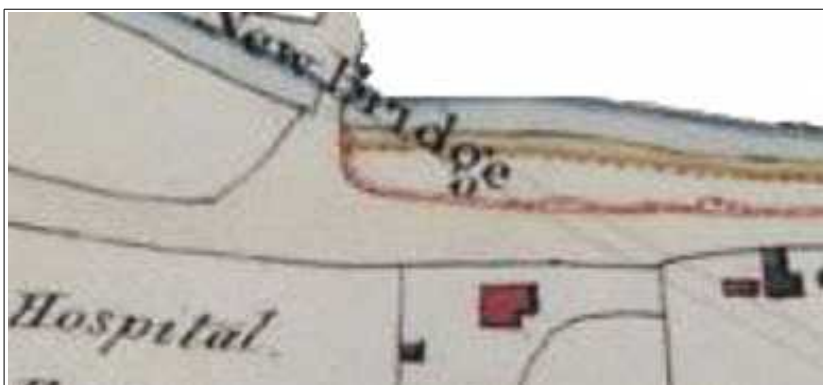
Fig 26: Moor bridge from 1816 Inclosure plan of Congresbury and Puxton.

This is (slightly confusingly) another New Bridge.

It is shown on the map as a broad short feature, which was presumably its original plan.

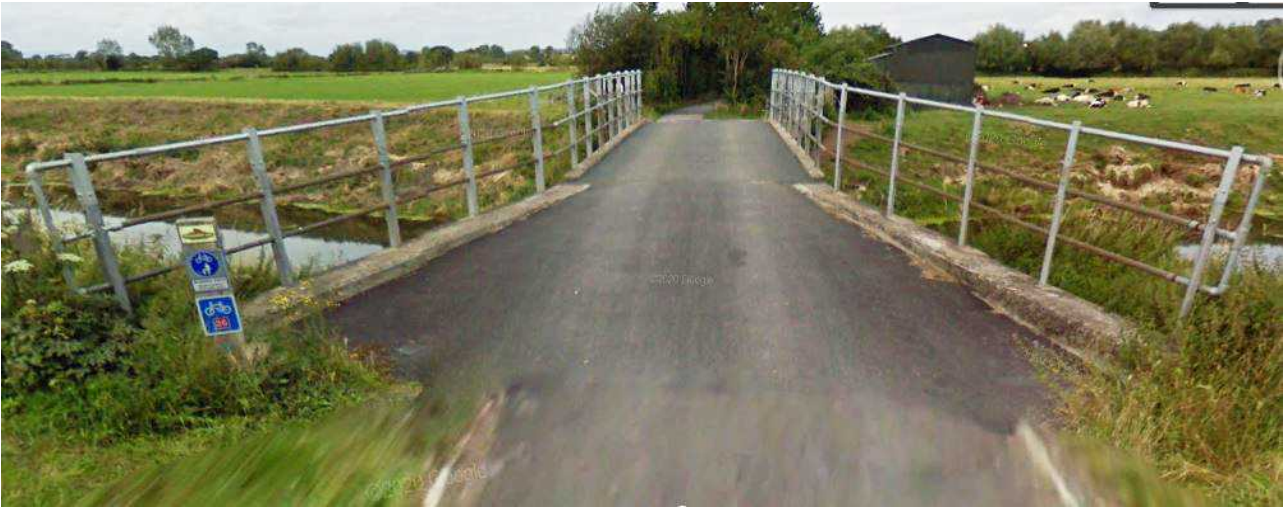
The current structure at this site is modern, probably late 20th century.

The bridge today is used by commercial traffic serving a yard off Moor Lane, which may account for its upgrading.

Fig 27: Moor Lane bridge 2022 (Google Earth Street View)

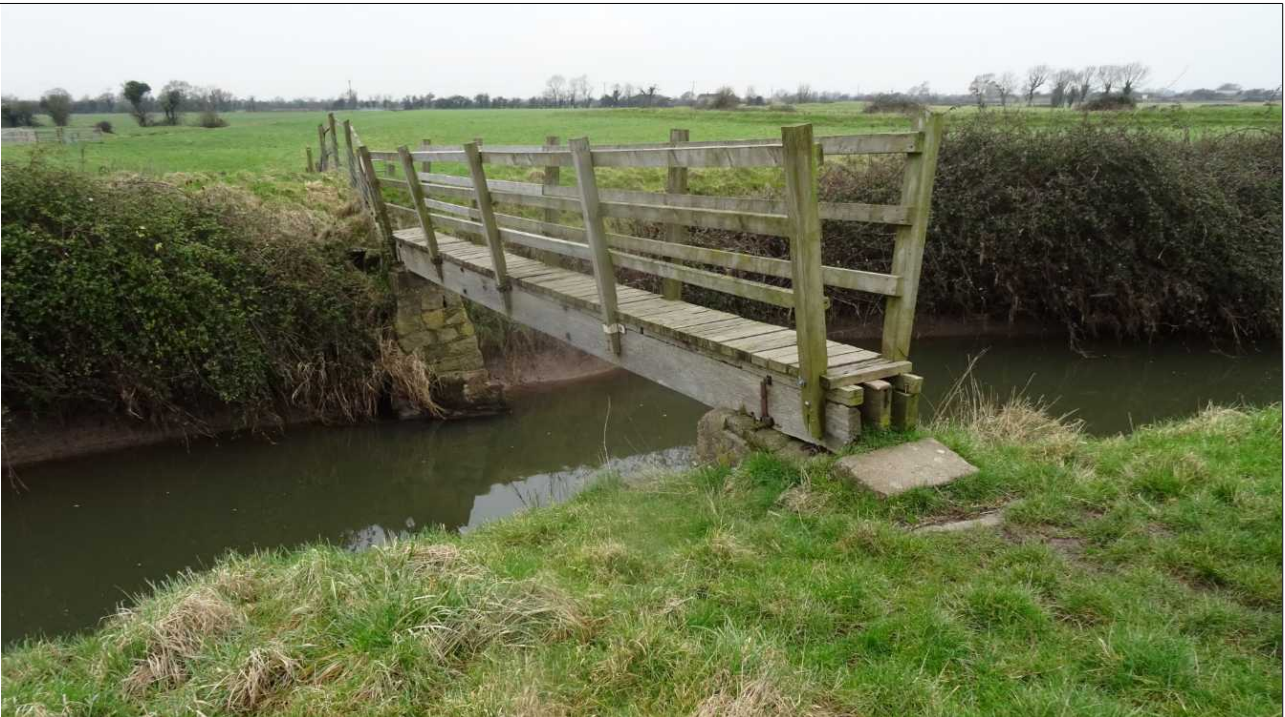
Fig 28: Gangwall pedestrian bridge on footpath at the junction of Gangwall and the Yeo, 2017

The present bridge is a wooden plank-built structure with wooden fenced sides, resting on coursed stone abutments on either side of the river.

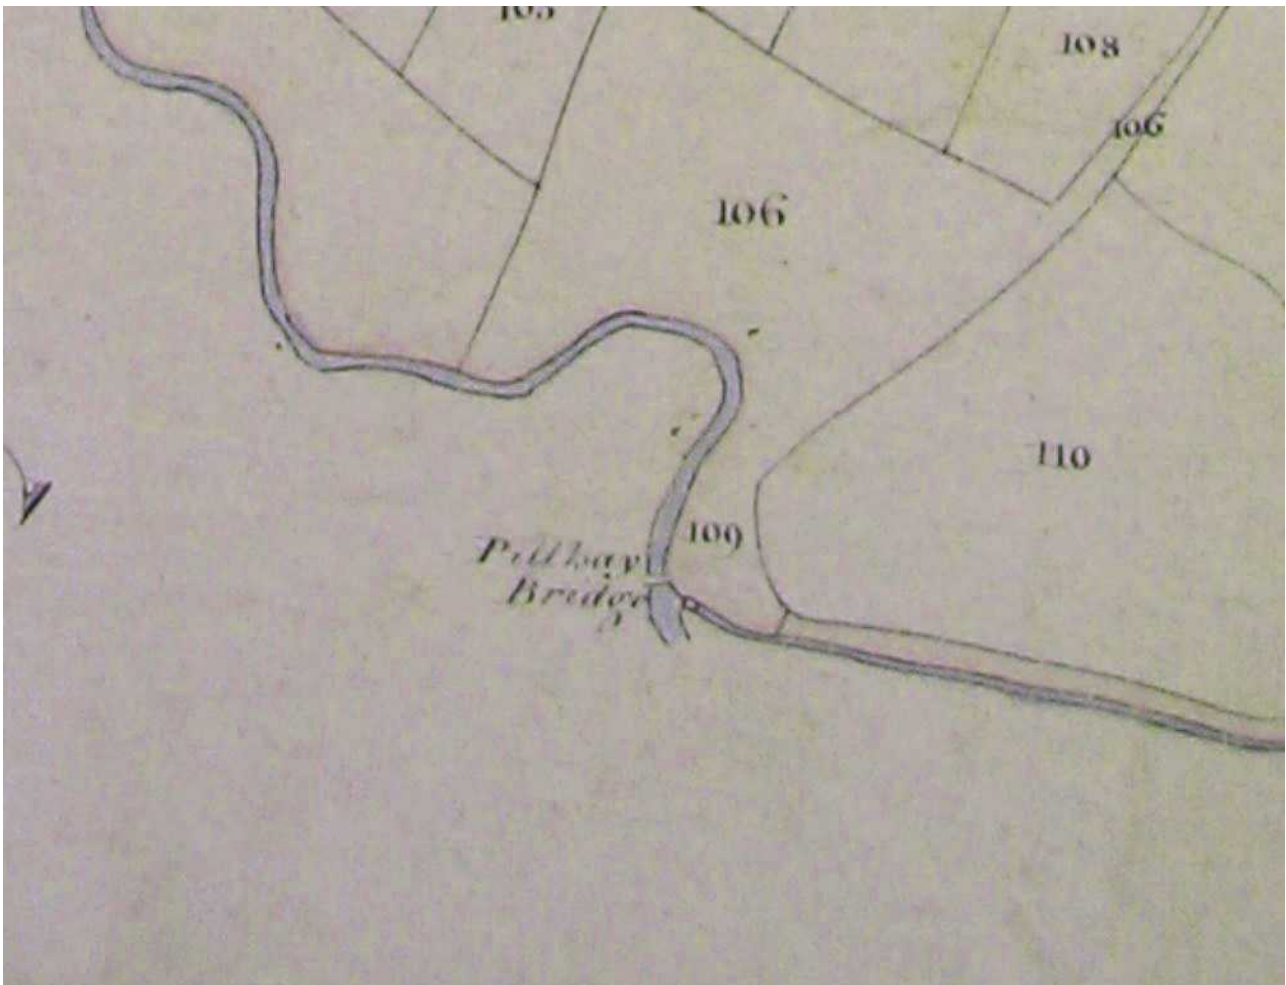
Fig 29: Pillhay bridge from the 1821 Yatton map (SHC D/P/yat/13/1/3)

Although the bridge is never depicted as large on maps (e.g. Fig 29 below), there must have been a more substantial structure at one point, serving the footpath leading from Yatton, down the bank of Gangwall, across the bridge and on to the farms at Hewish. The structure was maintained for centuries by the manor owners, Queen Elizabeth's Hospital, a

There are stone structures in the south bank of the river close to this site, but they are all connected to the construction and operation of Rennie's syphon (YCCART 2017). As mentioned above, the bridge has never been depicted on maps as large (Fig 29 below), but it is clear that QEH regarded the bridge as important enough (like Phipps Bridge below) to maintain over decades (accounts post-1734 are not currently available).

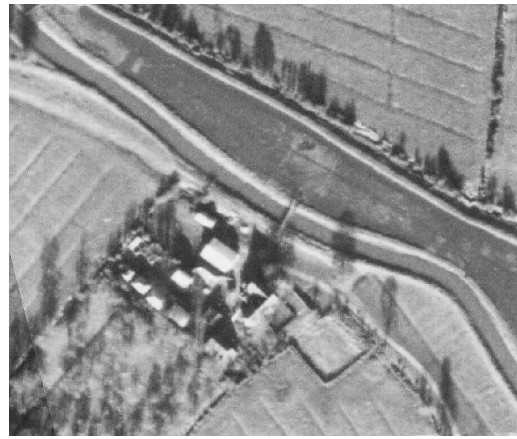
The initial footbridge was at approximately ST31476498 (see Fig 30 below). It may have been recently new, although it figures on the Yatton 1821 (but again, not on the Tithe Map of 1840). The crossing goes on figuring on OS maps (where referred to as a FB - footbridge) until 1930: it was missing by 1946, when RAF air photographs show a vehicular bridge has been built close to the farm. (Fig 30).

Fig 30: First Pillhay farm bridge 1821 (left); current in 1946 (right)

It has been reconstructed at least once since then (see Fig 30 above), and now boasts flat-arched bolted panel sides with metal side-rails: the 1840 map seems to show the support in place for a double-arched structure.

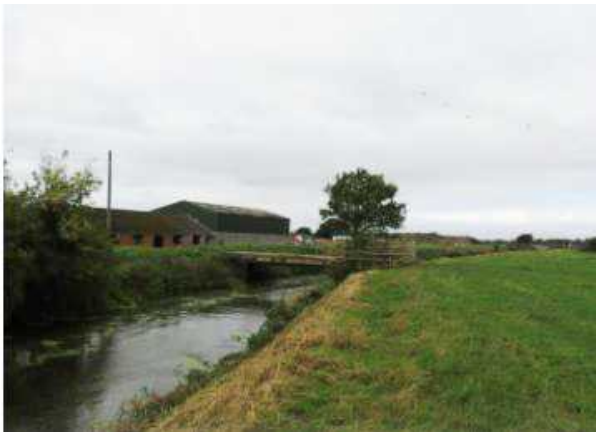
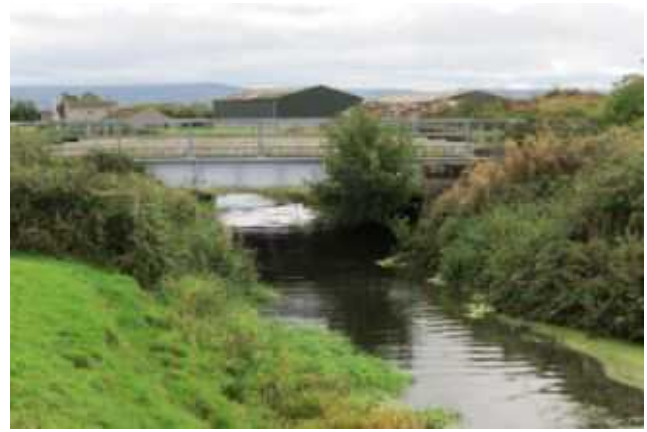
Fig 31: Pillhay Farm bridge (left) and Fig 32: Pillhay railway bridge, 2021

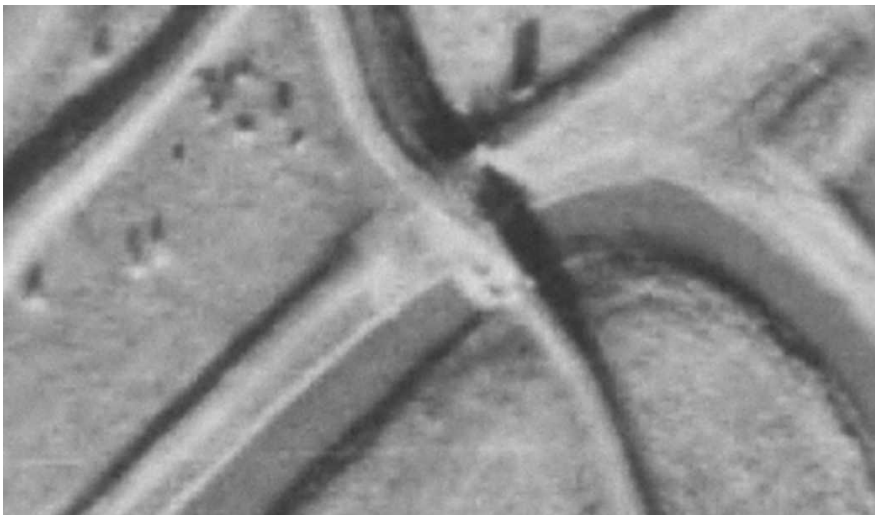
Fig 34: 1946 air photograph of Phipp's Bridge

The 1946 air photograph shows that the structure of the bridge did not much overtop the banks of the river, so the lack of remaining structure is not entirely surprising, although some stonework in the river below the sluice may be some remains of the bridge (Fig 37), most easily seen at low water level in the summer.

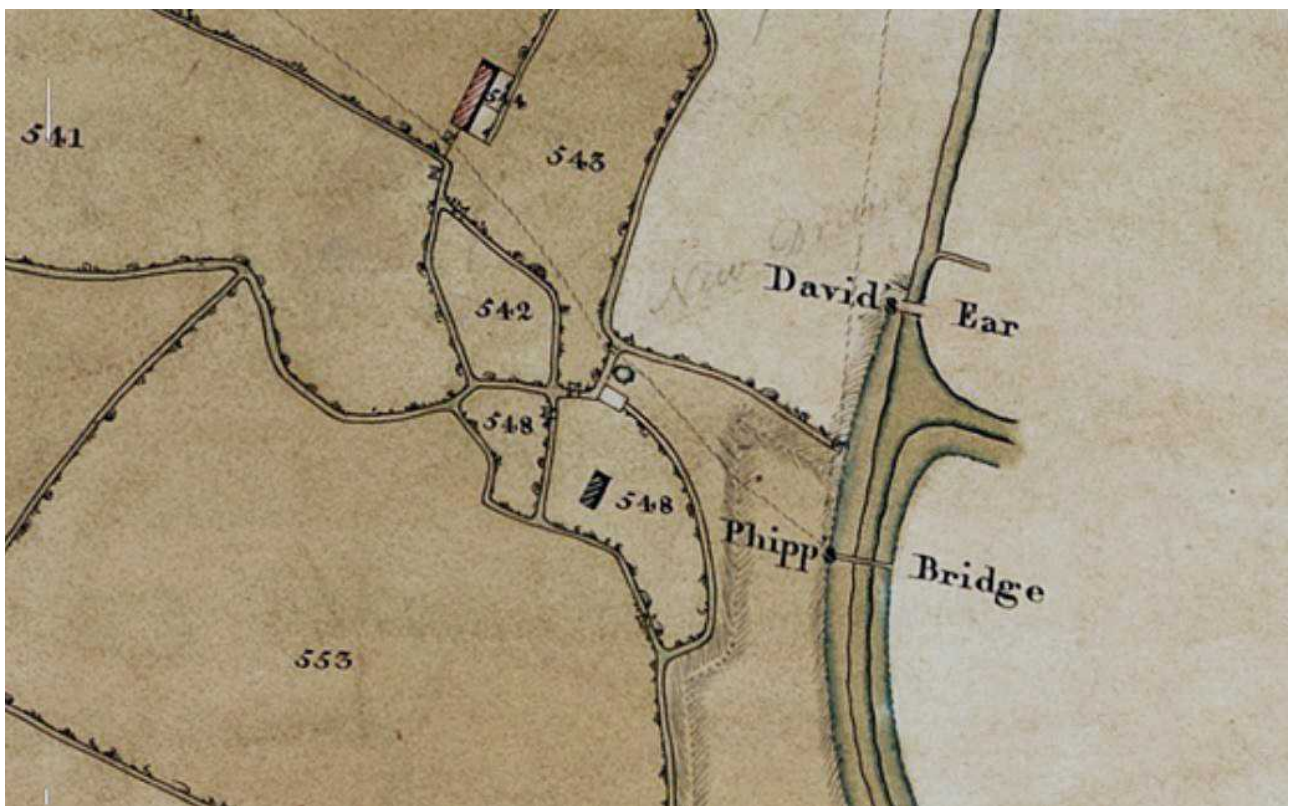
The 1821 maps of Yatton and Kingston Seymour both show the bridge: a cottage to its north, removed by works for the M5, was known as Phipp's Bridge Cottage.

Fig 36: Phipp's Bridge from 1821 Kingston Seymour map (with thanks to Jane Bell)

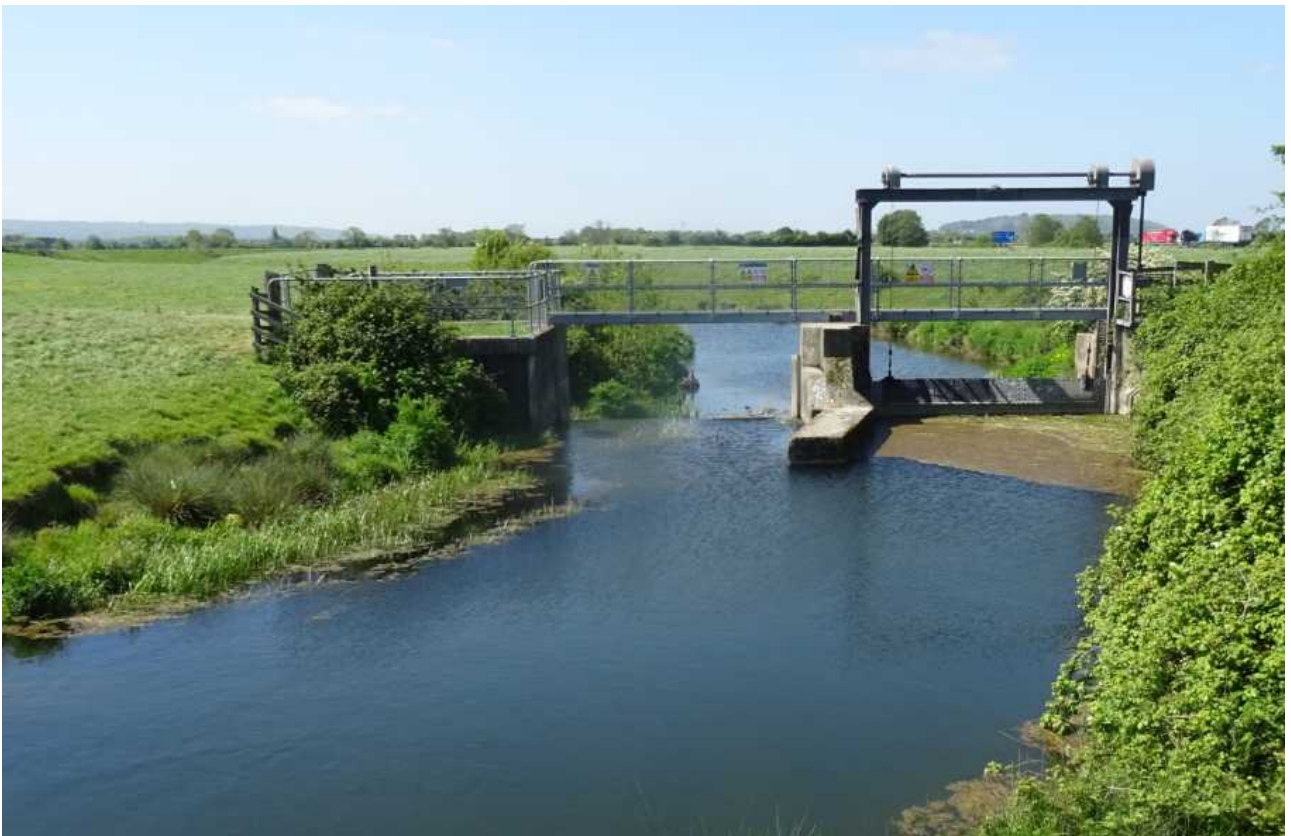
At some time after 1946, a sluice was built at the site: although it completely removed any obvious visible trace of the former bridge, at least the name survives (Fig 39).

Fig 38: Phipp's Sluice 2017

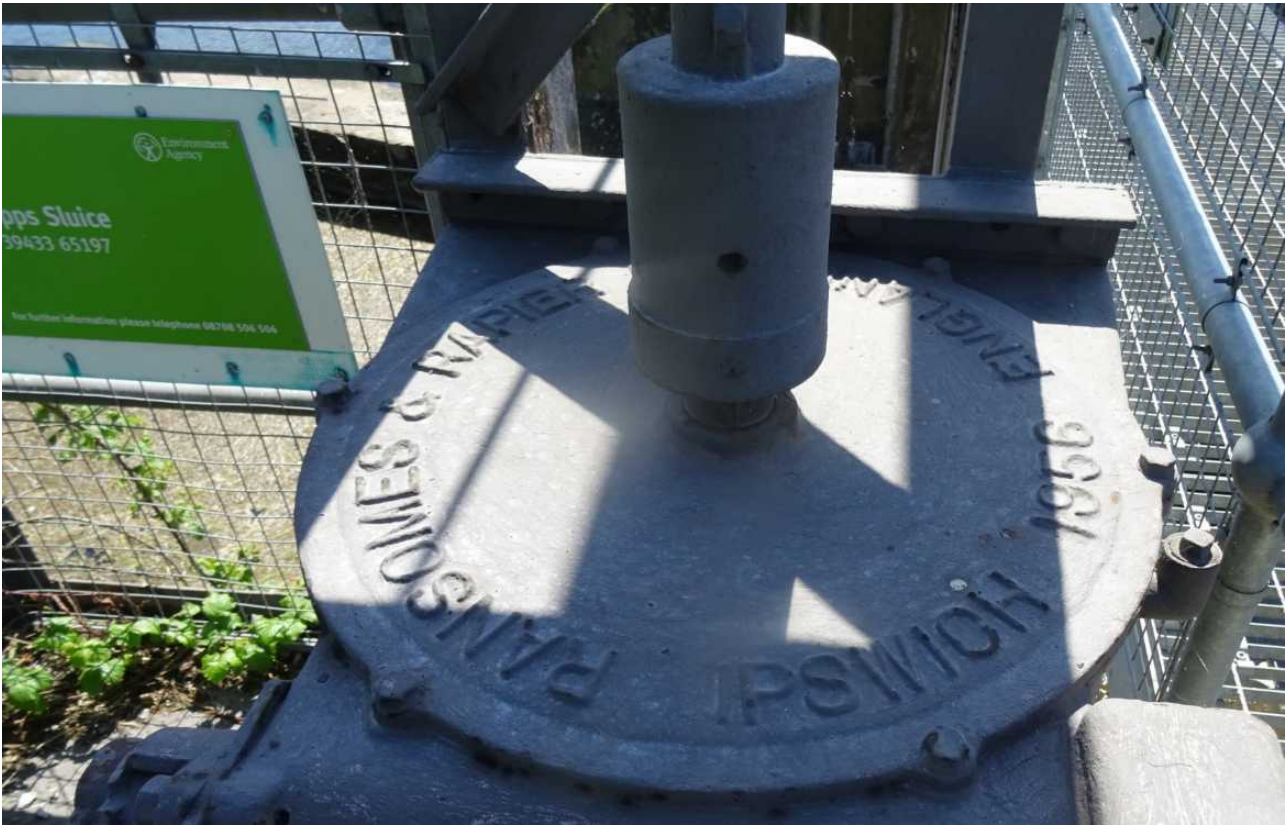
Fig 39: It is quite rare for archaeological sites to bear convenient dating evidence!

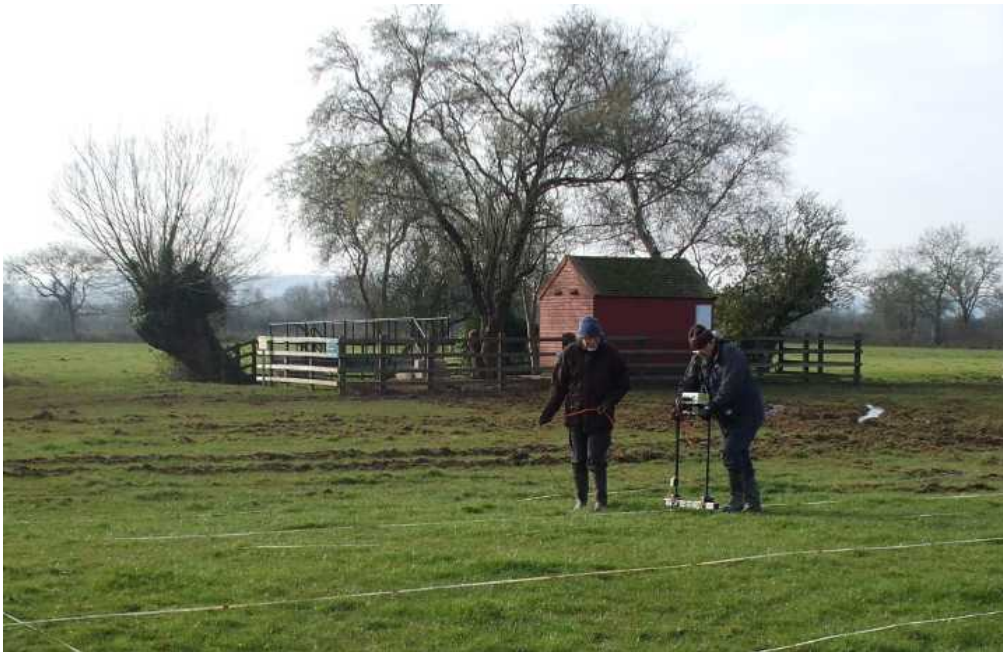
Fig 40: Water metering structure at Iwood from east and YCCART team

A water meter at Iwood (which can be consulted on-line to check current water levels - riverlevels.uk/congresbury-yeo-congresbury-iwood).
