YCCART 2024/Y3

Crossing the water: Congresbury Yeo: the other bridges (Wrighton to the sea)

**YATTON, CONGRESBURY, CLAVERHAM AND CLEEVE ARCHAEOLOGICAL
RESEARCH TEAM (YCCART)**

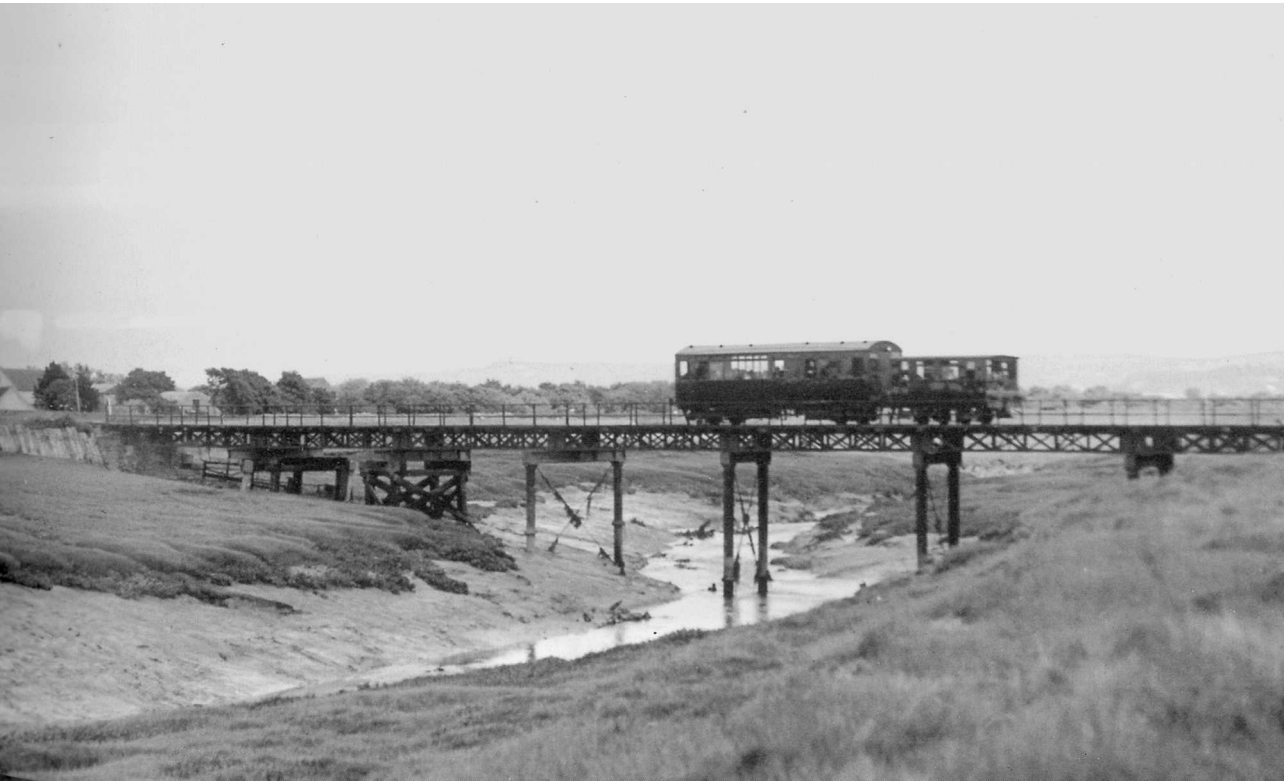
This bridge was specifically created for the WC&P railway, and is shown in use below (Fig 41).

Fig 41: Weston, Clevedon and Portishead bridge in use c1930 (Mitchell & Smith 2003)

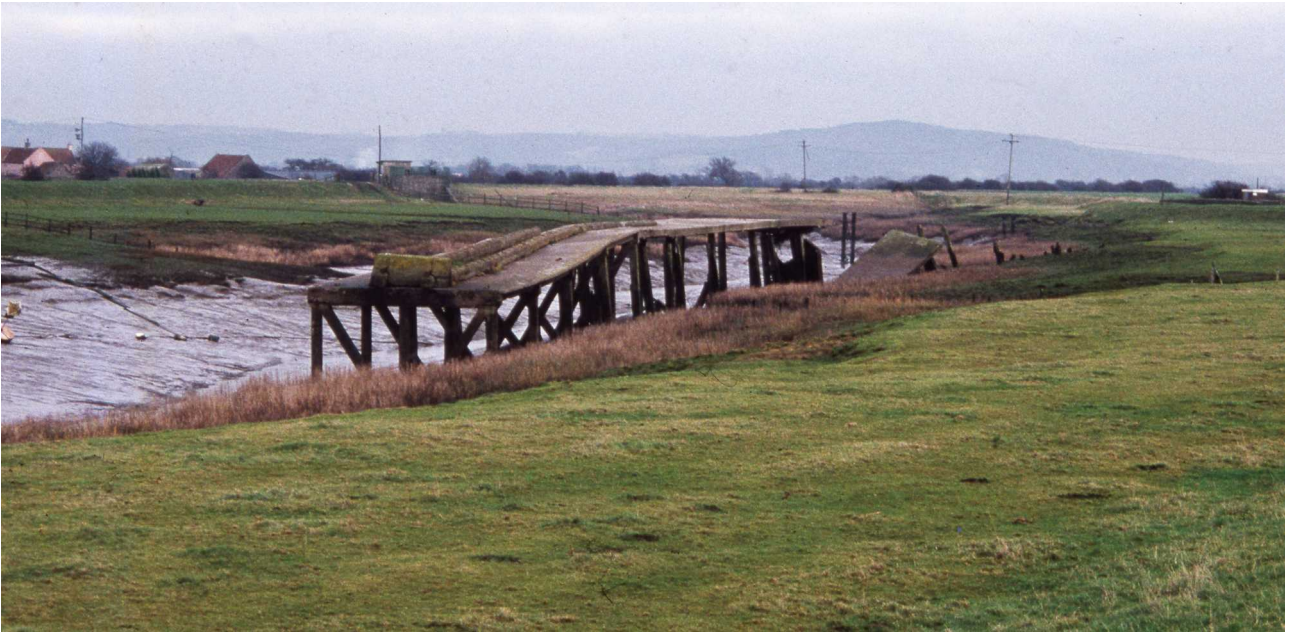
Fig 42: 1912 jetty at Wick St Lawrence, 1998

A wreck of the jetty survives today (Fig 42): when visiting in c 2000, I was told by a local farmer that during construction, the company had stored some of the pre-cast sections in his farmyard, and that there were two still there!

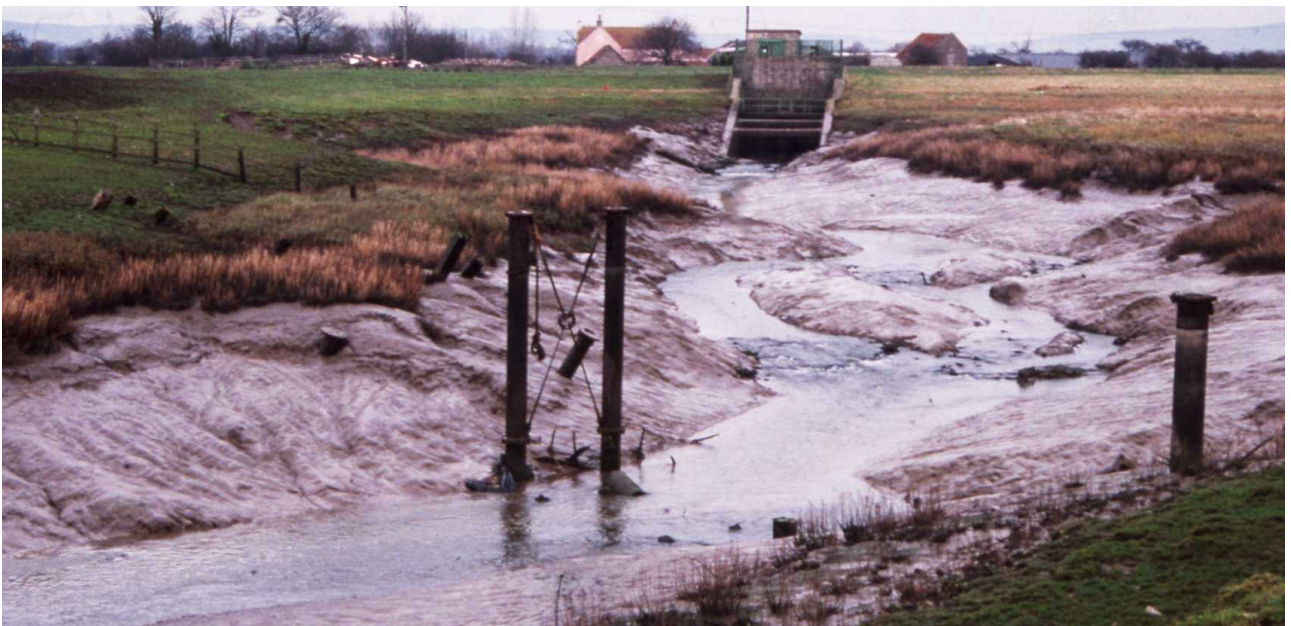
Fig 43: Bridge stanchions, 1998

The western side can be seen in the background of Fig 43 above.

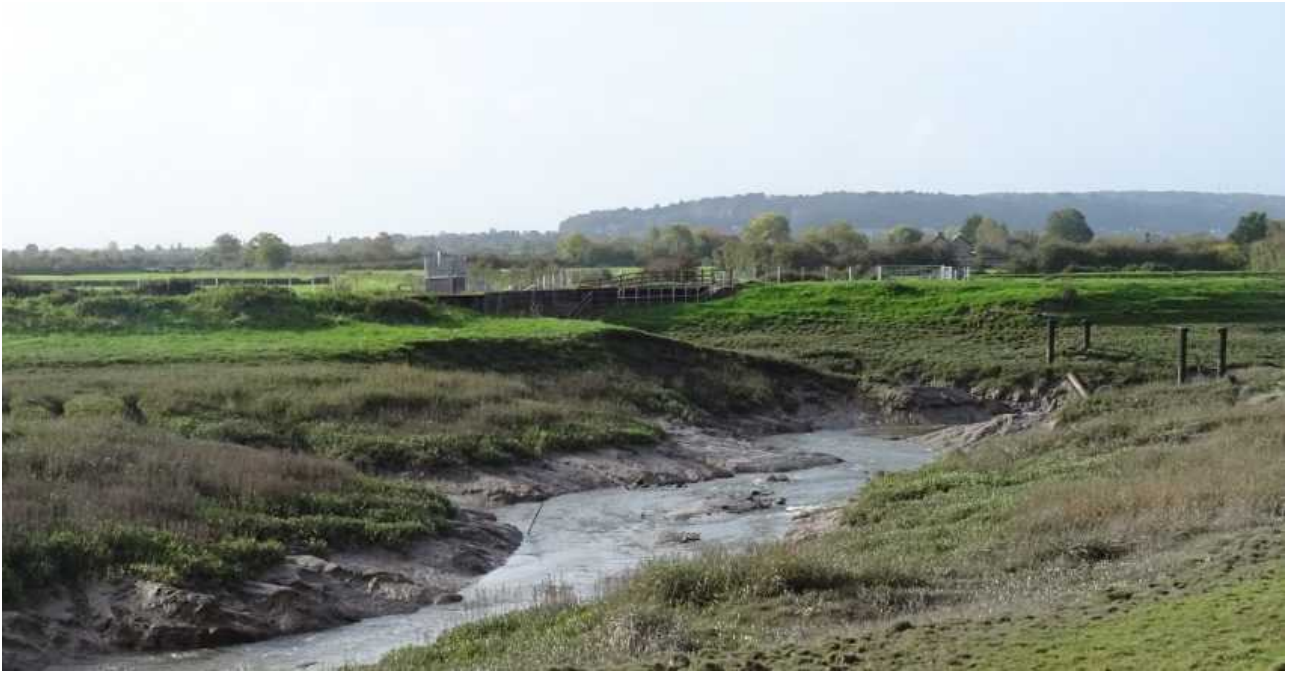
Although they have partly fallen over since 1998, the stanchions still mark the line of the railway today (Fig 44 below).

Fig 44: The bridge stanchions at Tutshill Ear, October 2023

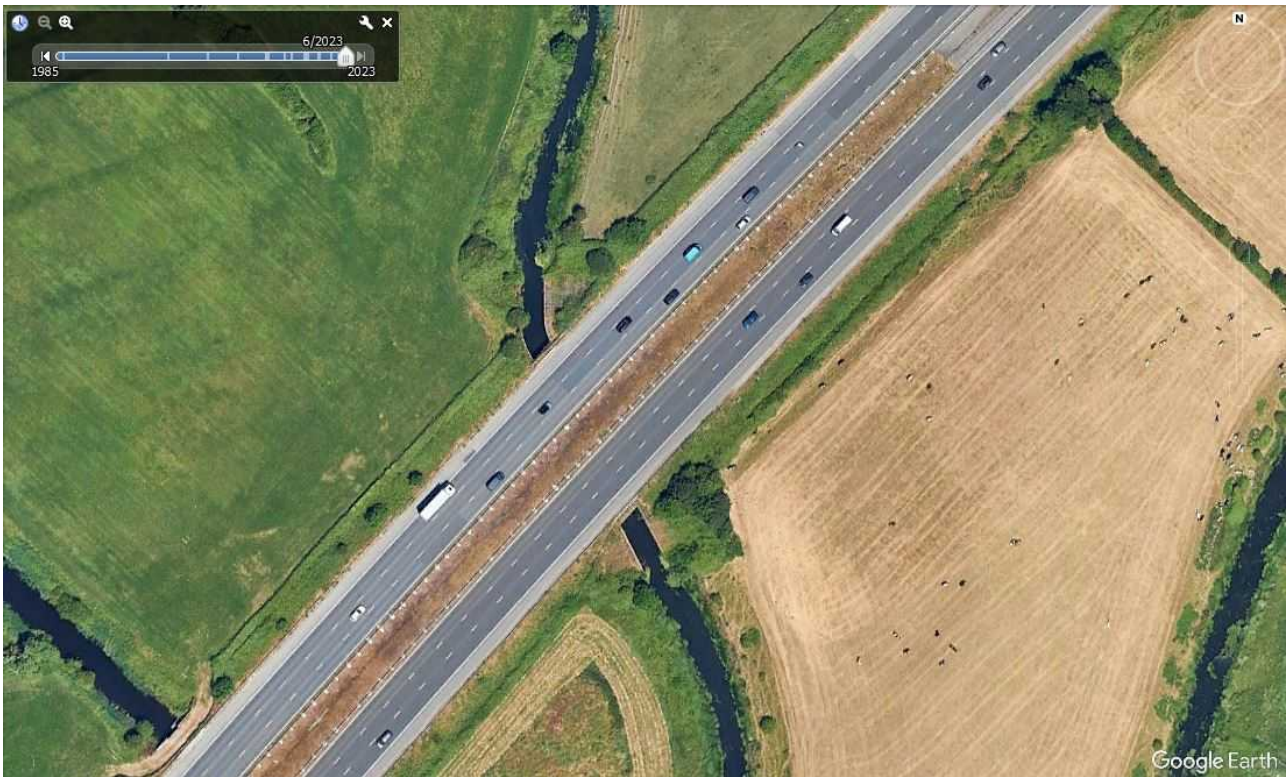
Fig 45: M5 river crossing at Wemberham, 2023

This bridge, a typical cast concrete motorway river crossing, was constructed between 1970 and 1972. There is no passageway or footpath through it.

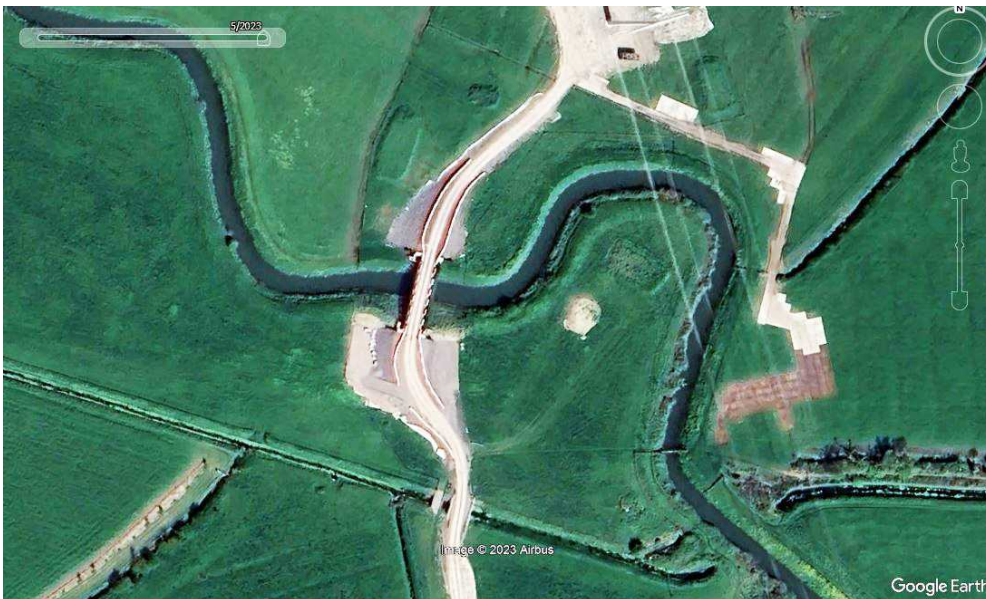
Fig 47: Hinkley construction bridge at Pillhay, May 2023, crossing Congresbury Yeo and New Rhyne.

At the time of writing, a large number of temporary bridges are being used on the Hinkley C connection project, which is erecting new 400kV lines on new T-pylons, among other areas from Sandford cross-country to Nailsea.

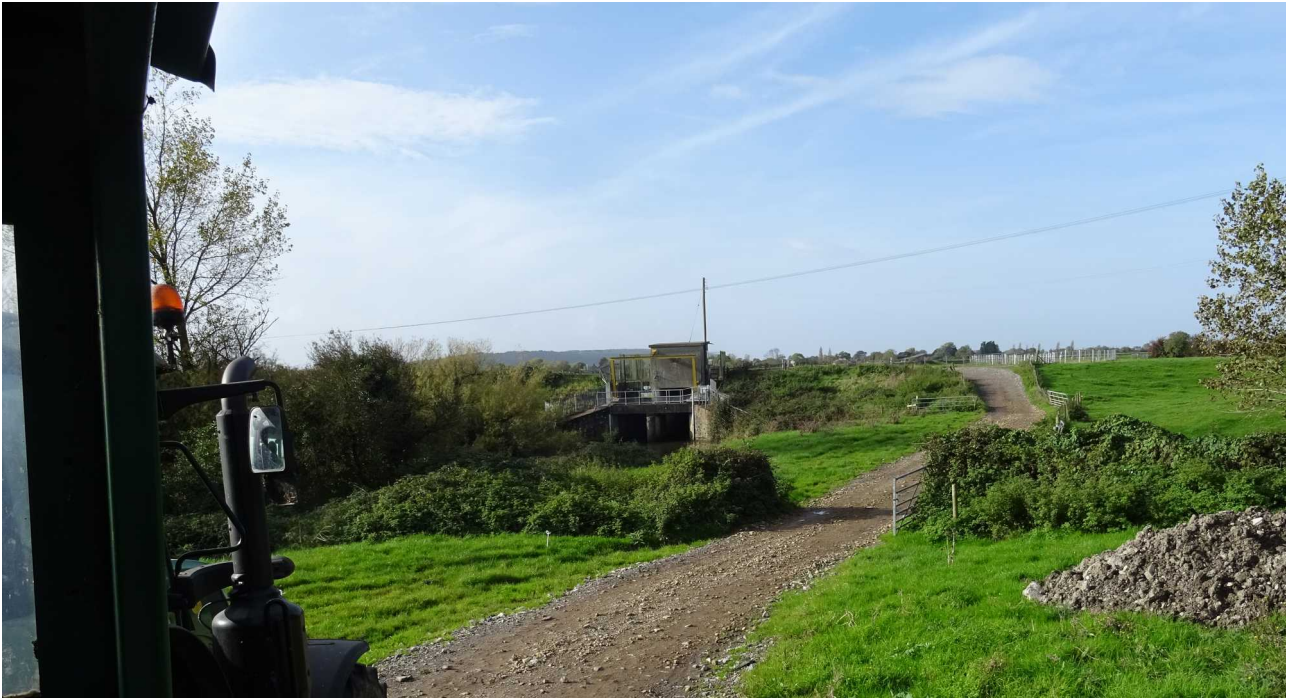
The sluice was the result of major engineering in the 3rd quarter of the 20th century (between air photographs of 1946 and 1971) and included a substantial realignment of the Yeo at the point, the old river course being partly backfilled to carry the track.

Fig 50: Tutshill ear sluice, 2023

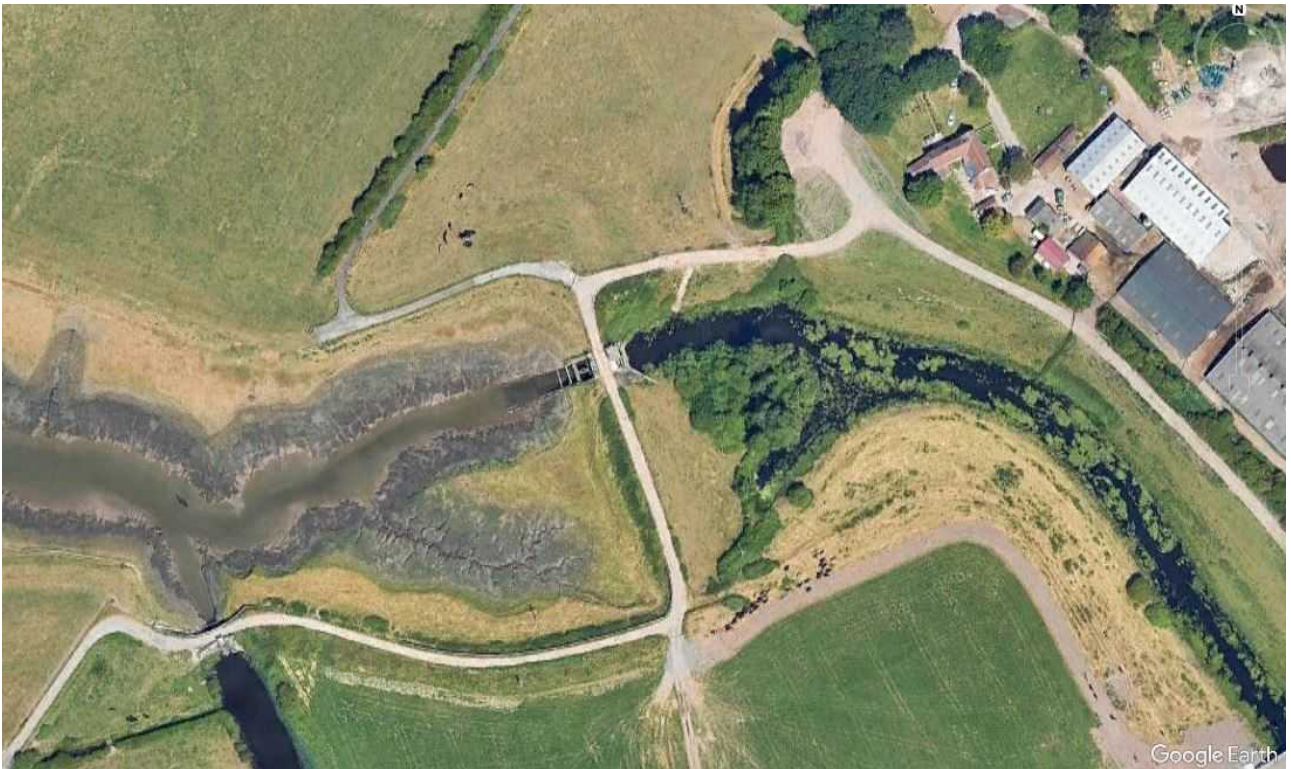
Fig 51: Tutshill Ear sluice, 2023
