**YCCART 2024/Y4**

**A nineteenth century limekiln at Prestow Wood, Wrington  
North Somerset HER MNS1126**

**Prestow Wood Conservation Group  
YATTON, CONGRESBURY, CLAVERHAM AND CLEEVE ARCHAEOLOGICAL  
RESEARCH TEAM (YCCART)**

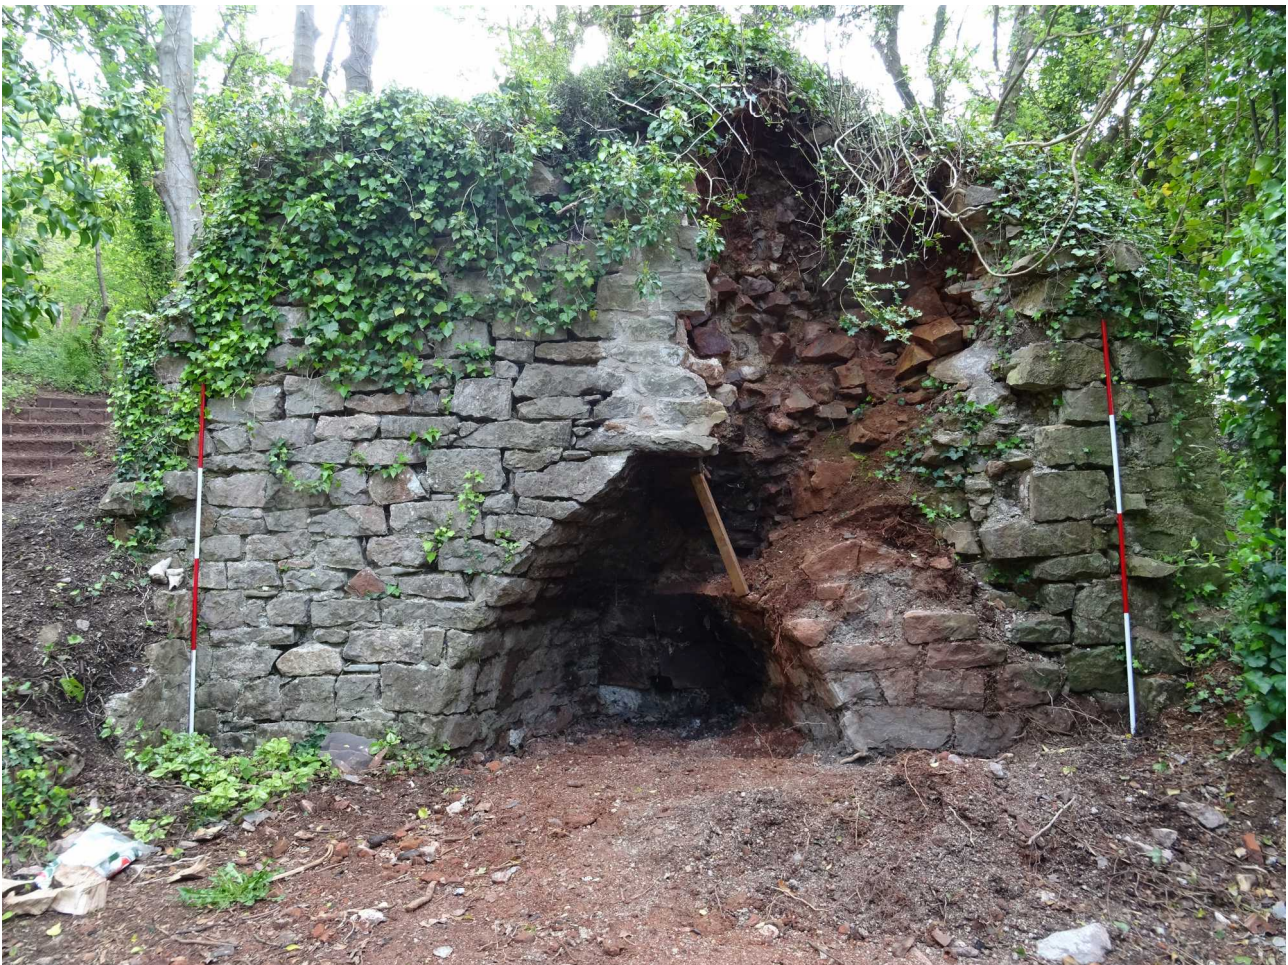
Front elevation of the western limekiln at Prestow Wood before conservation repair

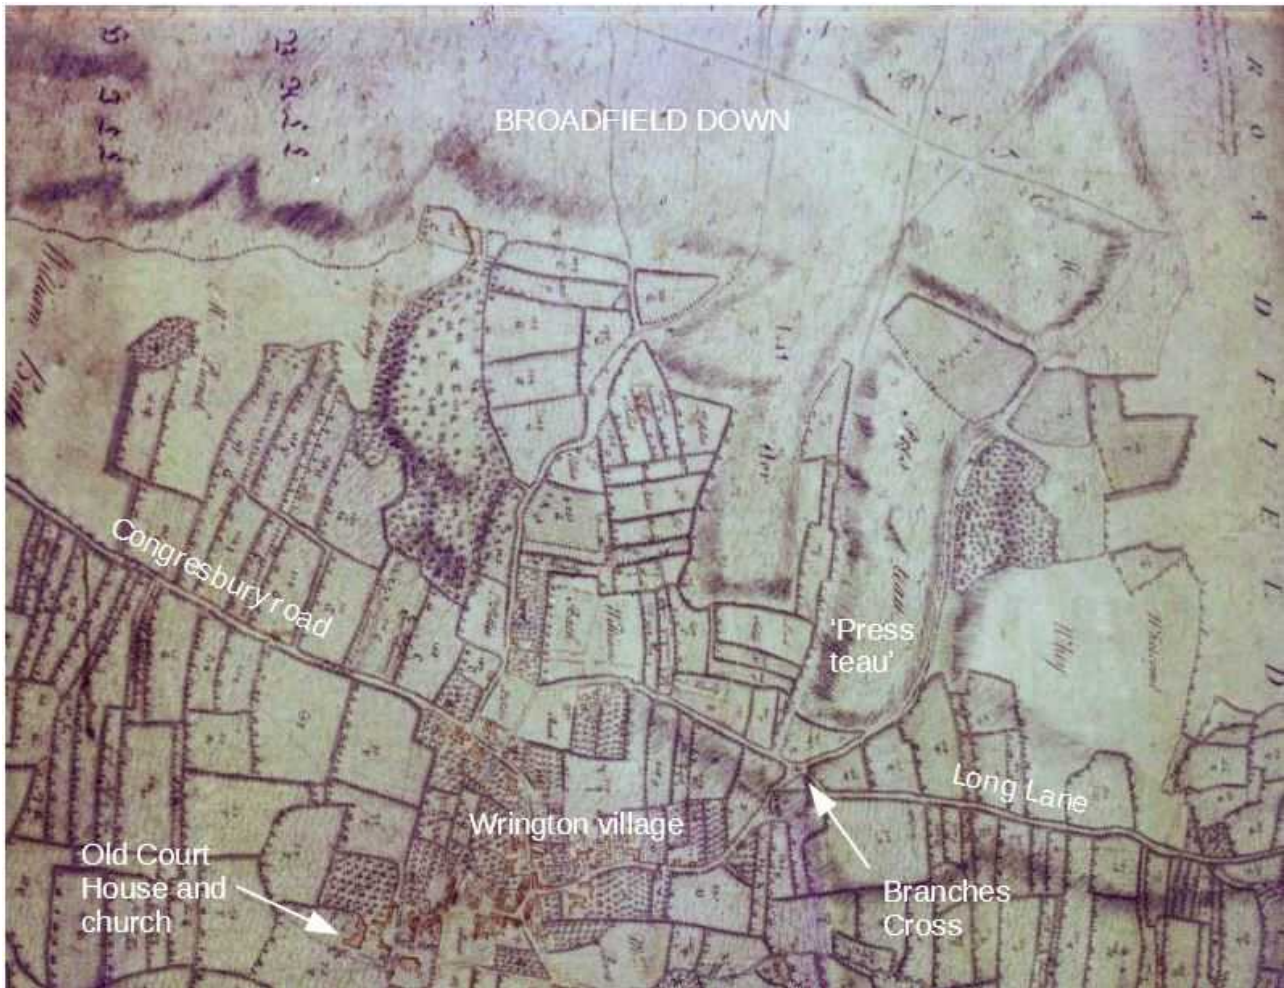
Fig 3: 'Presteau' from the 1739 Wroughton map

According to this map, the lynch of Prestow was not wooded at the time - although bear in mind the reference in 1516: Prestow 'clumps of oaks worth 40s when cut' (Neale 1968), the old woodland being on the other side of Old Hill (Lane), above Barley Farm: according to Google Earth, this area is still wooded today.

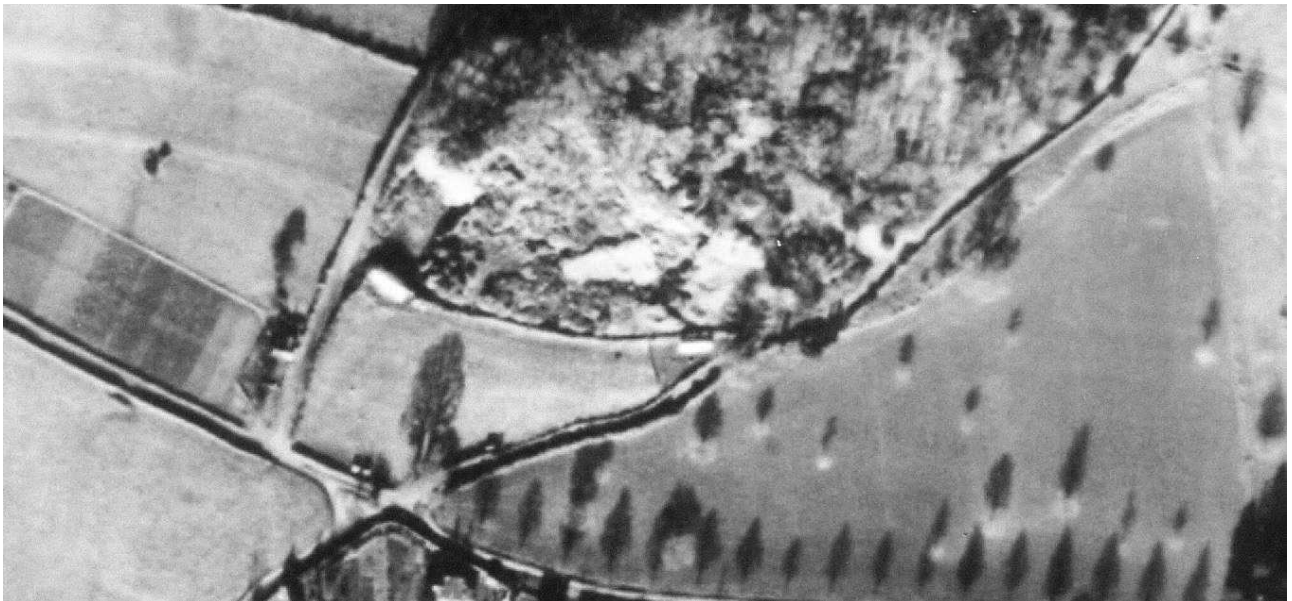
Fig 8: Prestow Wood quarries area, 1946 RAF air photographs

By the time of the 1946 air photographs of the area (Fig 8), the kilns and quarry had gone out of use, and were beginning to become overgrown.

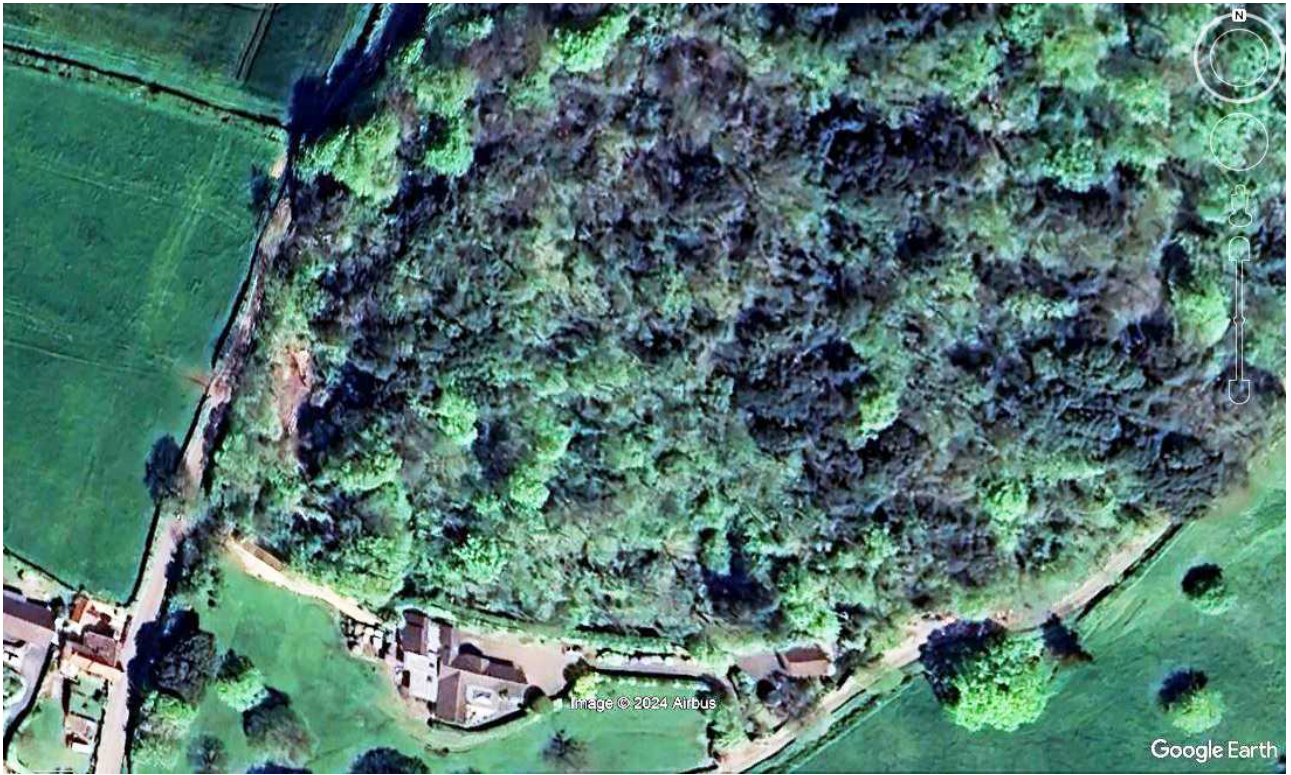
*Fig 9: Google Earth image of 2023 shows the cleared glade at the west side of the wood*

By 2023, the conservation work by the Prestow Wood Conservation Group was starting to be visible on air photographs (Fig 9 below): the work (of which this study forms part) continues.

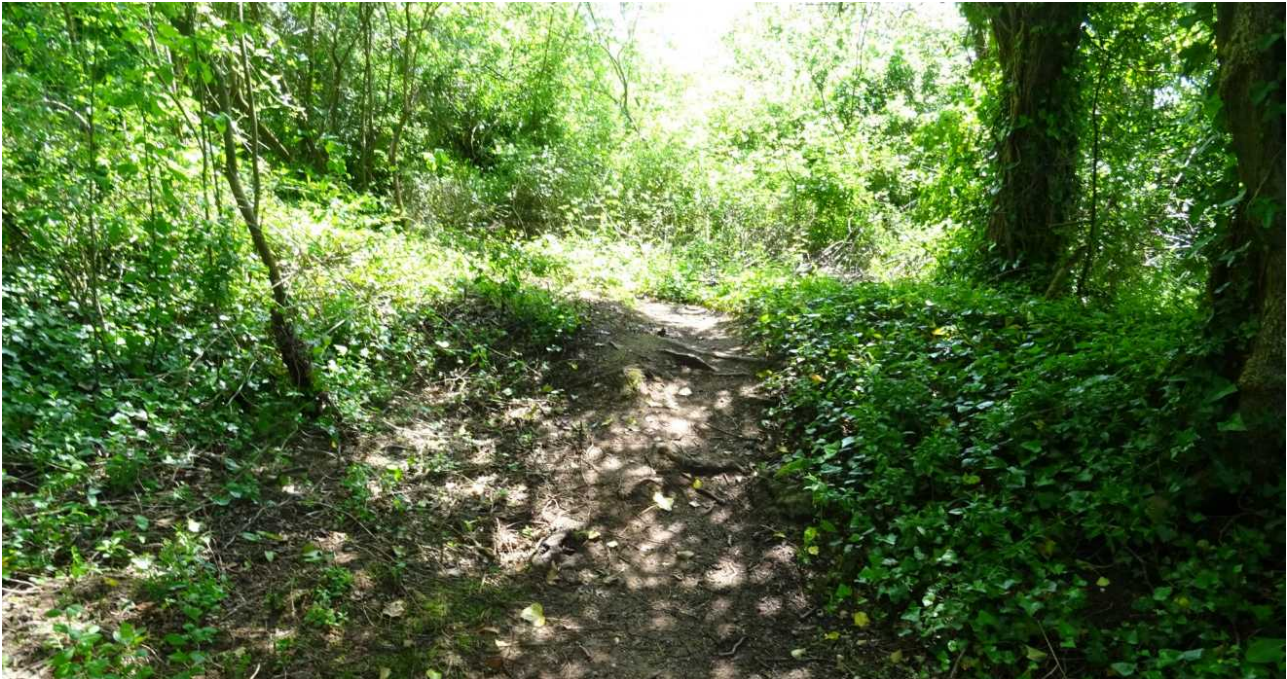
*Fig 10: Site chosen for trench 1: where path crosses linear earthwork at rear of kiln*

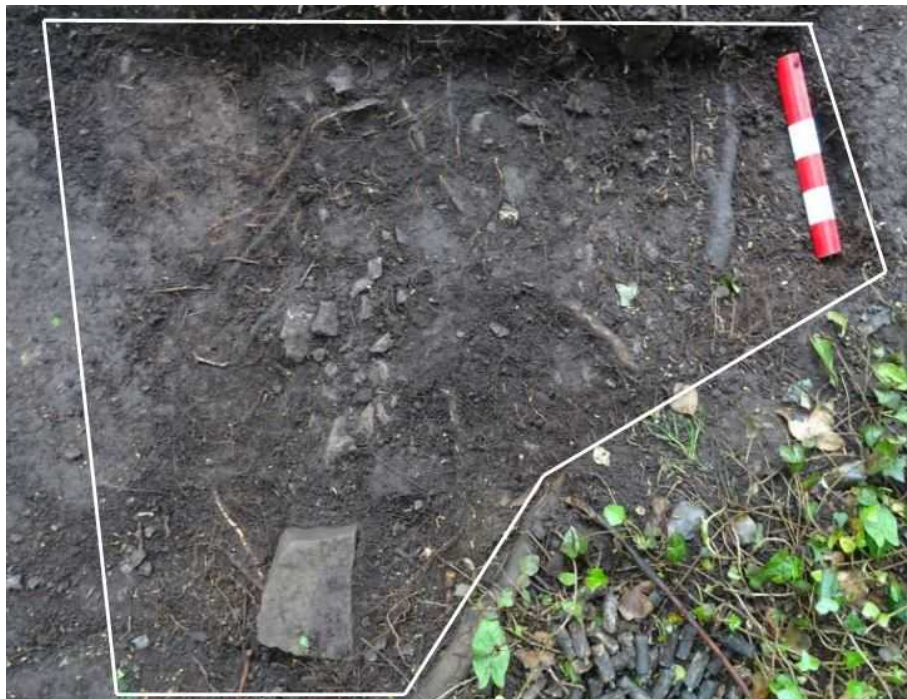
*Fig 11: Cleared section across ramp earthwork at rear of kiln*

The chosen area of trench had been worn by foot traffic, but a central gravelly section (much bioturbated by adjacent tree roots) showed in the centre.

Next to the trench on Fig 11 may be seen the one group of finds made in the trench - a group of 41 old 7V carbon-zinc batteries, whose origin is obscure!

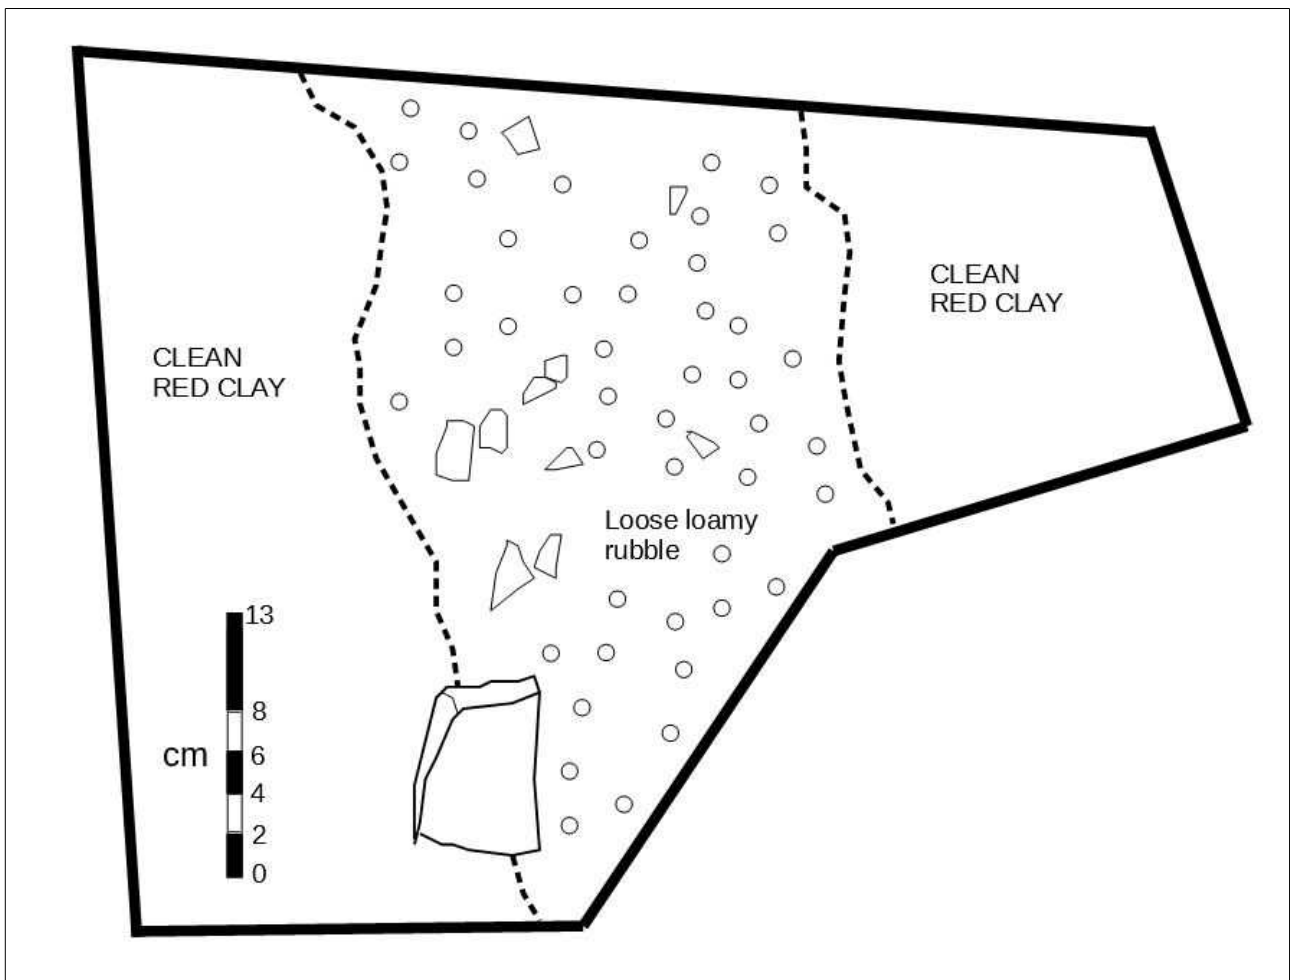
This feature (about 5cm thick in the centre: see Fig 12) is recognisable as the fill of a feature running directly across the path, along the earthwork.

The fill was of stoney loam and would have formed the fill of the ramp: by comparison with better preserved examples from Mendip (see Appendix 1), it is clear there would have been low walls on either side, which have been completely removed (apart from the one stone at lower left).

*Fig 12: Features in trench 1*

It was just about possible to recognise the imprint of the stones removed on the left side of the rubble, but these imprints were extremely shallow.

This is definitely enough, with the surviving linear earthwork and analogies with kilns on Mendip, to say there was indeed a ramp above the kiln, used to wheelbarrow coal and limestone to the top of the kiln.

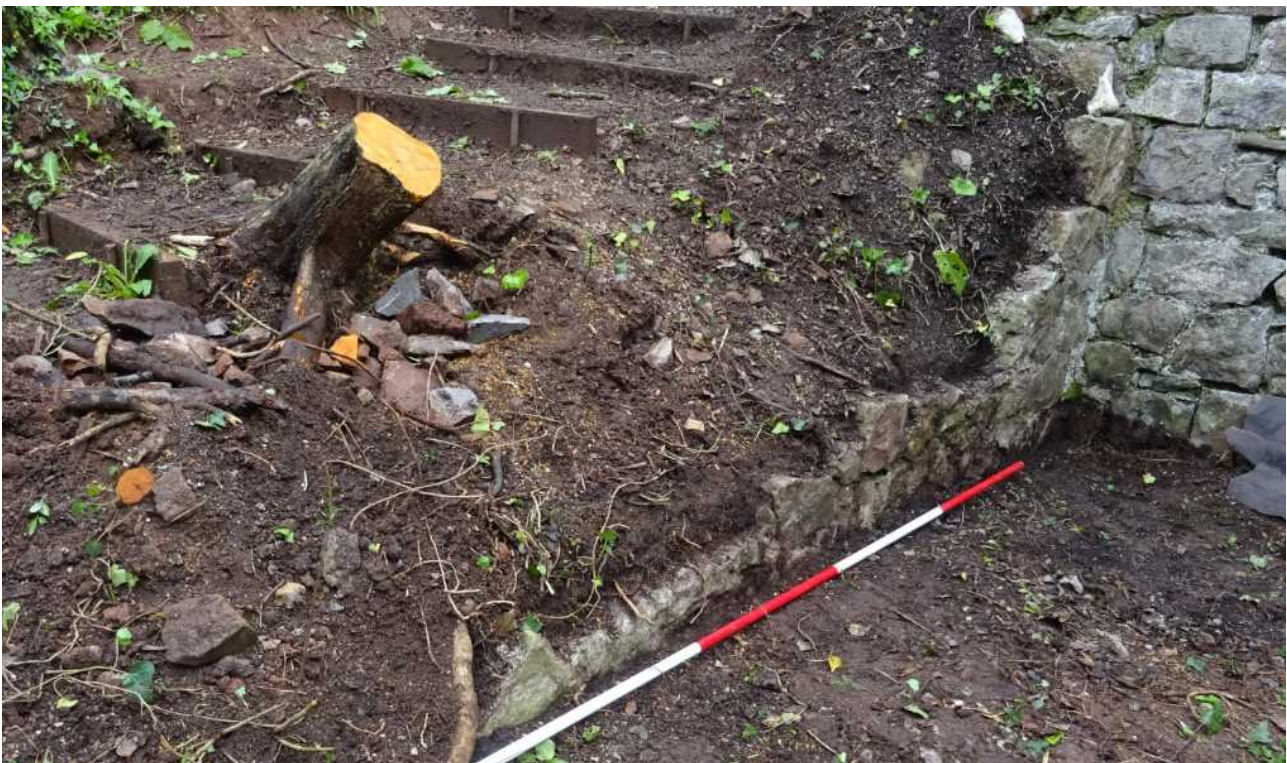
However, the north cheek wall, of which little had been thought to remain, was found on clearing ivy to survive for 3.2m, which appeared to be the end of the wall (Fig 13; Fig 14).

*Fig 13: North cheek wall of kiln cleared of ivy*

This not a typical cheek wall, since it also seems to function as a retaining wall to the slope north of the kiln, as can be seen in Fig 13 above.

Little now survives: at its eastern end it is built up against the structure of the front elevation of the kiln.

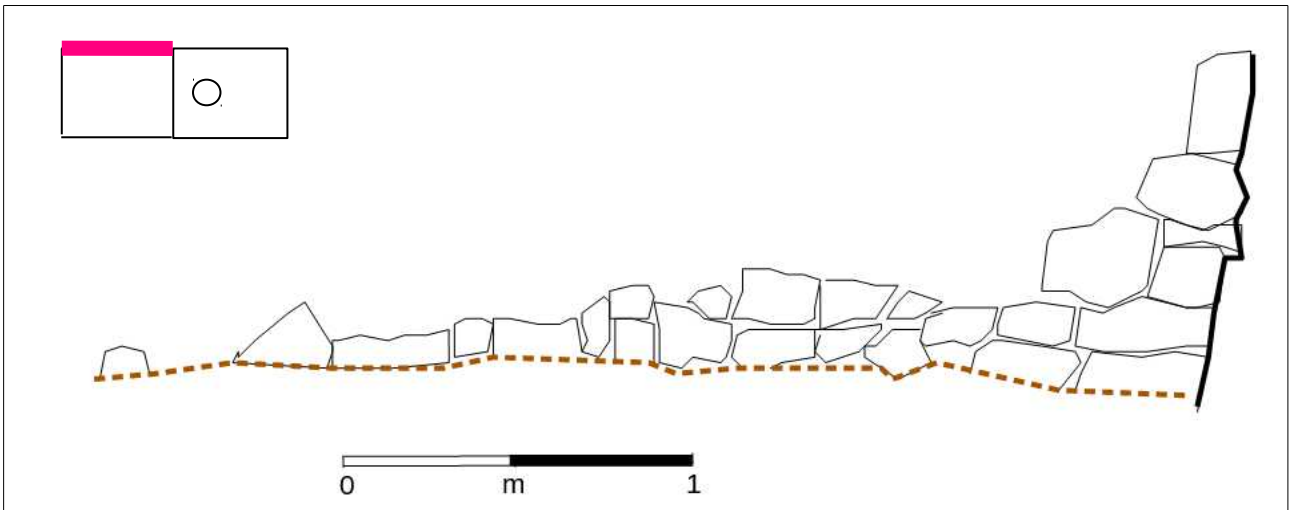
The evidence for both walls having once existed is clear on the front elevation of the kiln (see Figs 14 and 20 below), as spreads of mortar smeared on the faces of the stonework, above that resulting from building the kiln itself.

Fig 14: Elevation of north cheek wall of kiln

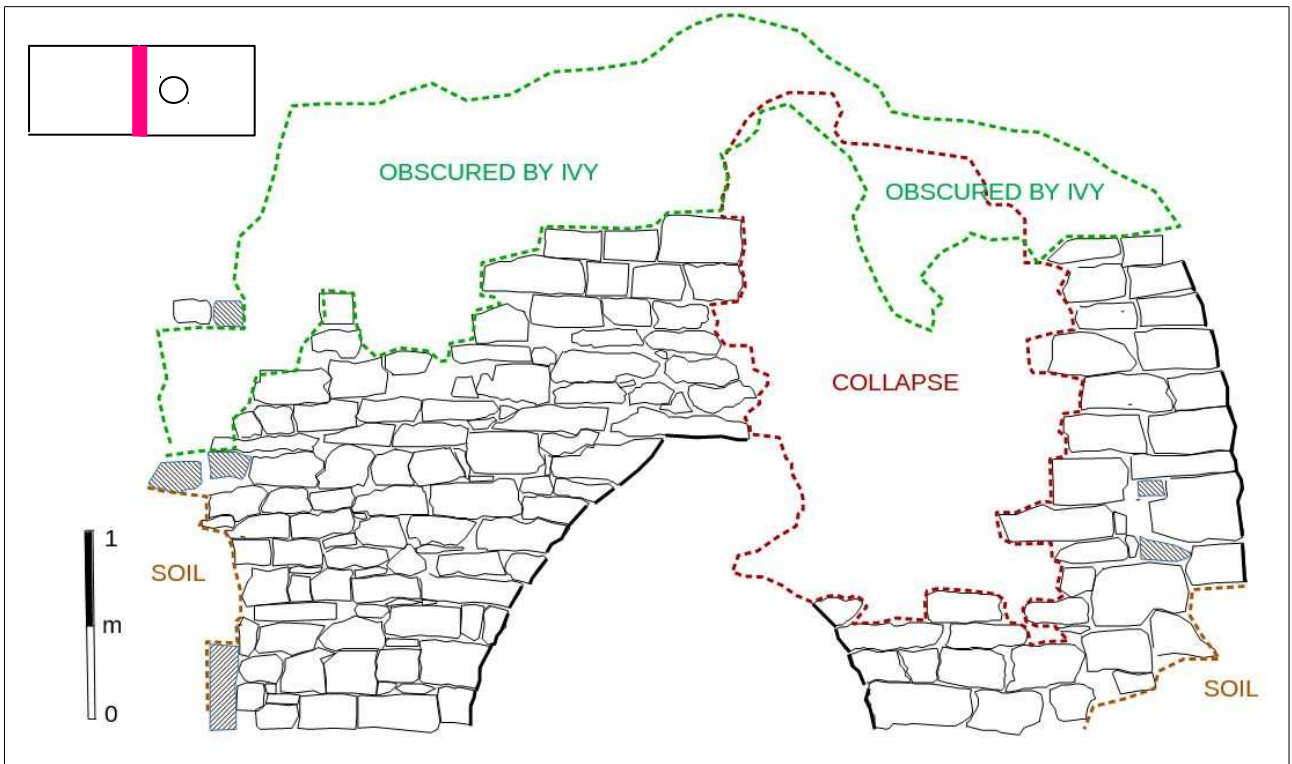
Fig 15: Front elevation of kiln (4.70m wide)

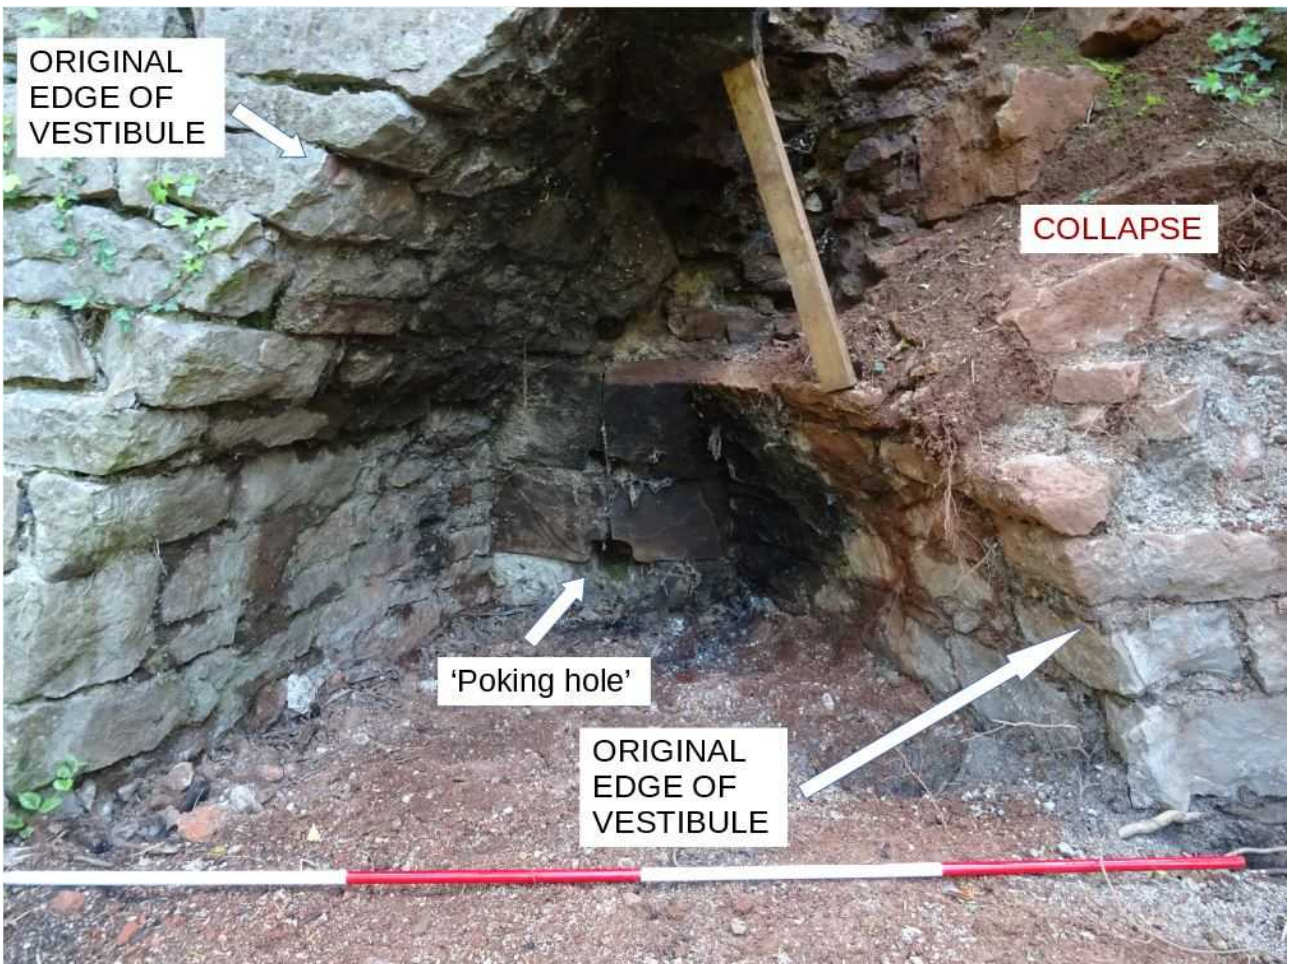
The central hearth / vestibule (both names are in common use) was a recess in the front elevation of the kiln, where the poking hole was sited, so lime was removed from the kiln through this area.

Fig 16 shows this area at the west limekiln in Prestow Wood. The wooden stick is part of the 'safety' repairs to the kiln before evaluations began.

Fig 16: Collapsed hearth of the kiln

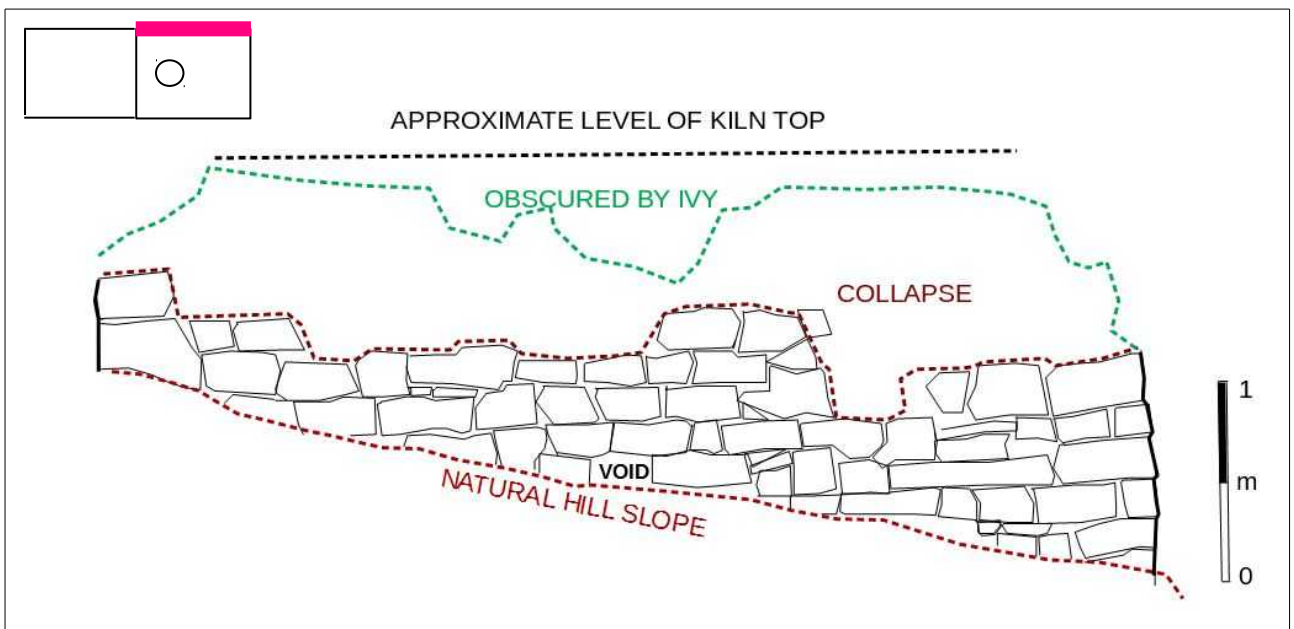
Fig 17: North elevation of kiln (front to right)

The side elevations of the kiln show how deeply it is buried in the hillslope.

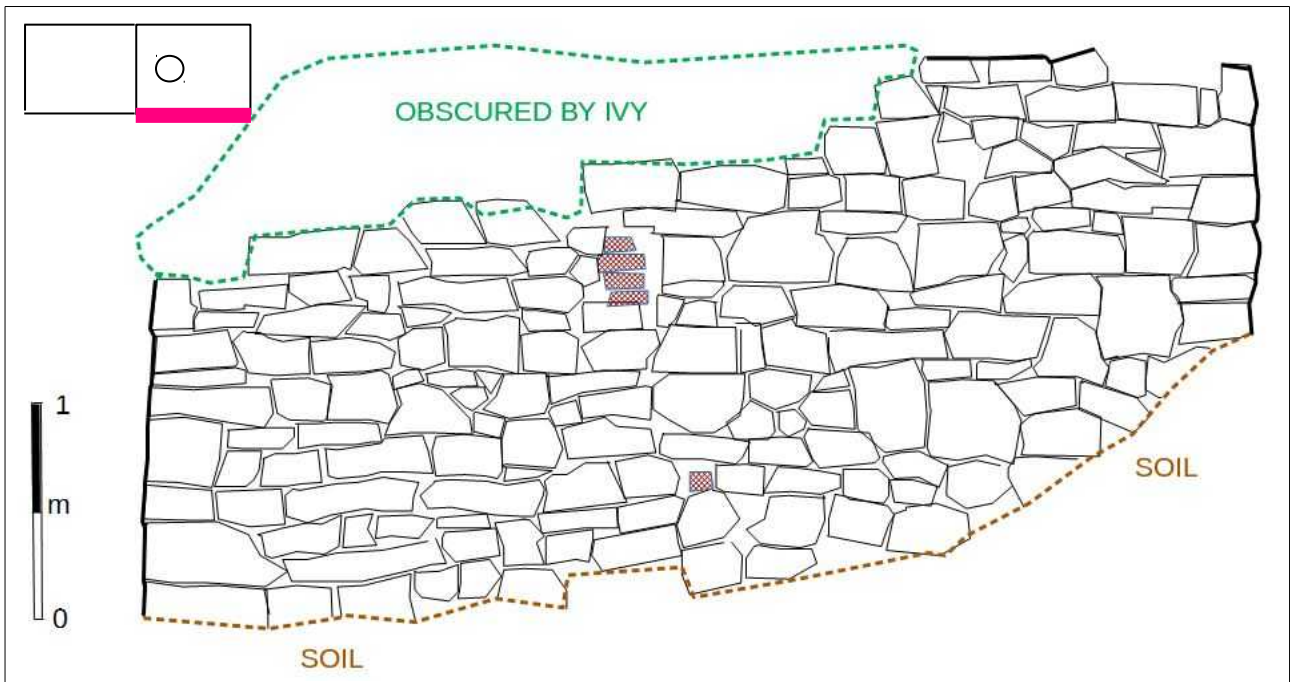
Fig 18: South elevation (front elevation to left)

In the centre top of the south elevation of the kiln is a rectangular opening, blocked with bricks and surrounded by smears of modern concrete.

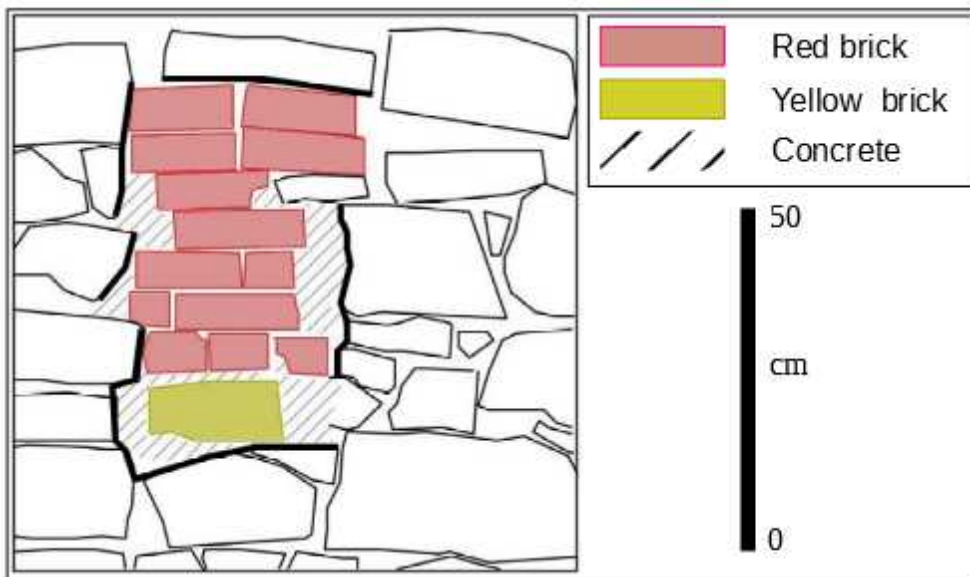
Fig 19: Filled-in feature in south elevation of kiln

These features, while rare, are not unknown: there is a good example in a kiln at the top of Batcombe Hollow, in Cheddar.

The inside of the feature becomes hot during firing.

These features are probably used for the drying of material for lighting the kiln (although local folklore at Cheddar says that it was used to cook the limeburner's dinner, which could also be true!)

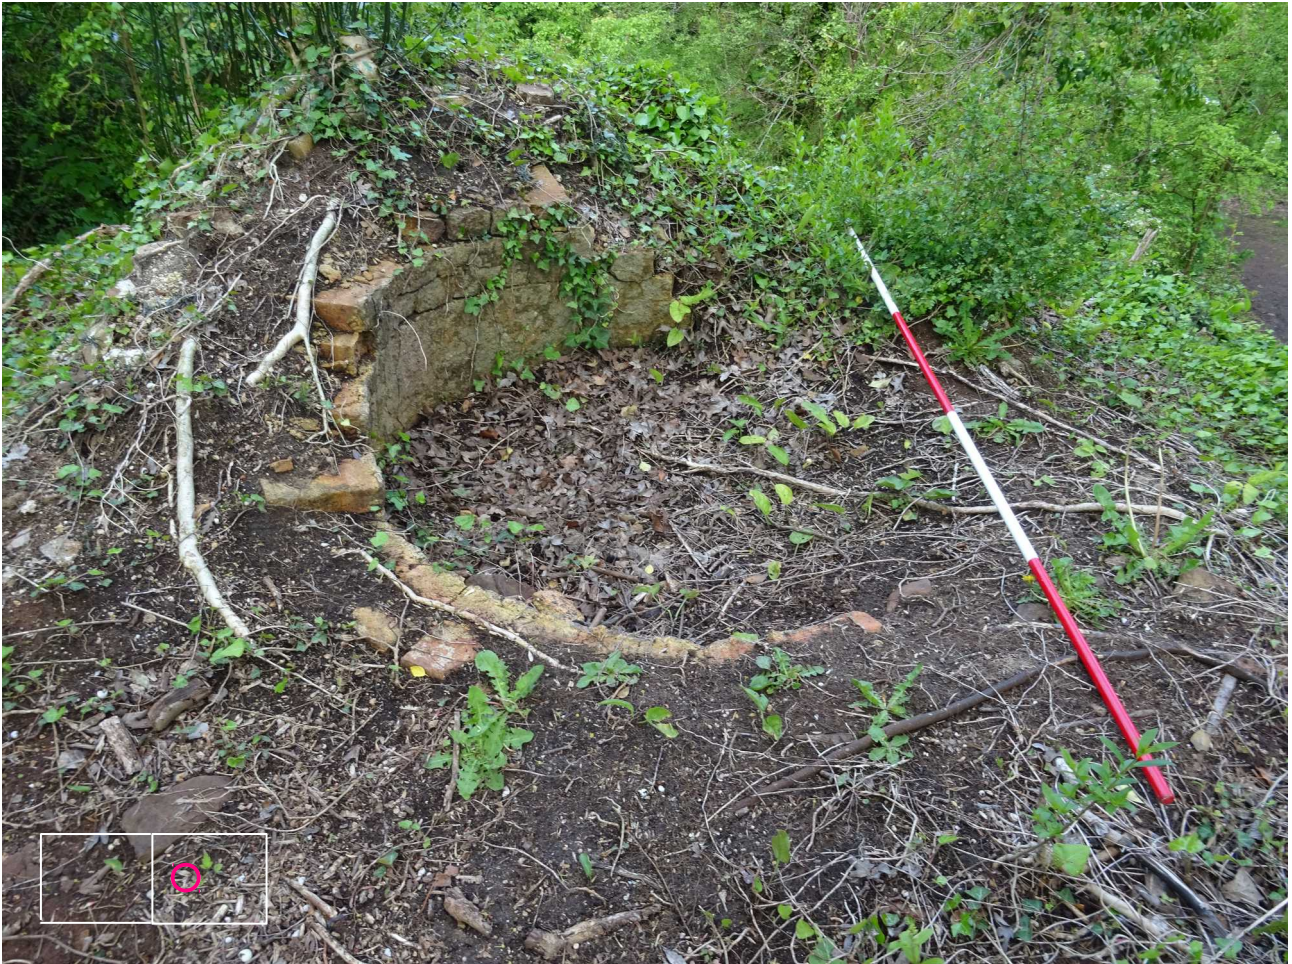
The top of the combustion chamber (Fig 21) is clearly visible after partial clearance of the kiln top surface.

The opening at the highest surviving course is approximately 1.5m wide, circular, and built with refractory yellow brick, being far more resistant to high temperatures than Carboniferous Limestone (which itself calcines) or red brick (which often melts at the temperatures involved). The usual lining in agricultural field kilns is simple limestone, but this kiln being semi-industrial in nature, and which therefore would see much heavier use, explains the use of the refractory brick. Limestone combustion chambers frequently require rebuilding, usually every several years (YCCART 2019).

*Fig 21: Combustion chamber, top surface of kiln*

The top of the chamber would have been flush with the upper kiln surface, which gives an indication of how much of the kiln has been robbed.

The top of the kiln would also have been levelled, to facilitate the movement to and from the combustion chamber with barrow loads of charge.
